LAN ASSOCIATES

**CONDITIONS ASSESSMENT
& RECOMMENDATIONS
FOR THE
HOMINY HILL CLUBHOUSE (BUILDING 1301)
HOMINY HILL GOLF COURSE
COLTS NECK, NJ**

LAN REFERENCE #2.2882.2
August 11, 2008

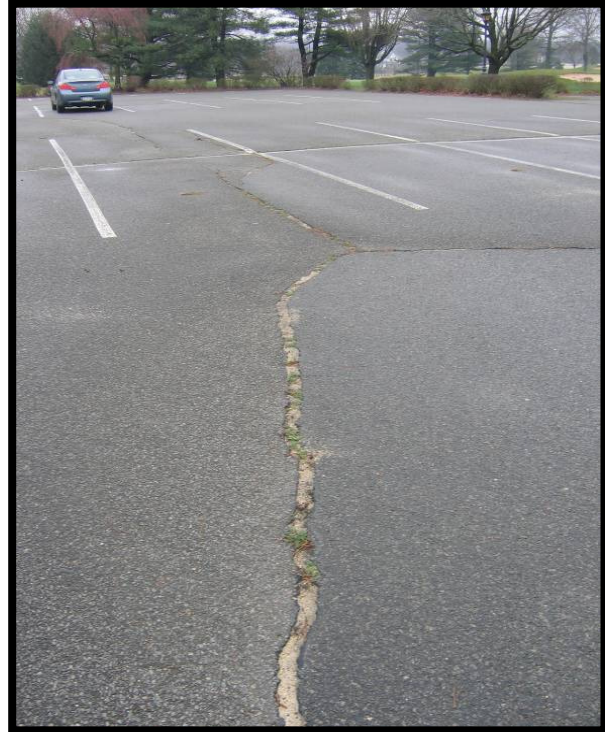
Photo No. 26

Depicts cracking and some deterioration of the main parking lot macadam.

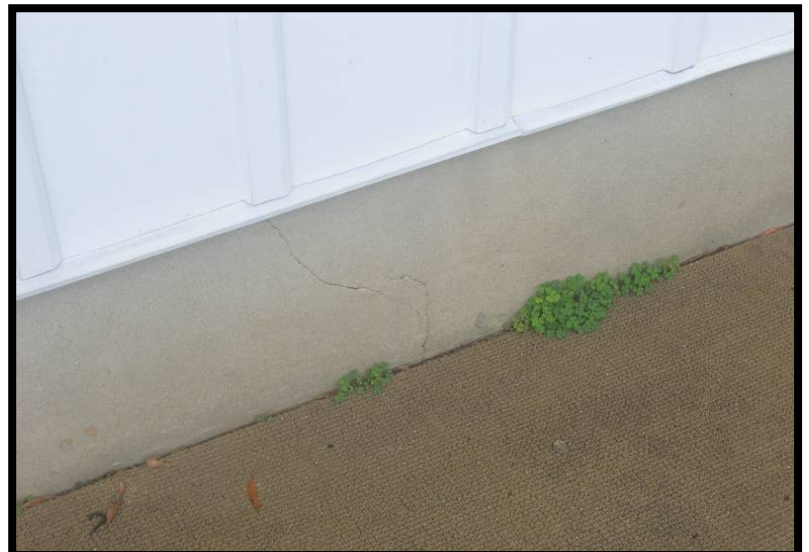
Depicts some cracking of parging of CMU foundation walls for the Club House.

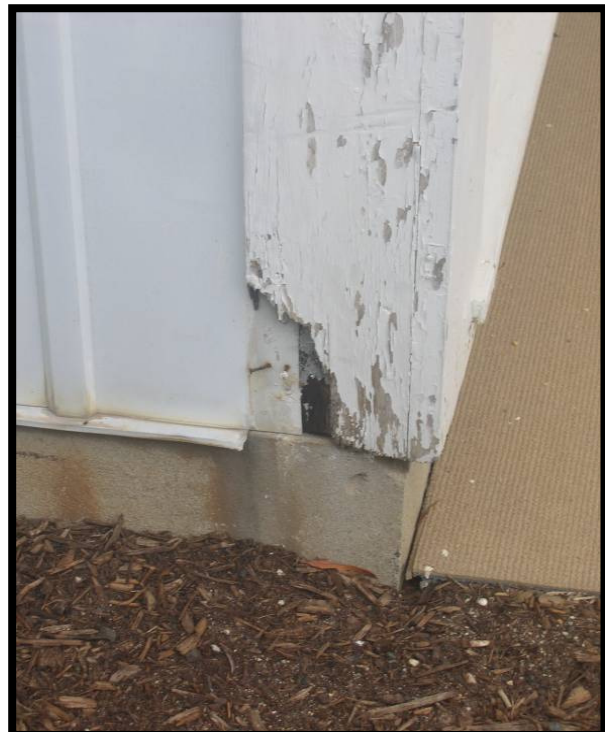
Depicts damage of wood corner trim boards at southwest corner of main entry.

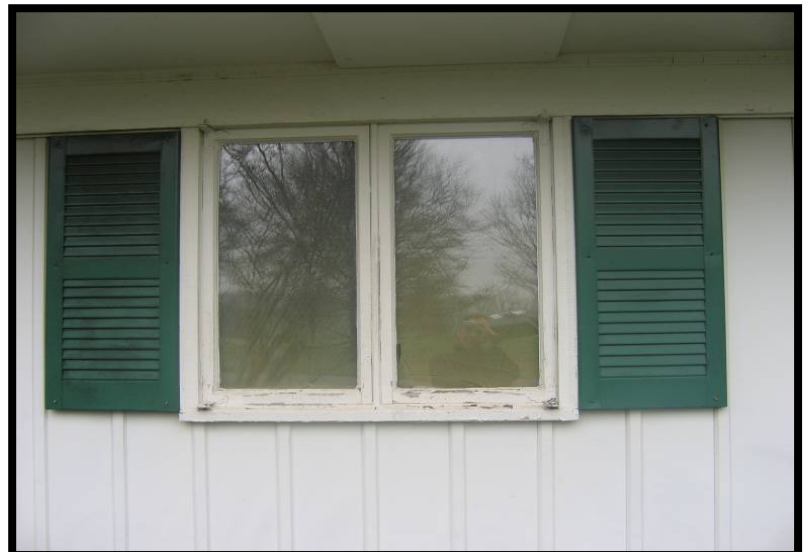
Depicts typical lower level casement windows and depicts exterior shutters. The windows are older Andersen single glazing with exterior wood finish which is in poor condition. Typical.

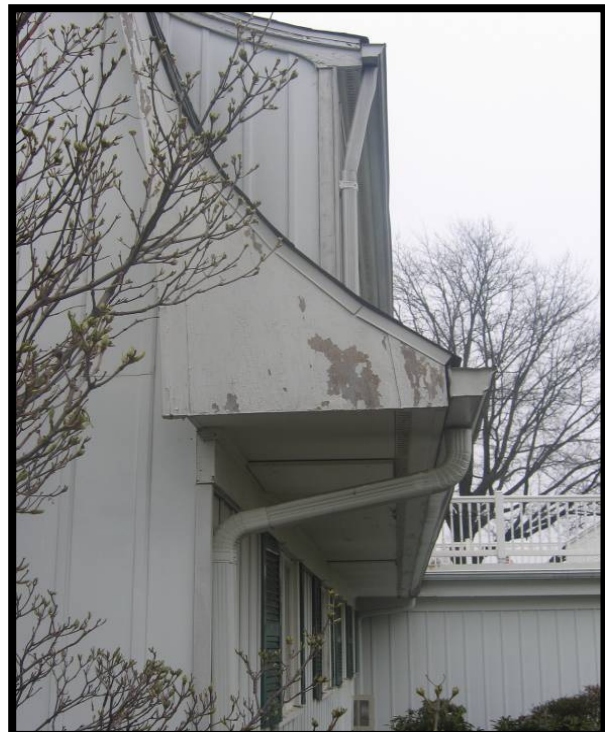
Depicts overall view of soffit, aluminum gutter, leader and roofing conditions at the southwest corner of the Club House. Wood trim repair and repainting are required.

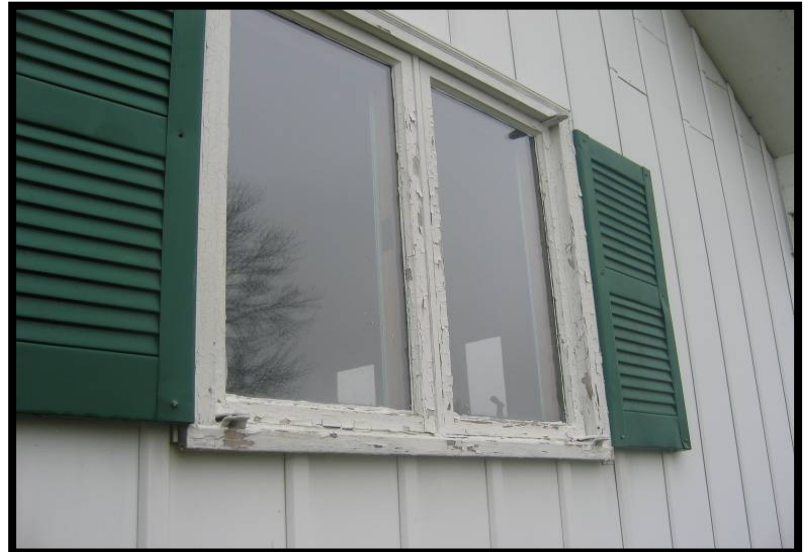
Depicts typical exterior casement window conditions at the first level. Note peeling paint on wood finishes.

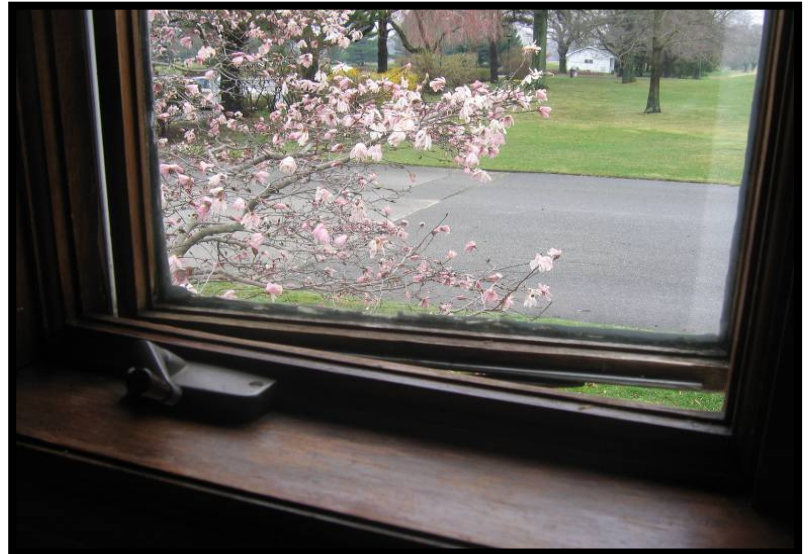
Depicts typical interior view of lower level casement windows and hardware which are in fair condition and are in need of replacement.

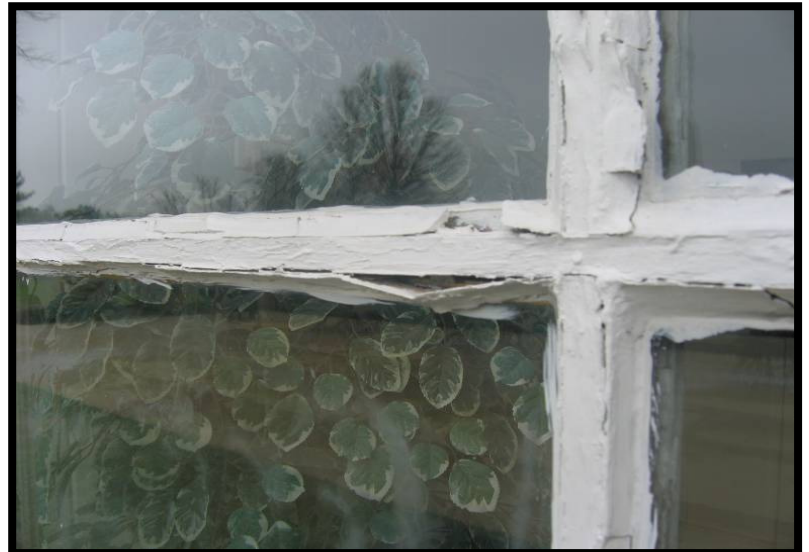
Depicts deteriorating window glazing and muttons at the main north vestibule entry to the Club House. Typical.

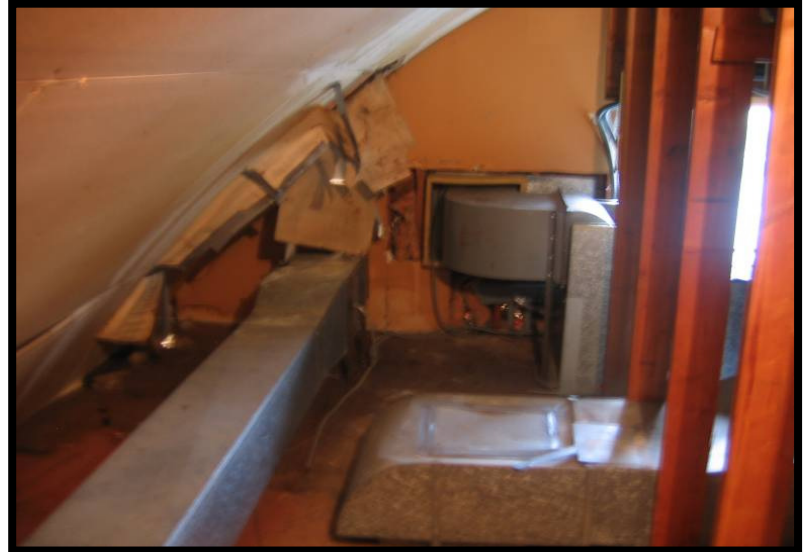
Depicts water damage of interior gypsum board in attic space at the northeast corner of the main Club House. The photo also depicts ductwork for HVAC and Kitchen exhaust systems.

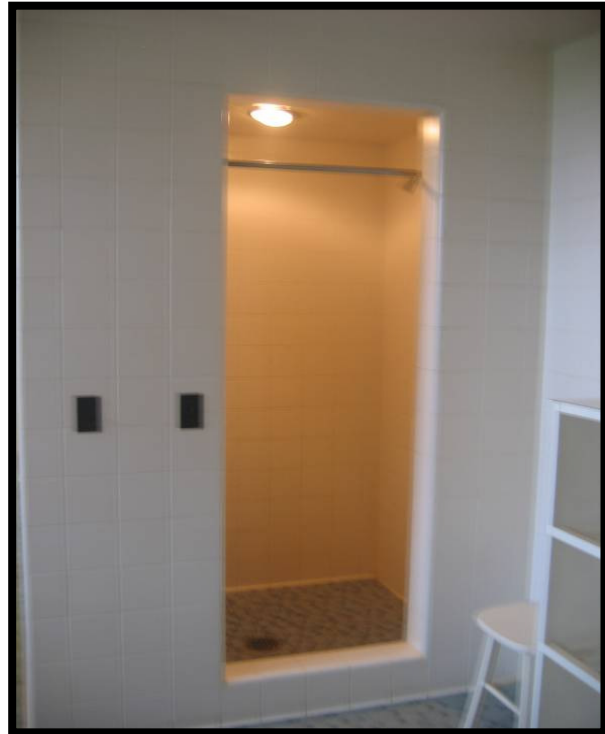
Typical entry to shower stall in Men's Locker Room facility. Note wall and ceiling tile is in good to excellent condition and was replaced. The original floor tile is in poor condition.

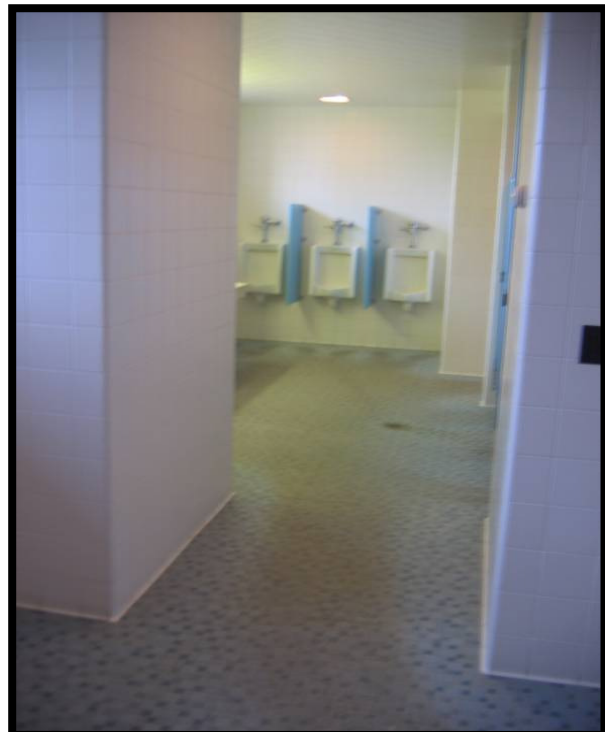
Depicts original floor tile in Men's Locker Room which is in poor condition. The photograph also depicts existing urinal installation along the west wall.

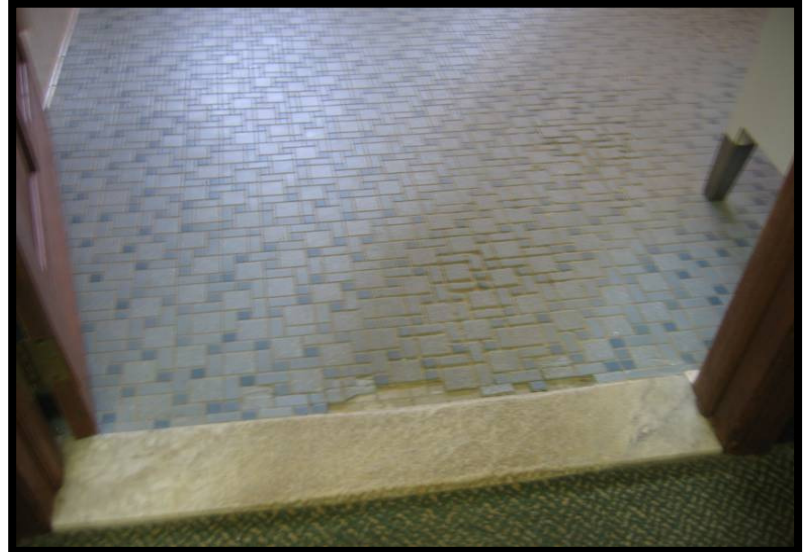
Depicts damaged marble saddle and ceramic floor tile in Men's Locker Room caused by golf shoe spikes which should be replaced.

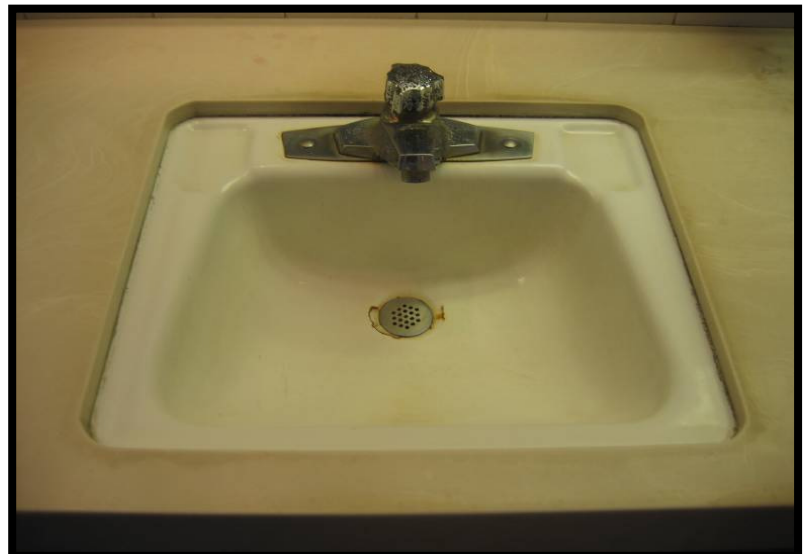
Depicts undercounted mounted lavatory typical for four (4) with metered faucet. Note the overall condition of the lavatories and faucets are in poor condition and should be replaced.

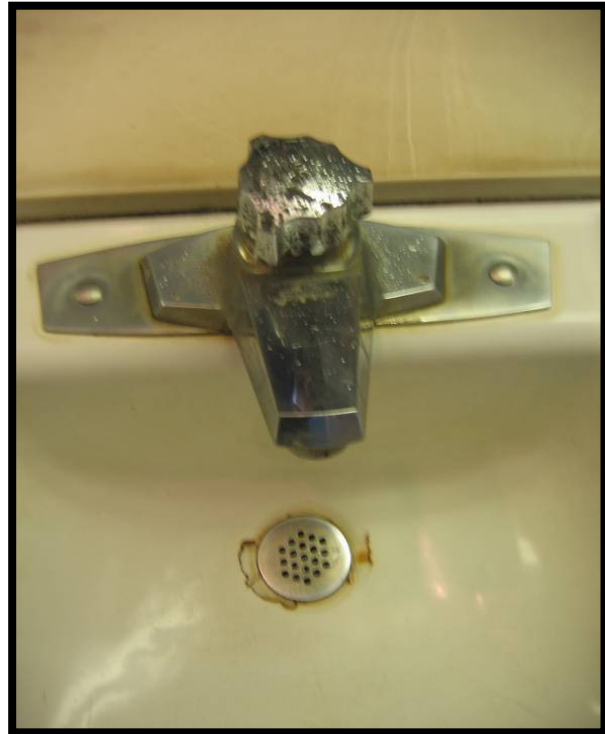
A more close-up view of rusting at the main drain of a typical lavatory and the metered faucet configuration.

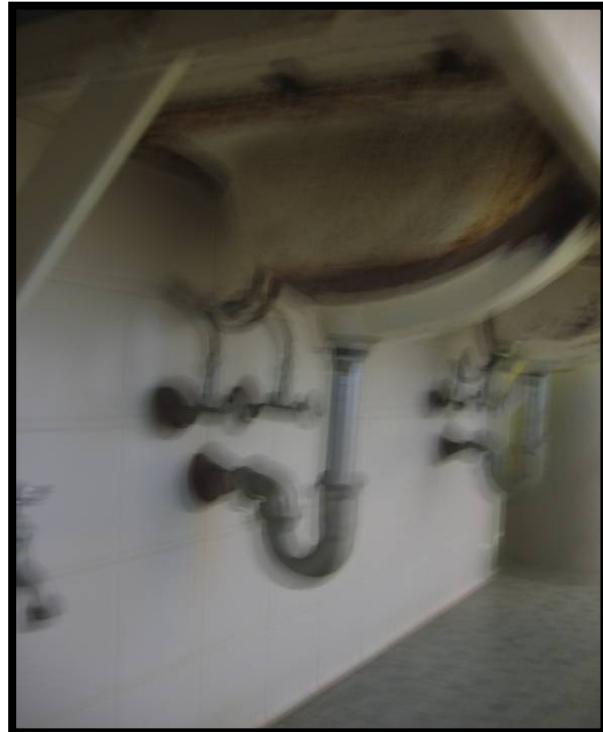
Depicts overall condition of underside of typical lavatory, P-trap, and supply hot and cold water piping. Note significant rusting on underside of lavatory.

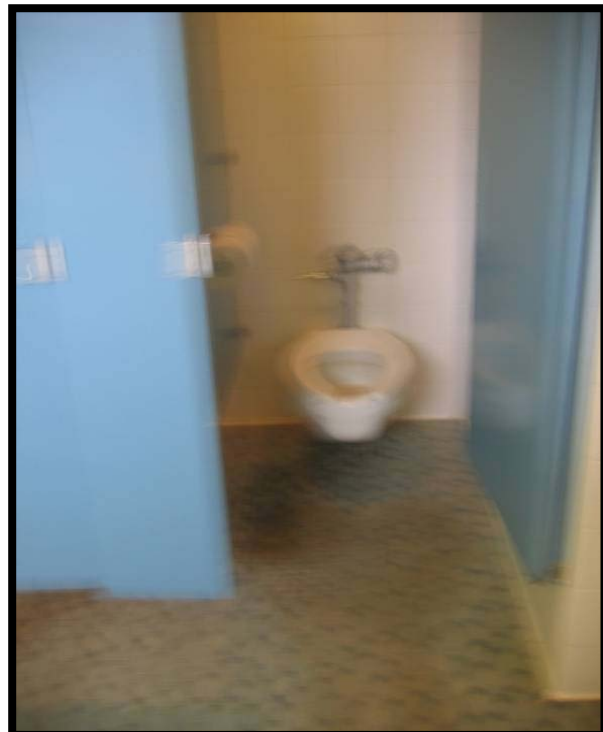
Depicts a typical water closet toilet partition configuration. Note the water closets are wall hung flushometers. Note that one (1) of the seals at the drain for the water closet has failed and is leaking water which should be repaired.

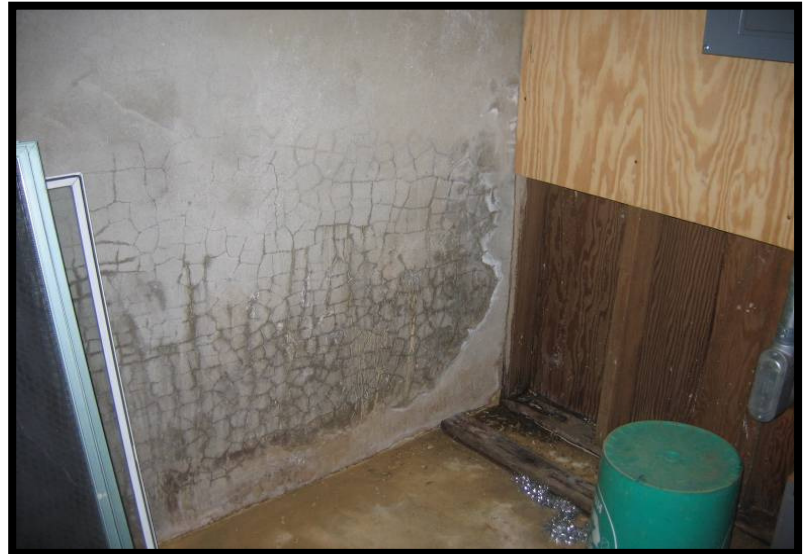
Depicts water damage at north wall of the Basement at the back side of the electrical panels.

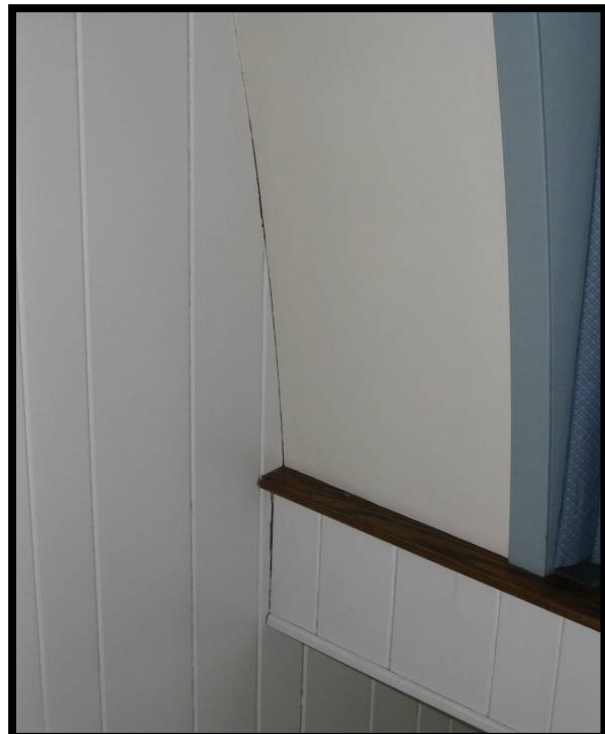
Depicts a view of a crack between the underside of the roof plaster and the wood wall paneling. This is located above the open staircase between the Foyer and the second floor.

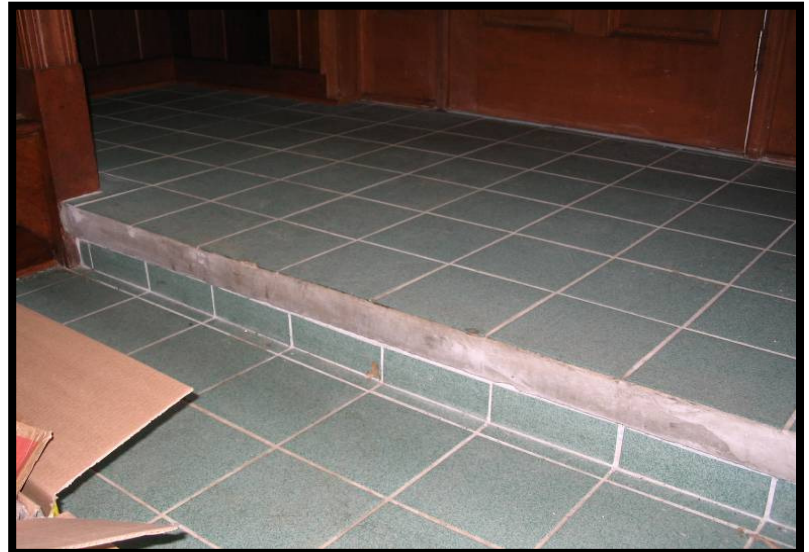
Depicts a view of the porcelain tile floor finish in the egress stairwell. It was noted that the tile is chipping at the nosing to the step.

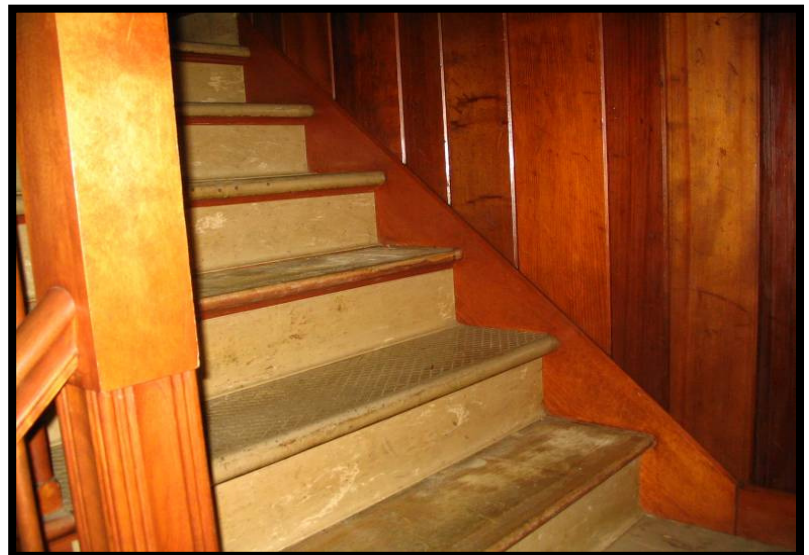
Depicts a view of missing treads in the egress stair.

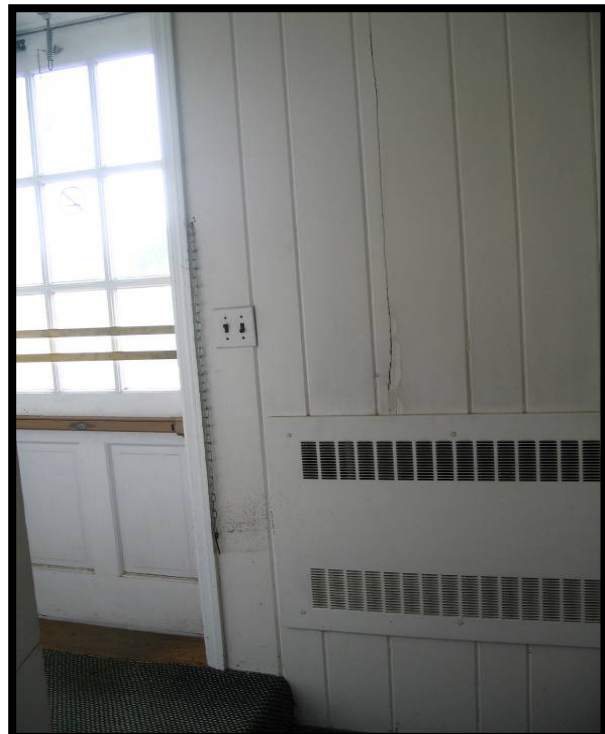
Depicts a view of a cabinet heater located adjacent to the western egress door. Also depicted in this photo is large cracking in the wood paneling.

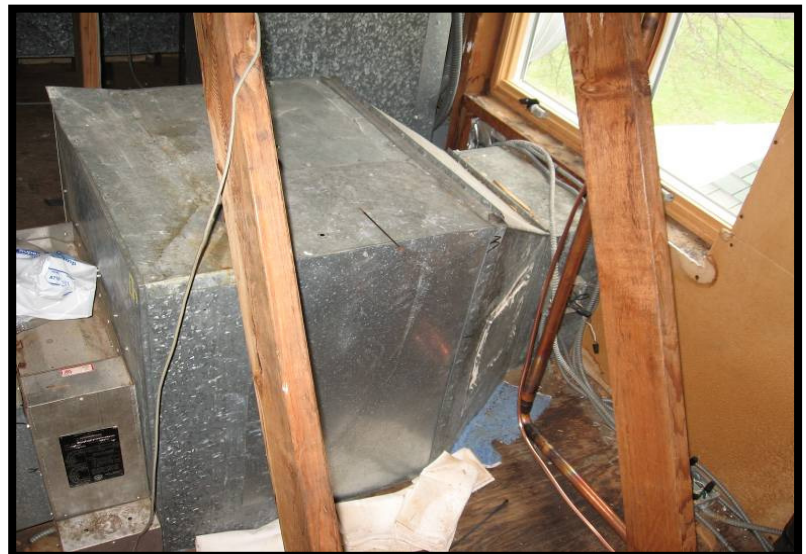
View of previous photo towards the east. This shows the connection to the outside. There are open electrical junction boxes should have covers put on. The entire ductwork should be removed and replaced and an air handler provided for make-up air to the kitchen. As previously noted the ductwork has been compromised a number of times by being cut open and patched.

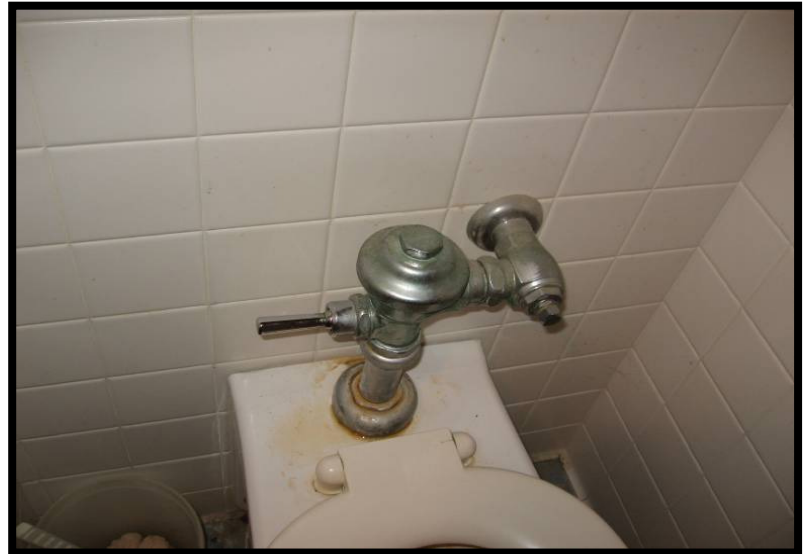
View of leaking flushometer at water closet in second floor bathroom behind kitchen area.
