SITE INVESTIGATION REPORT

**Vigh Property
Block 29, Lots 9.01 & 9.01Q
Millstone Township,
Monmouth County, New Jersey**

**Monmouth County Board of Recreation Commissioners
Monmouth County Park System
Land Preservation Office
805 Newman Springs Road
Lincroft, New Jersey 07738-1695**

April 19, 2005

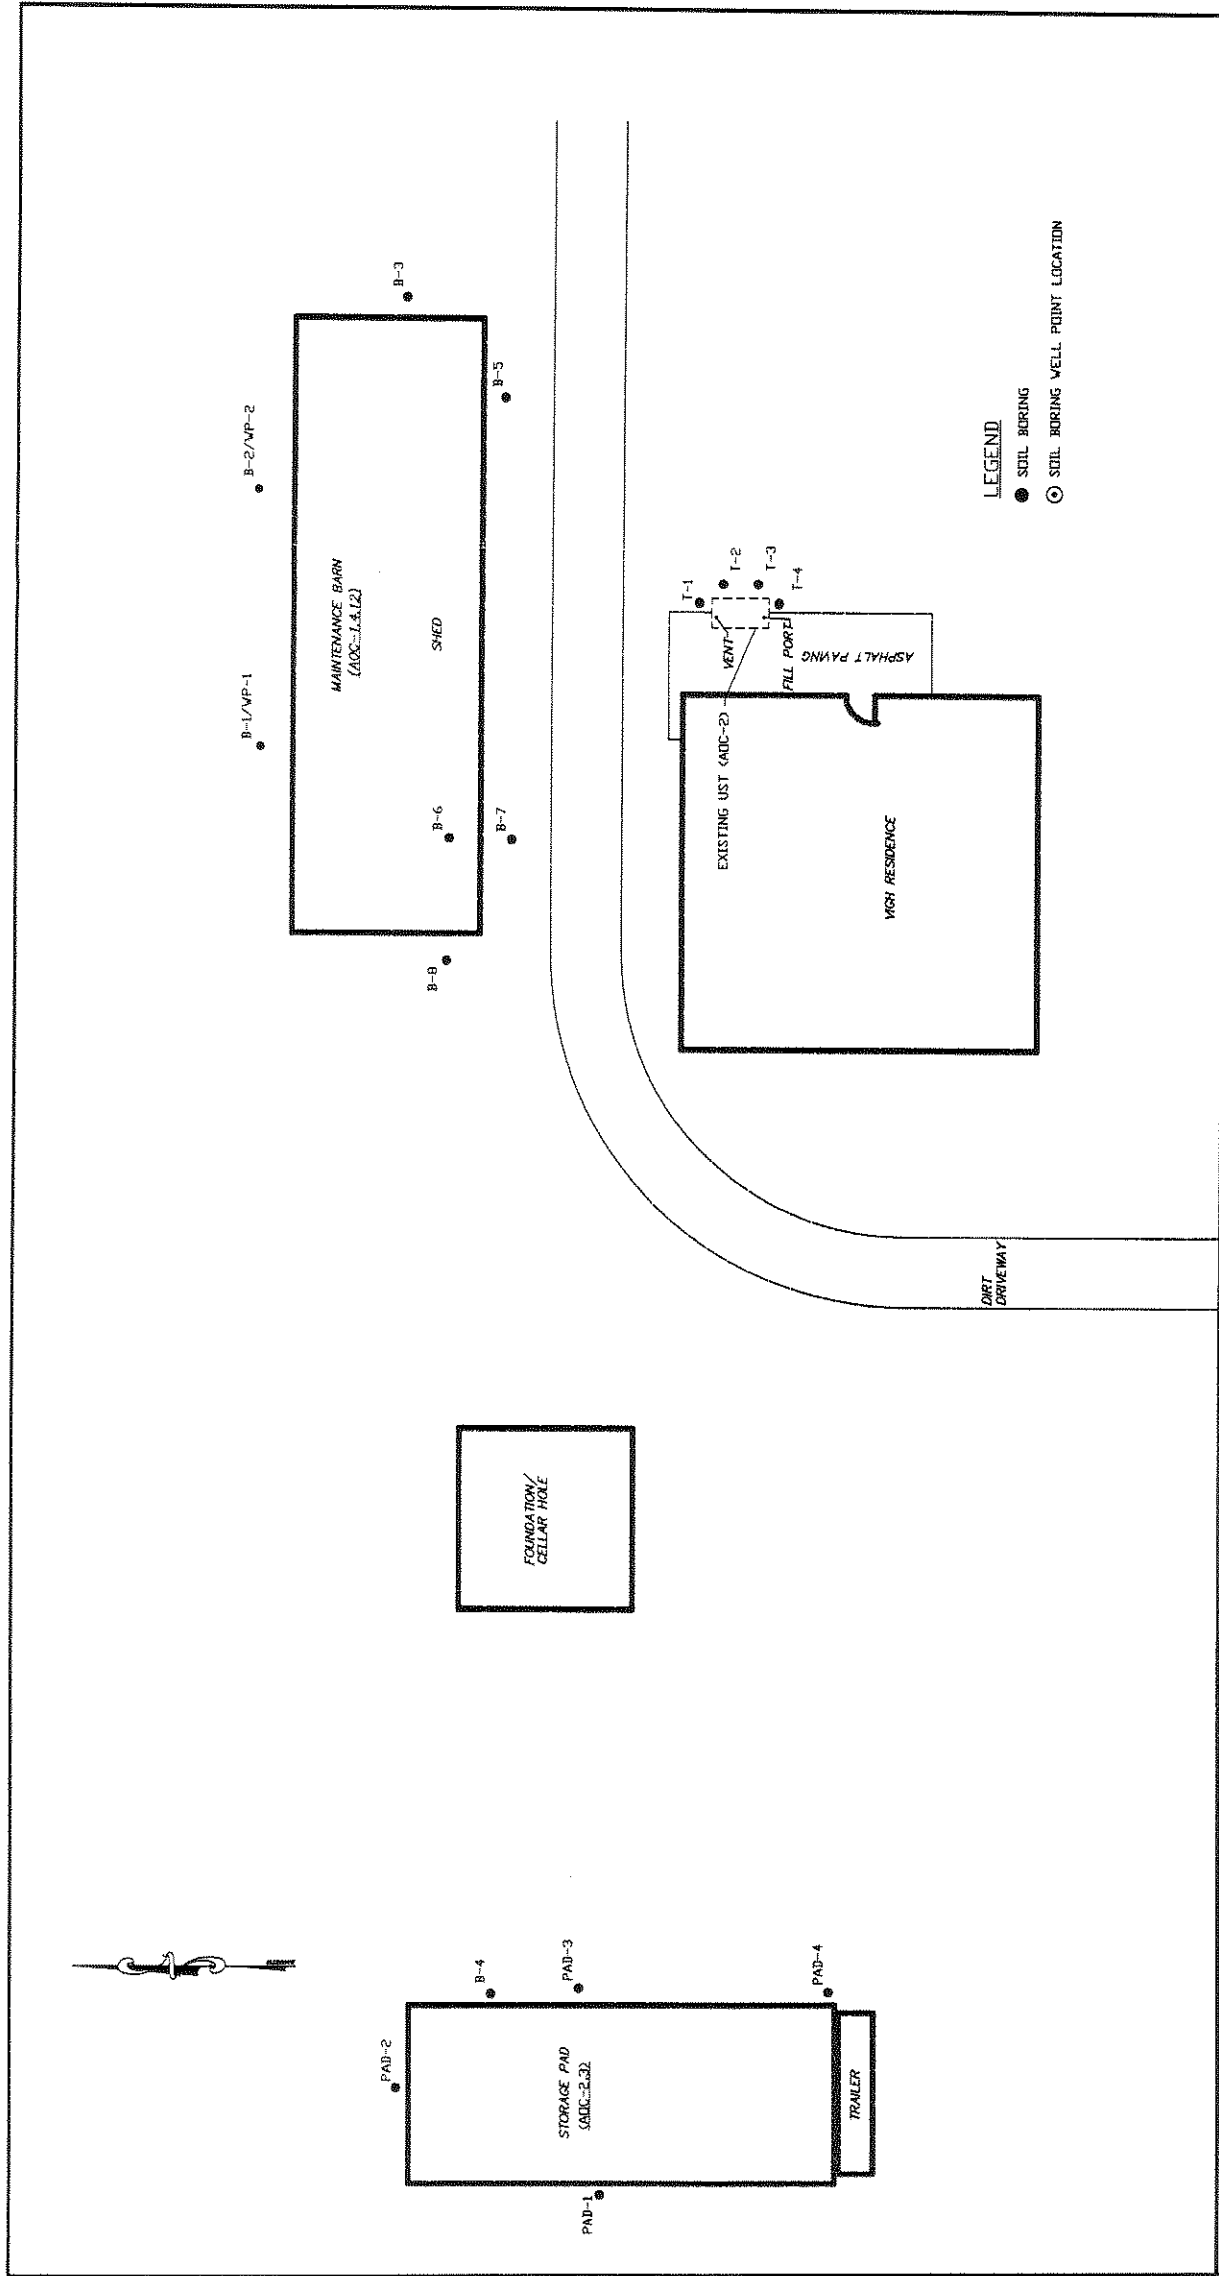
FIGURE-4 DETAIL OF AREA 1
VIGH PROPERTY
MILLSTONE, NEW JERSEY

SD advanced four (4) soil borings (PAD-1 through PAD-4) around the perimeter of the concrete storage pad related to the former dairy barn in order to assess subsurface conditions at AOC-3. The borings were advanced to a depth of approximately twelve (12) feet bsg and soils were field screened for VOCs utilizing a PID. The boring locations are presented on Figure 4. Detailed soil boring logs are included as Appendix C.

Perched water was noted between four and one-half (4.5) and six (6) feet bsg in soil borings PAD-1 and PAD-2, but the actual groundwater table was not encountered during installation of borings. Only slightly elevated PID readings were encountered (0.2 ppm) in boring PAD-1 at four and one-half (4.5) feet bsg. No PID readings above background were

SD advanced seven (7) soil borings (B-1 through B-3 and B-5 through B-8) around the perimeter and within the maintenance barn in order to assess subsurface conditions in these areas. Soil boring "B-4" was placed in the area of the gasoline storage tank which was discussed in Section 3.1.1 of this report. The seven (7) borings were advanced to a depth of approximately twelve (12) feet bsg and soils were field screened for VOCs utilizing a PID. Soil borings B-5 and B-6 were installed through the concrete floor within the maintenance barn interior. The boring locations are presented on Figure 4. Detailed soil boring logs are included as Appendix C.

No PID readings above background were recorded in the soil borings and no odors or staining were noted in the borings installed at this location.

Results of laboratory analysis indicated a TPHC concentration of 43.4 in soil sample B-2, which does not exceed the NJDEP threshold for TOCs of 10,000 ppm. Laboratory

analysis of soil samples B-1, B-3, B-5, B-6, B-7, and B-8, did not detect TPHC in any of these samples. Therefore, sample B-2 was analyzed for the contingent VO+10, BN+15, and PCB parameters. The results of the contingency analysis indicated all targeted and non-targeted compounds at concentrations which do not exceed the most stringent NJDEP criteria. A tabular summary of the February 2005 soil sampling results is provided in Table 2 (Appendix B). The laboratory analytical soil results are provided in Appendix E.

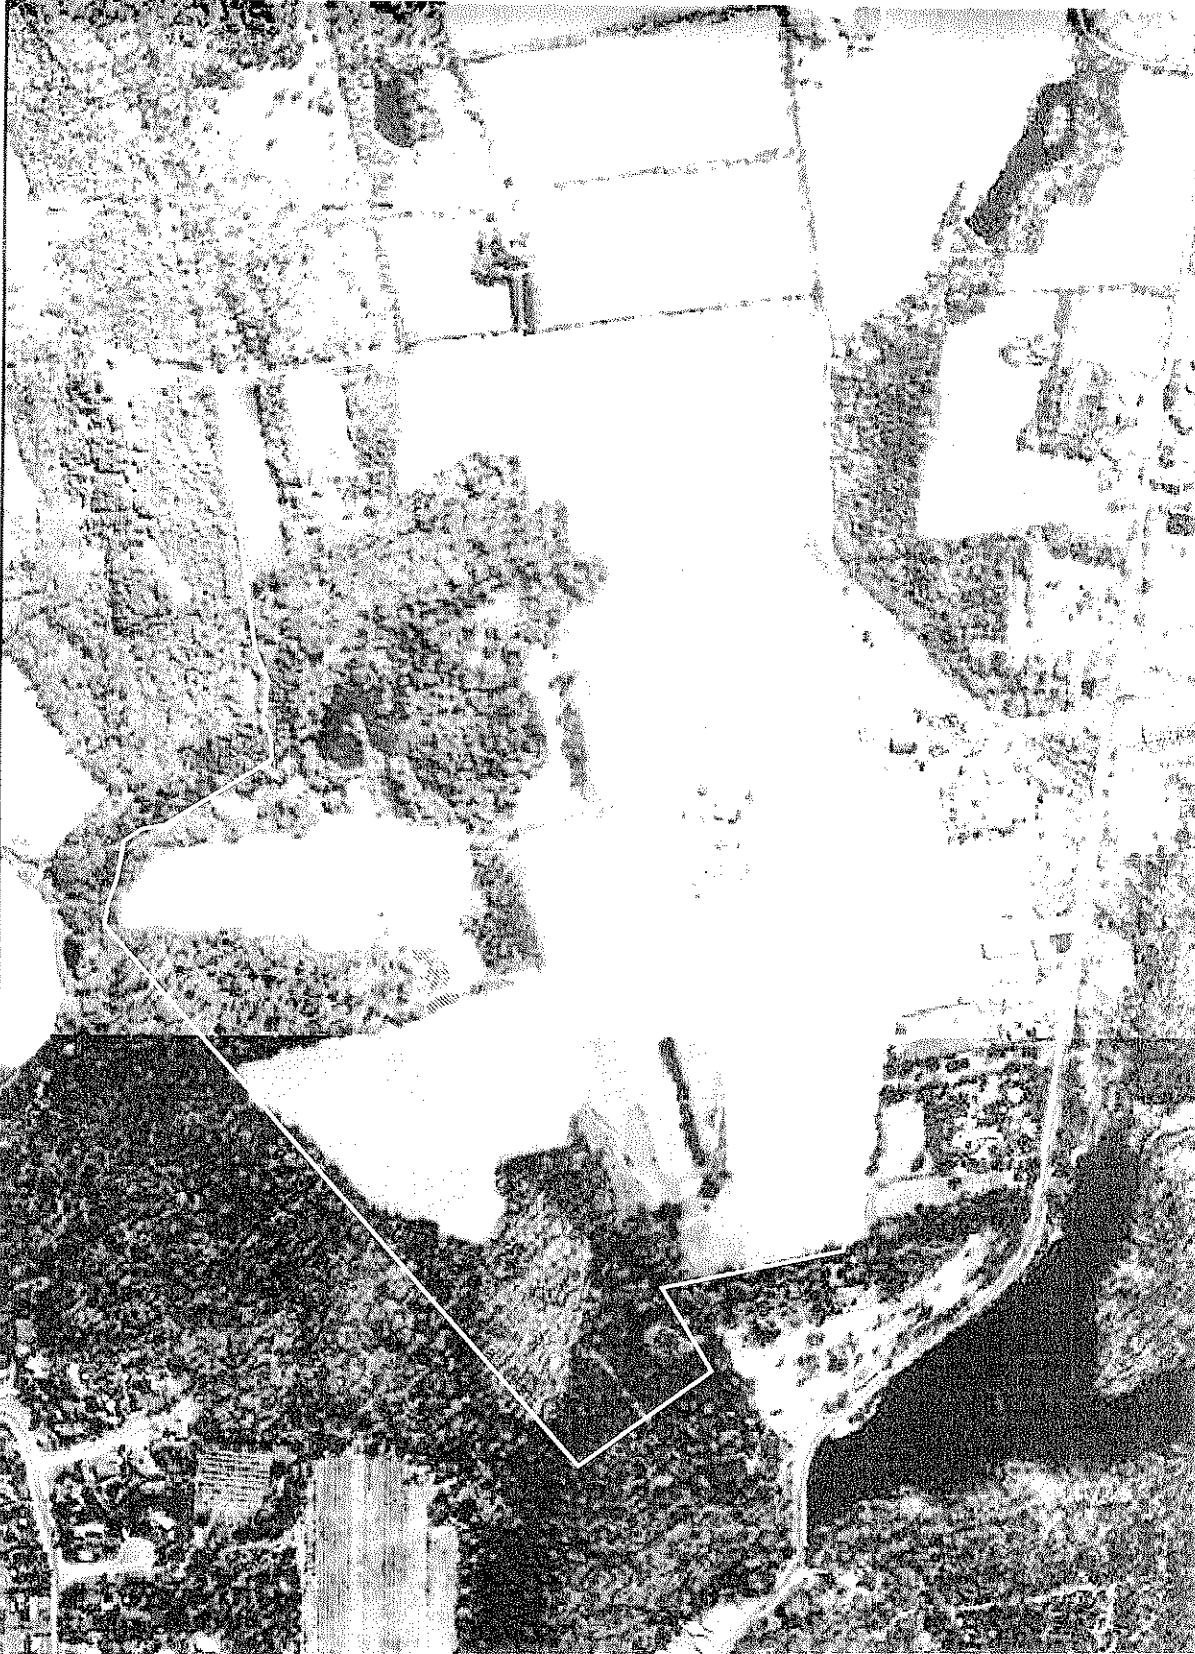
FIGURE-3 SITE MAP
VIGH PROPERTY
MILLSTONE, NEW JERSEY

SD collected surface soil samples from the area of noted stressed vegetation located on the northernmost farm field. Soil samples (SV-1 and SV-2) were collected from this area. The boring locations are presented on Figure 3.

Results of laboratory analysis indicated arsenic at concentrations which exceed the NJDEP RDCSCC and NRDCSCC of 20 ppm in surface soil samples SV-1 and SV-2. Specifically, arsenic was detected at 23.3 ppm in sample SV-1 and at 25.8 ppm in sample SV-2. All other targeted and non-targeted compounds were reported at concentrations which do not exceed the most stringent NJDEP SCC. A tabular summary of the February 2005 soil sampling results is provided in Table 2 (Appendix B). The laboratory analytical soil results are provided in Appendix E.

Laboratory analysis of surface soil samples (SV-1 and SV-2) collected from the area of noted stressed vegetation located on the northernmost farm field (AOC-11B) indicated arsenic at concentrations which exceed the NJDEP RDCSCC and NRDCSCC of 20 ppm.

Based on the preliminary information acquired from this investigation, it is possible that the elevated arsenic levels are related to historic pesticide use or may be a naturally-occurring condition. SD recommends further investigation of the farm fields regarding the elevated arsenic levels which may be conducted as part of an historic agricultural use investigation. It is SD's understanding that such an investigation may be performed at a later date at the discretion of Monmouth County Park System.
