TO: Jon Moren, Timothy Ryan
FROM: James Bager, Resident Engineer: (917) 826-8002
DATE: February 4, 2012 to March 2, 2012
RE: Project Status Report - 4

Attachments:

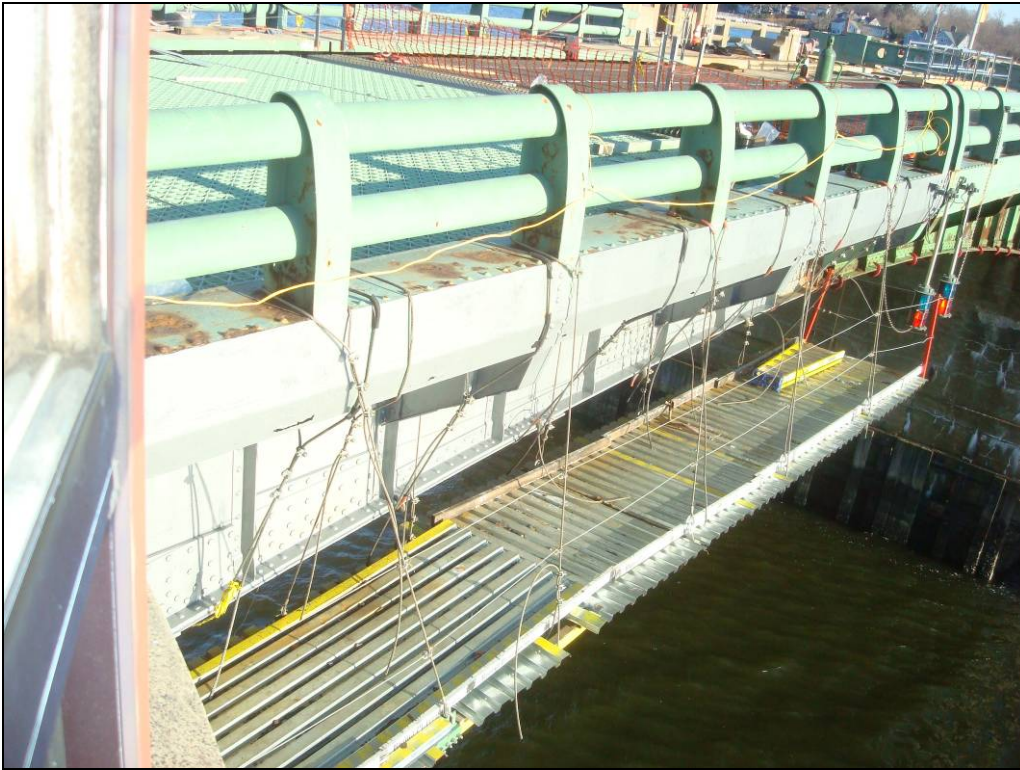
Photo 5: The painters primed the West fascia and touched up previously primed areas that were damaged due to the steel repairs.

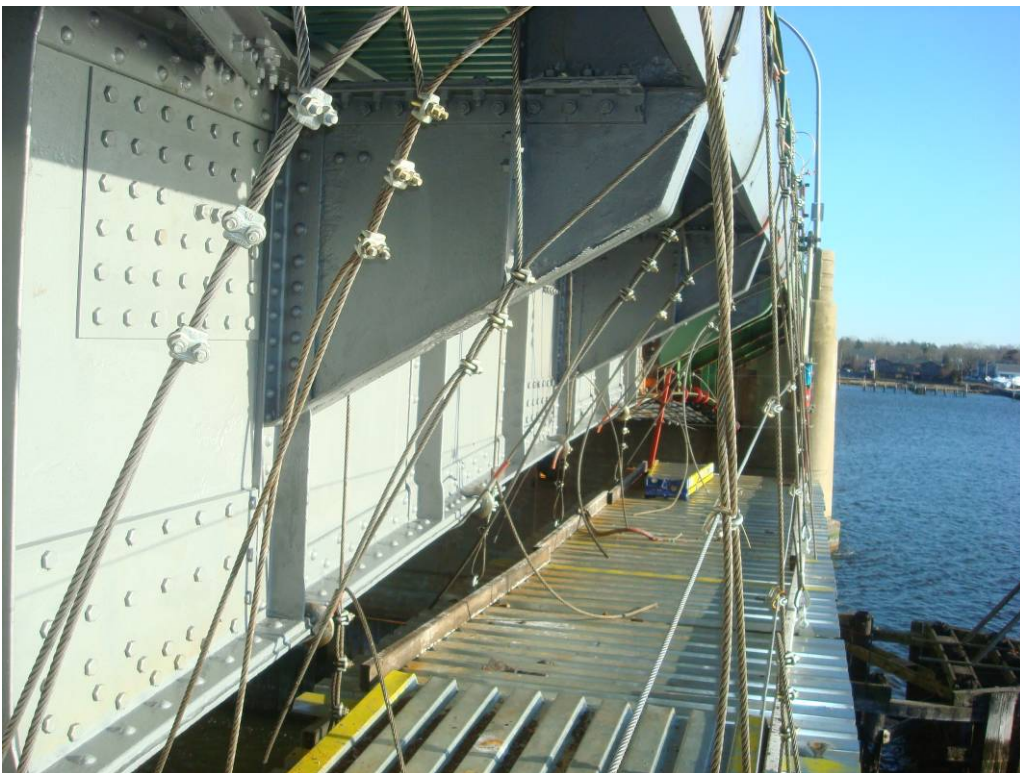
Photo 6: The painters primed the West fascia and touched up previously primed areas that were damaged due to the steel repairs.

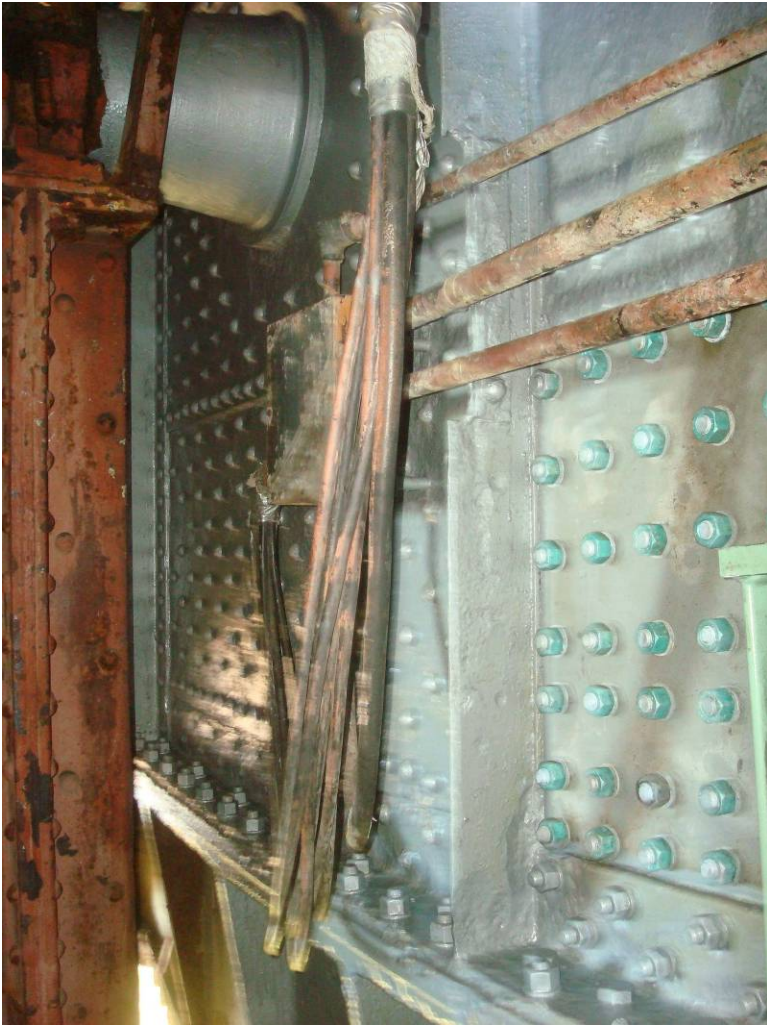
Photo 7: The painters primed the Southeast bascule girder and a portion of the rack at the trunnion area. East face shown.

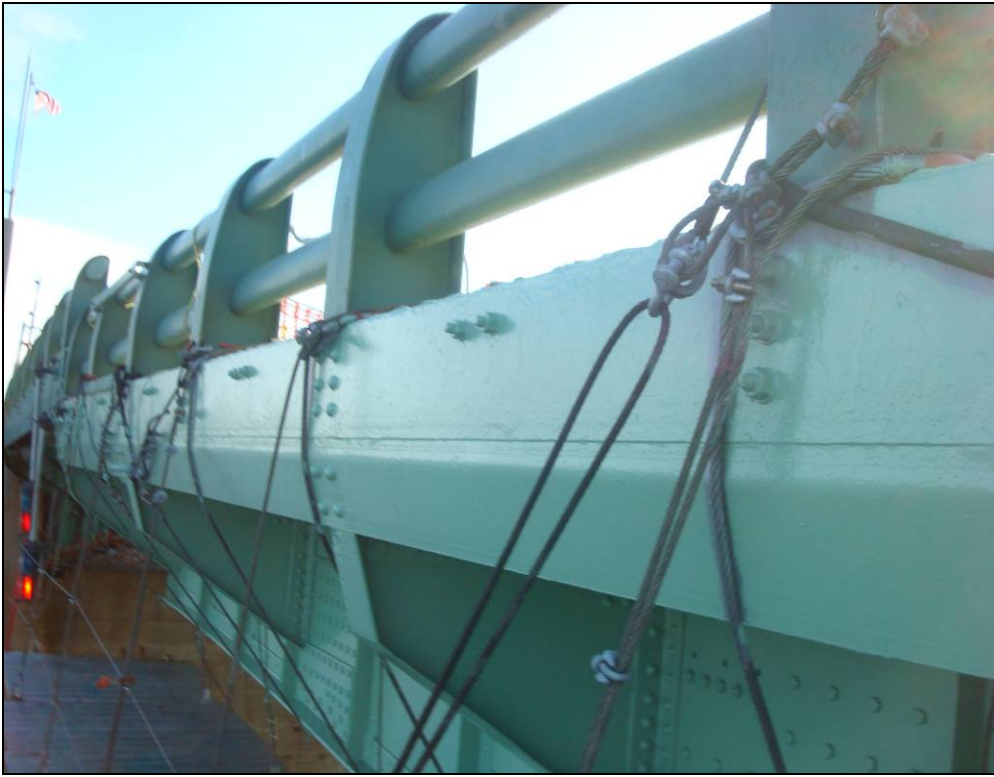
Photo 10: The painters primed the West fascia and touched up previously primed areas that were damaged due to the steel repairs.

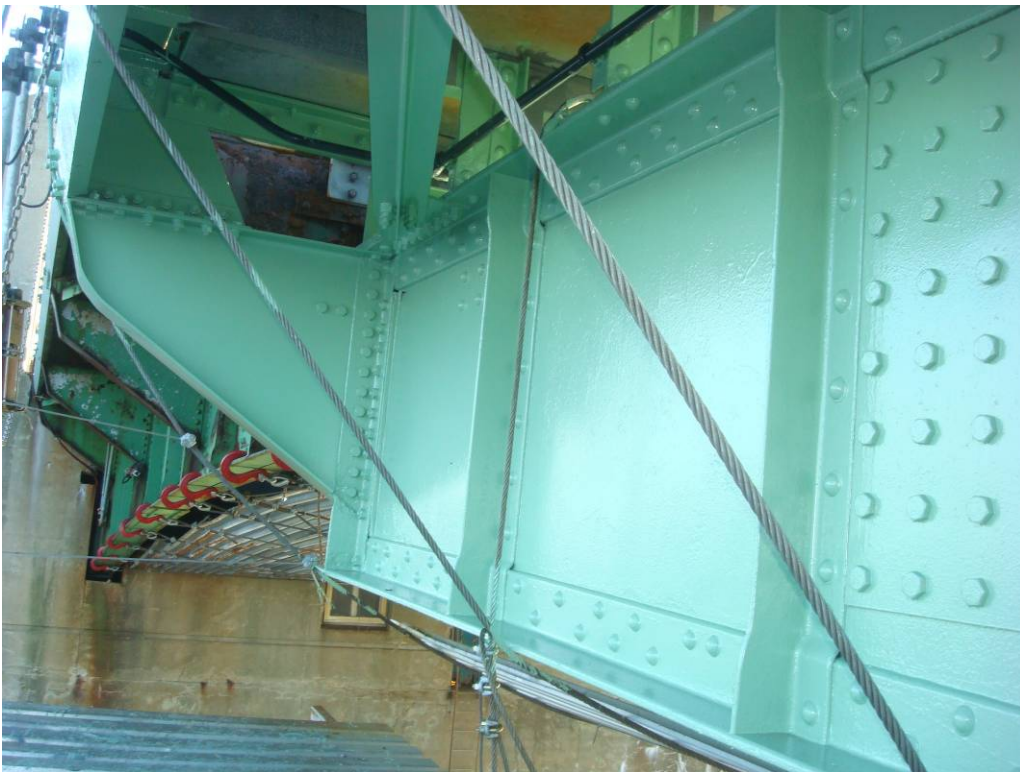
Photo 11: The painters primed the West fascia and touched up previously primed areas that were damaged due to the steel repairs.

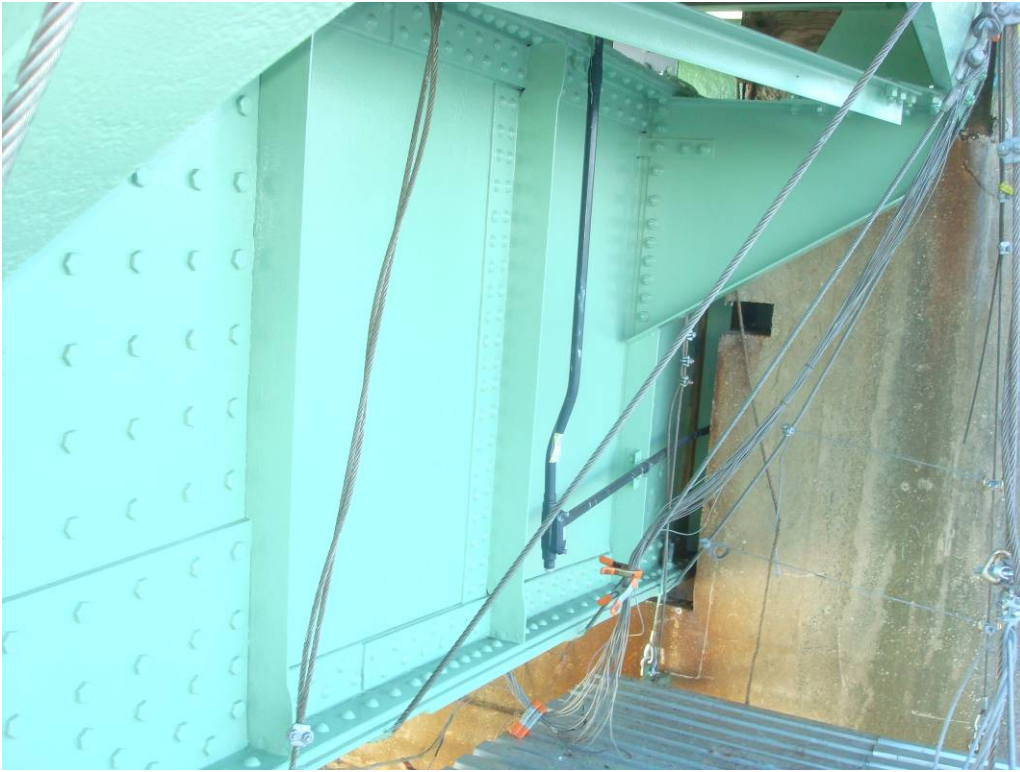
Photo 12: The painters primed the Southeast bascule girder and a portion of the rack at the trunnion area. East face shown.

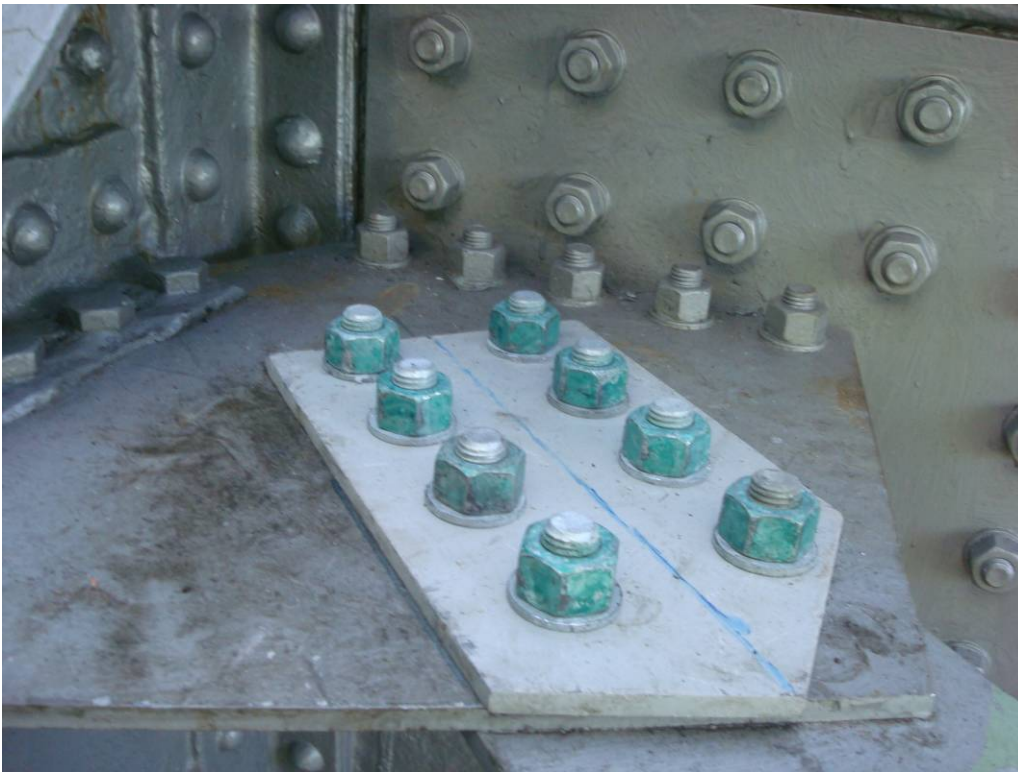
Photo 61: Cover plate installed over the gusset plate which was weld repaired to fix the misaligned holes at the bracing connection.

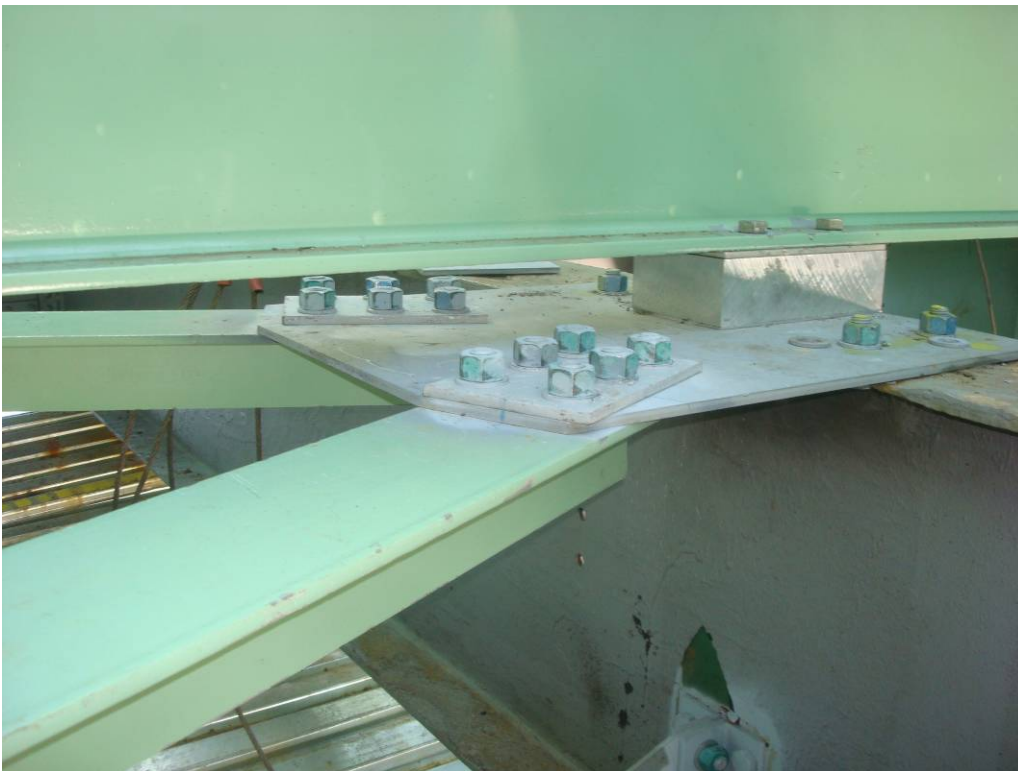
Photo 62: Cover plate installed over the gusset plate which was weld repaired to fix the misaligned holes at the bracing connection.

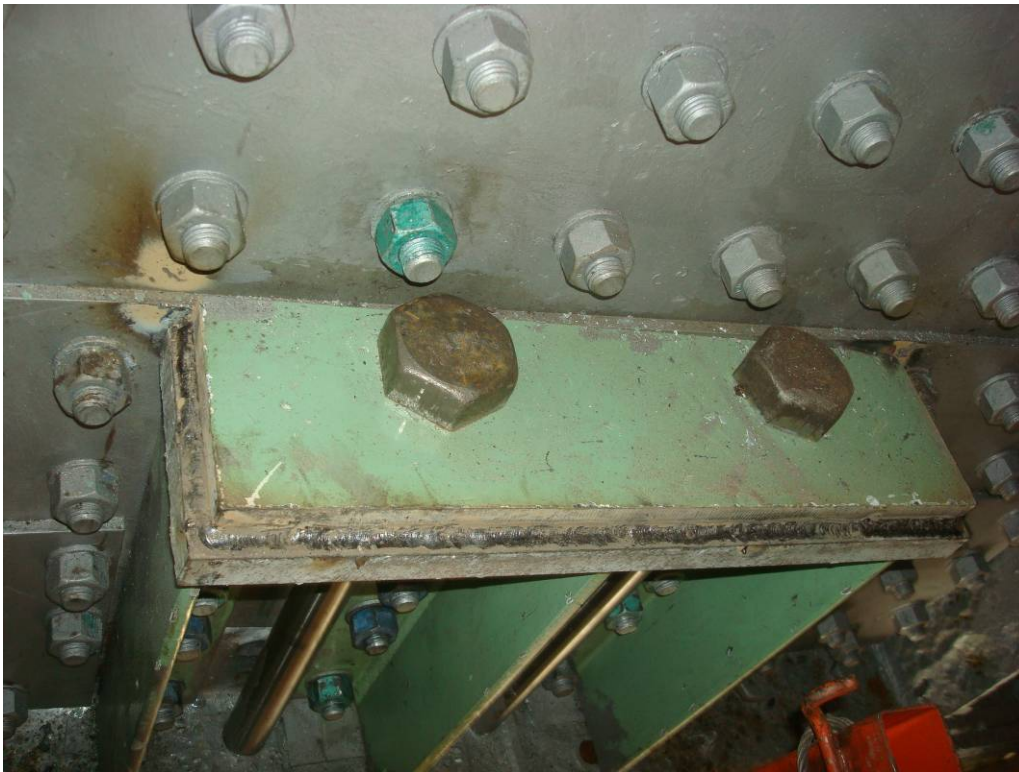
Photo 63: The West face of the East girder rack cap plate field welded to the rack stiffener. All four cap plate locations have been welded.

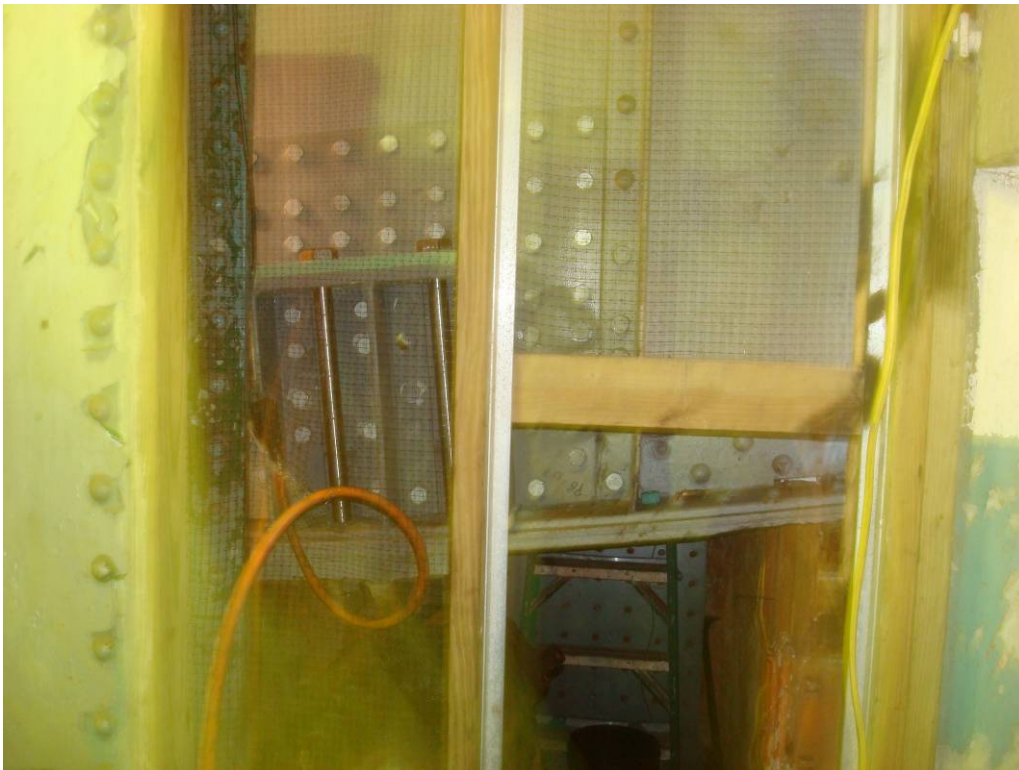
Photo 68: The Southwest girder (East face of girder) rack stiffener repair. Shims need to be completed.

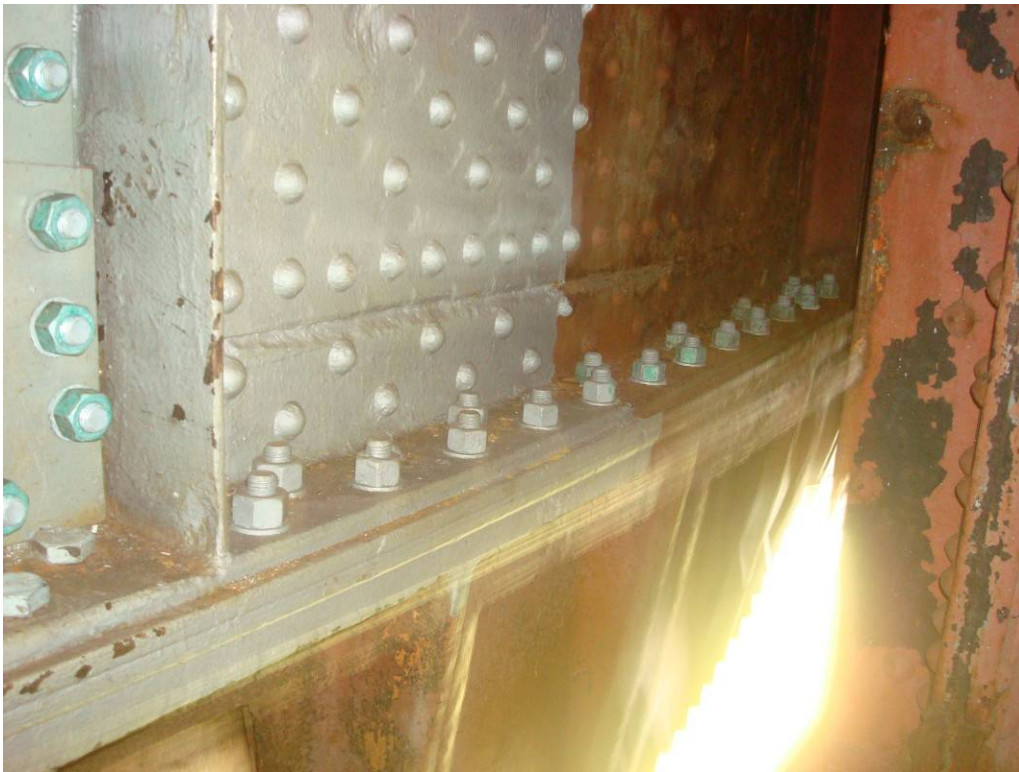
Photo 69: The Southwest girder rivet replacement between the girder bottom flange and the rack casting. Existing rivets have been replaced with 1" diameter H.S. bolts on the west side.

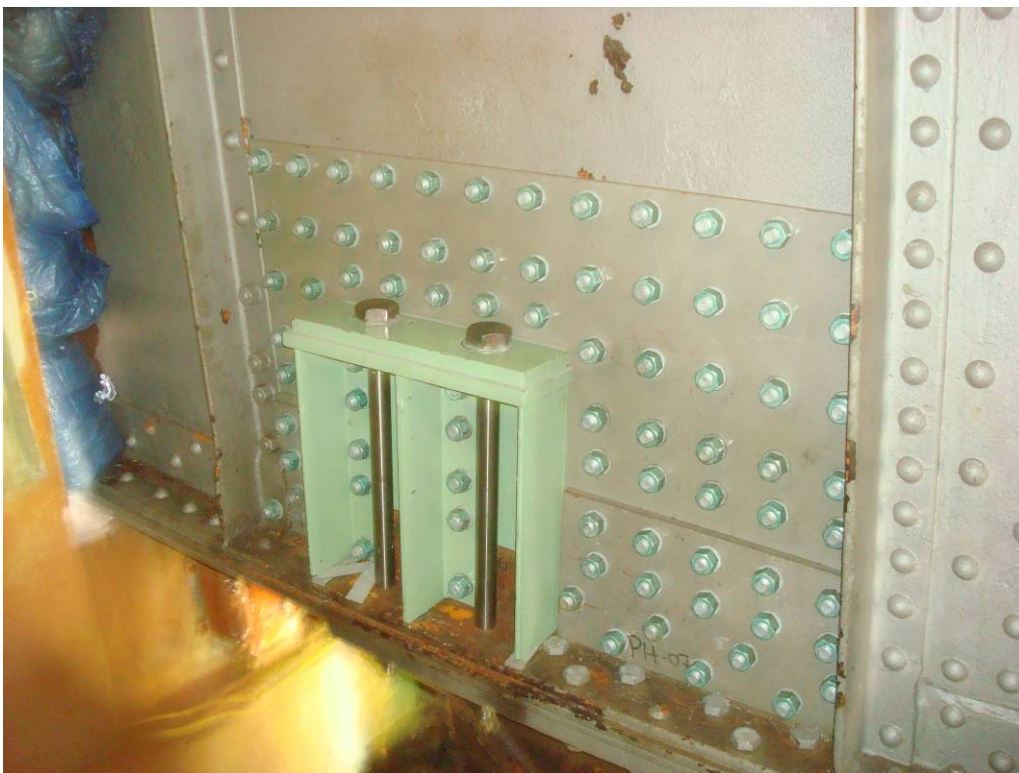
Photo 70: The Southwest girder (West face of girder) rack stiffener repair. Shims need to be completed.

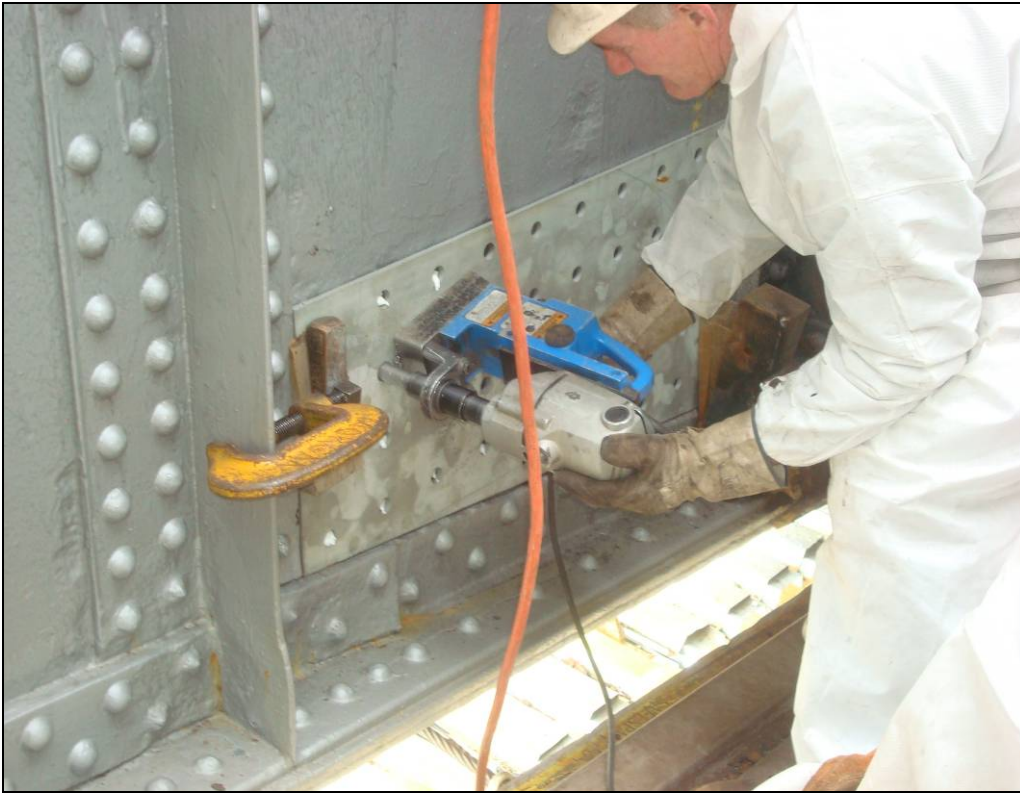
Photo 71: The Southeast girder repairs between the FB1 and FB2 in progress. Field drilling holes in the girder web using the repair plate as template.

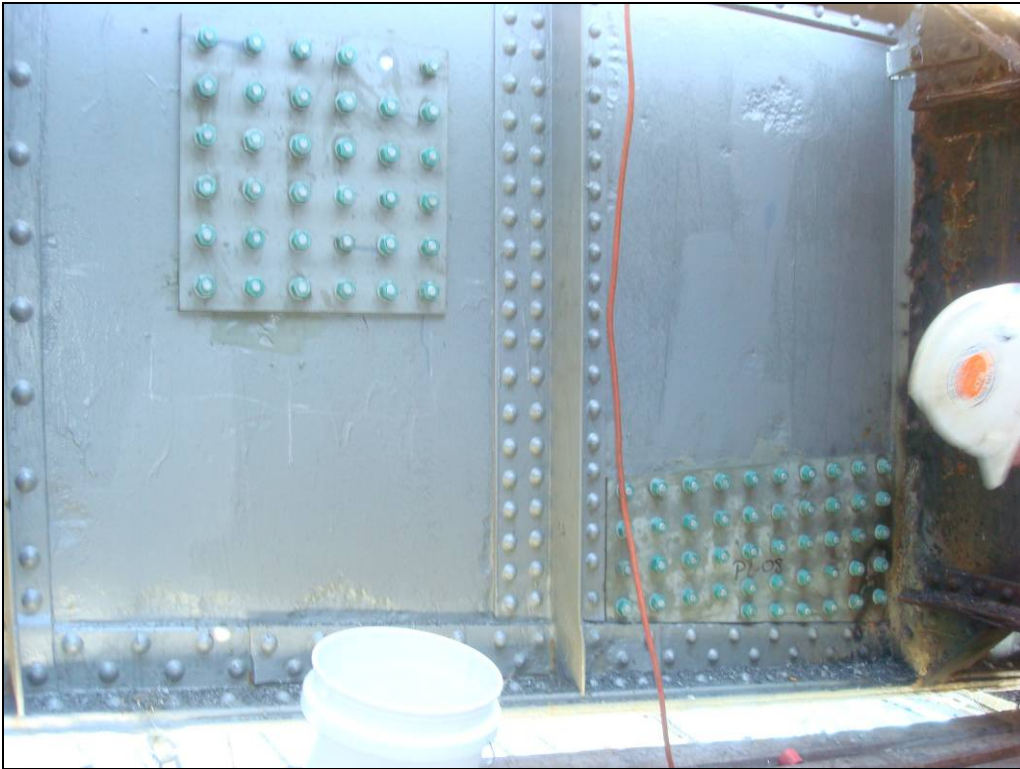
Photo 72: The Southeast girder repairs between the FB1 and FB2 in progress. The bolts still need to be tightened with an air impact wrench.

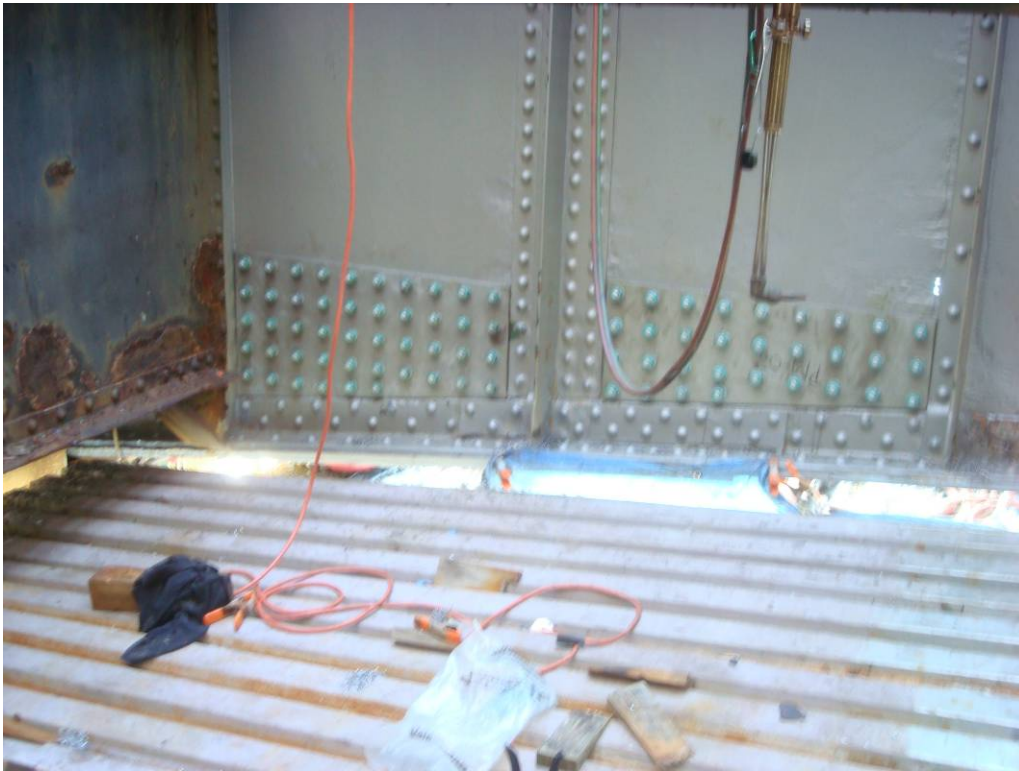
Photo 73: General configuration of the East face of the Southwest girder repairs between FB4 and FB3 installed. H.S. Bolts still need to be tightened with an air impact wrench.

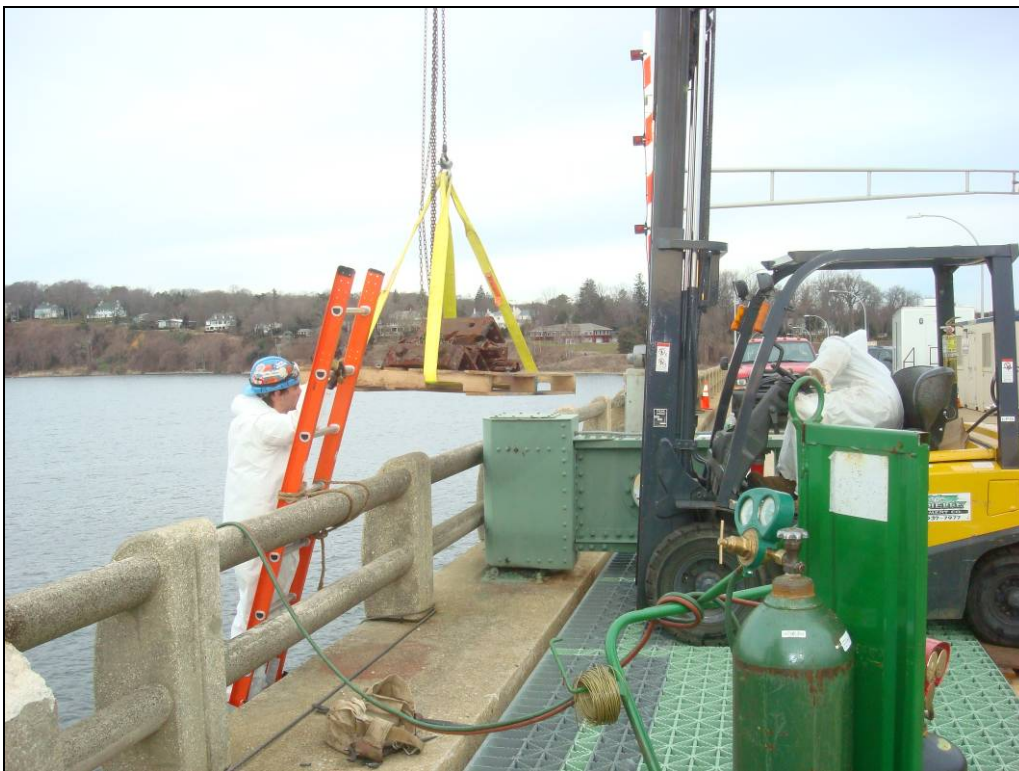
Photo 74: Removal of steel ballast plates in progress.

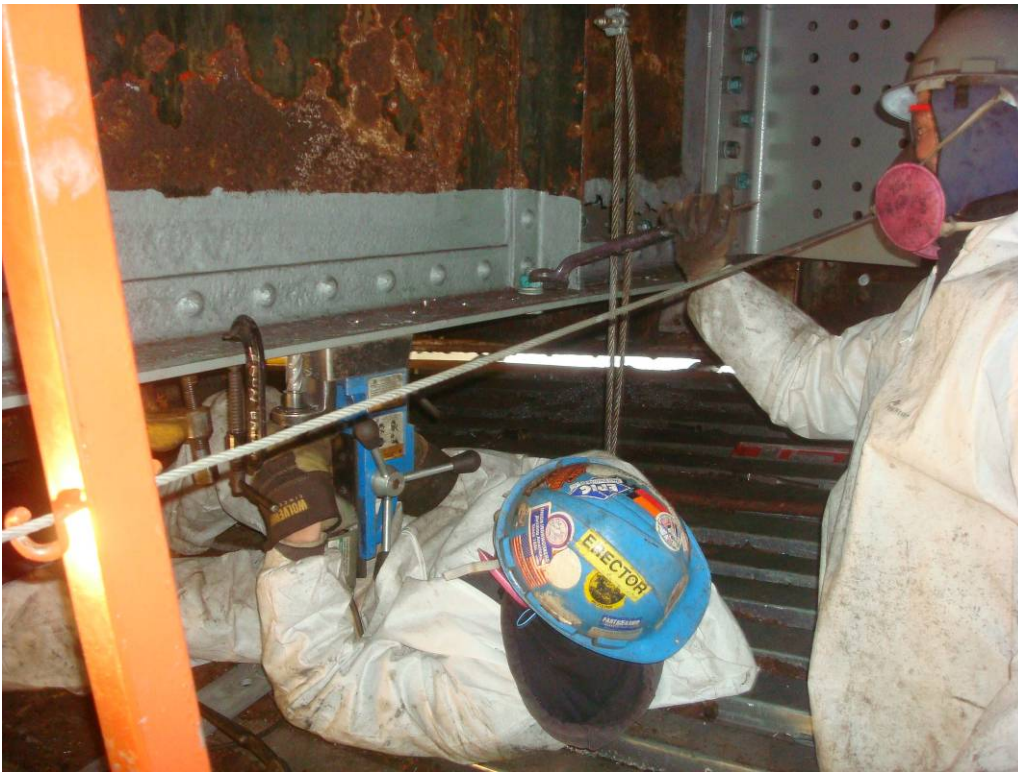
Photo 84: Bottom Flange of FB5 of South leaf repair in progress using the new repair plate as a template for field drilling of holes into flange.

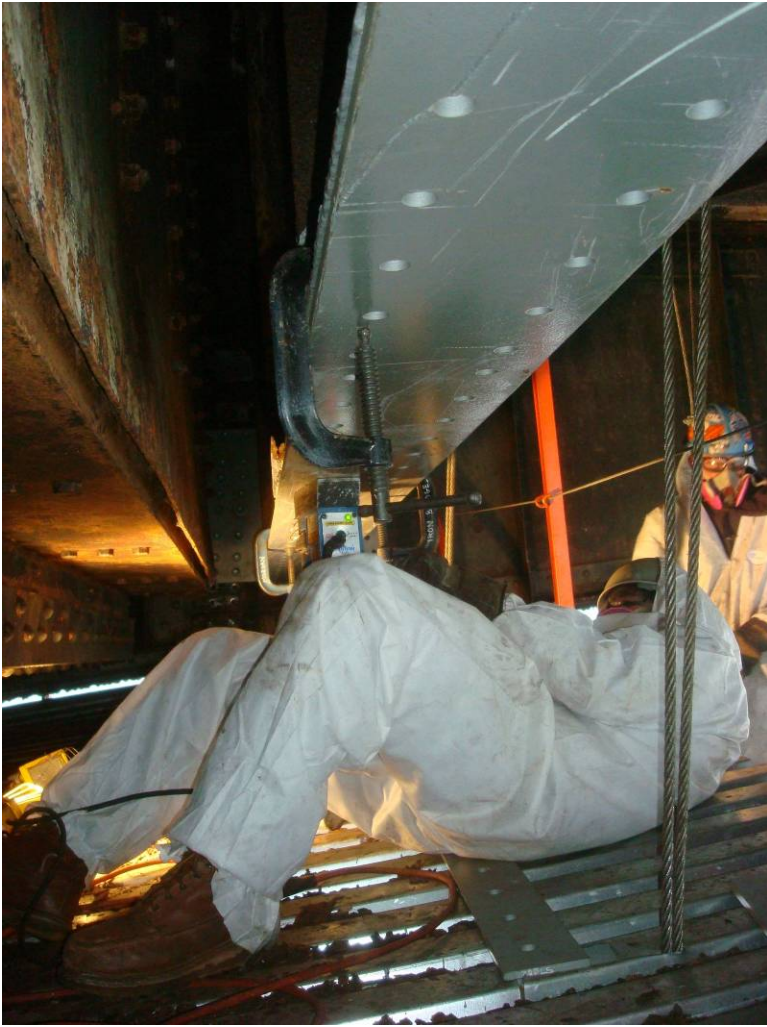
Photo 85: Bottom Flange of FB5 of South leaf repair in progress using the new repair plate as a template for field drilling of holes into flange.

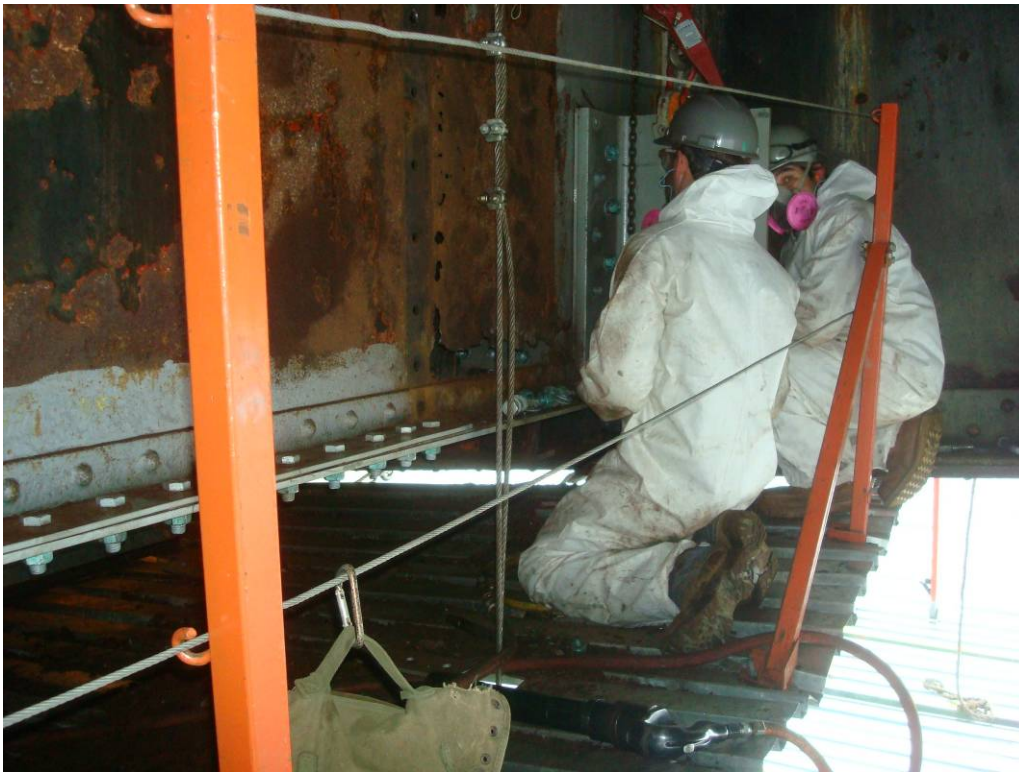
Photo 86: Bottom Flange of FB5 of South leaf repair in progress using the new repair plate as a template for field drilling of holes into flange.

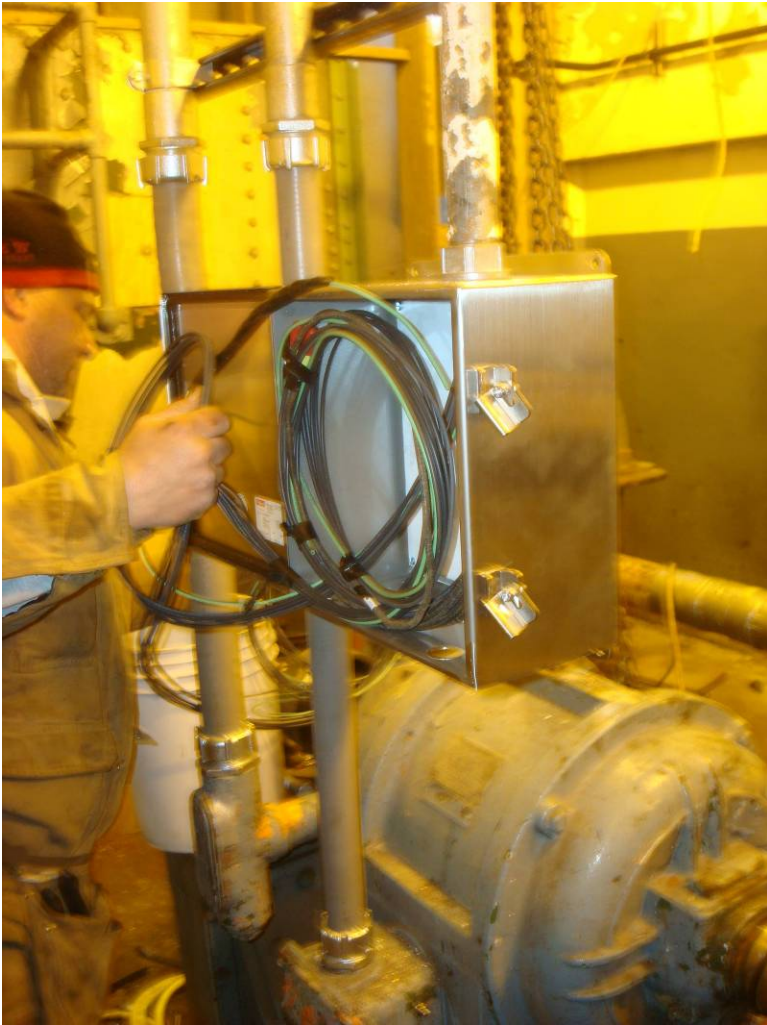
Photo 87: Installation of junction box for motor and machinery brake conductors in progress.
