**FROM:** James Bager, Resident Engineer: (917) 826-8002

**DATE:** October 17, 2011 to November 23, 2011

**RE:** Project Status

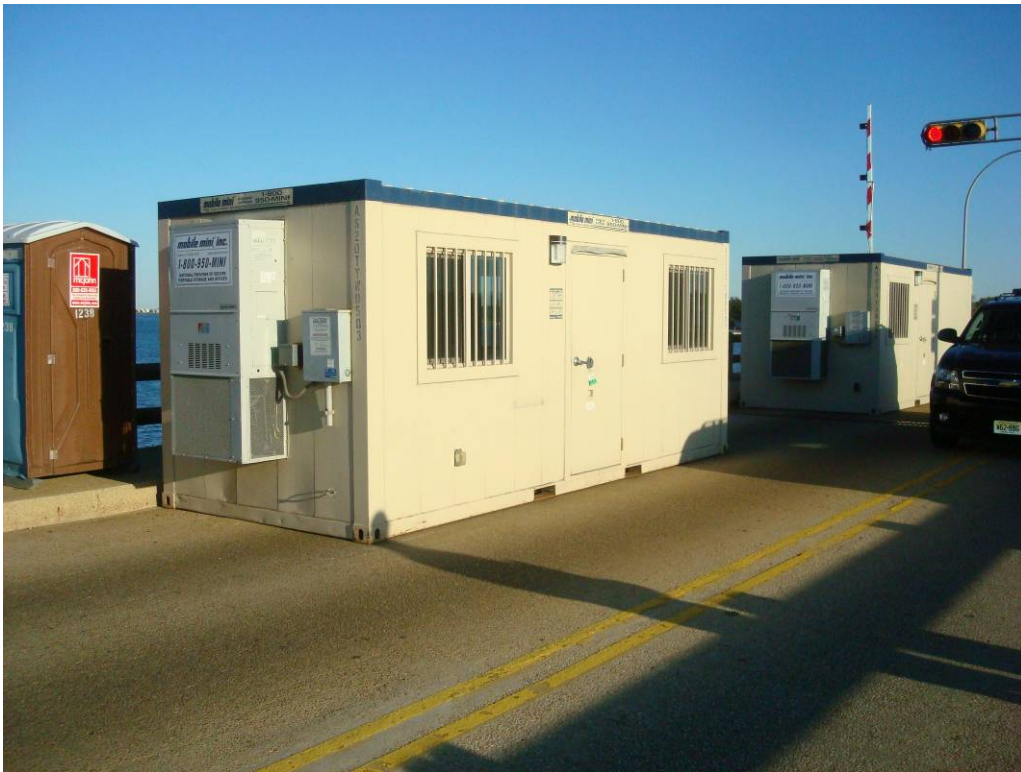
Photo 1: Contractor Mobilization

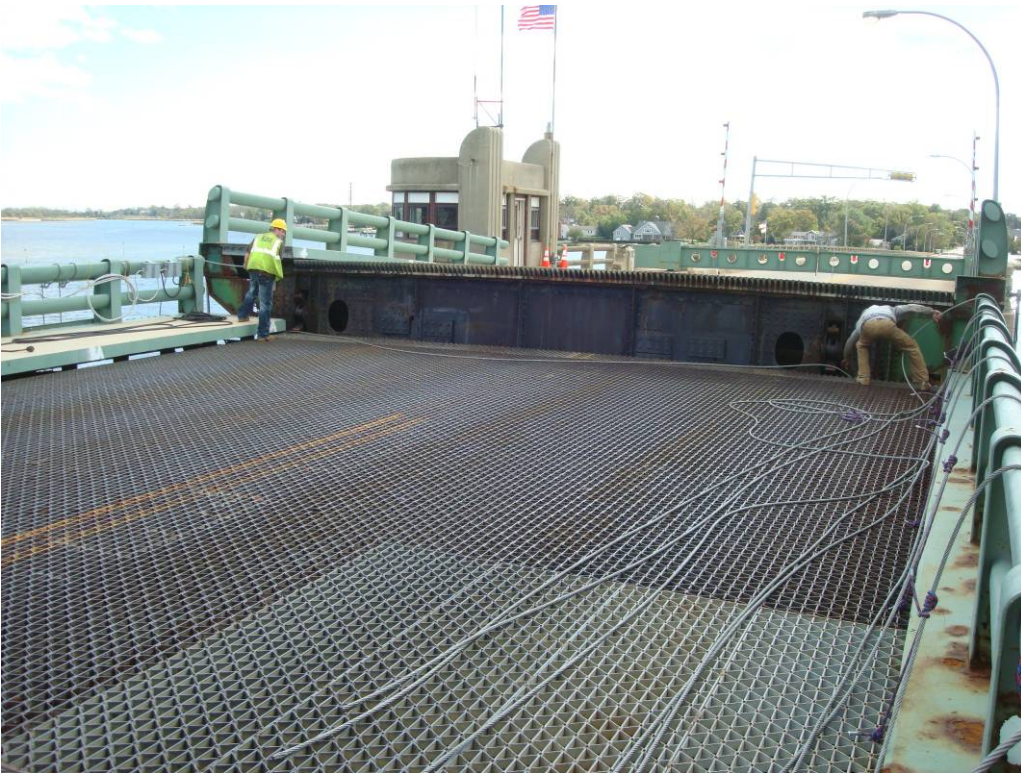
Photo 2: Installation of temporary work platform of North leaf.

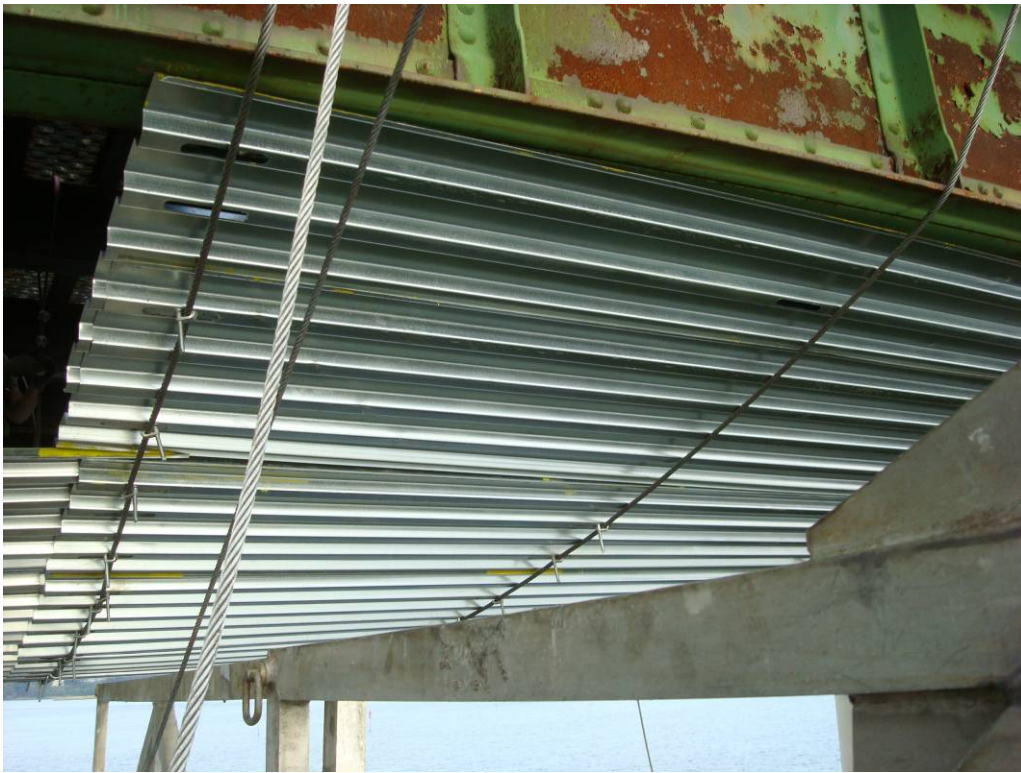
Photo 3: Installation of Temporary work platform.

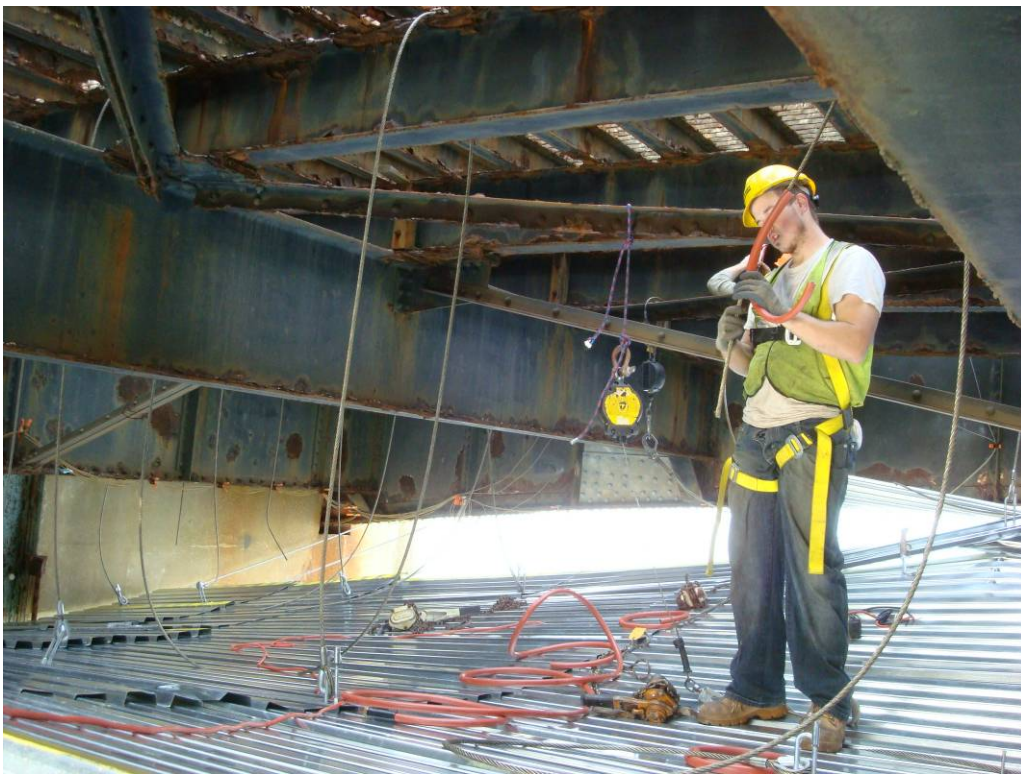
Photo 4: Installation of temporary work platform.

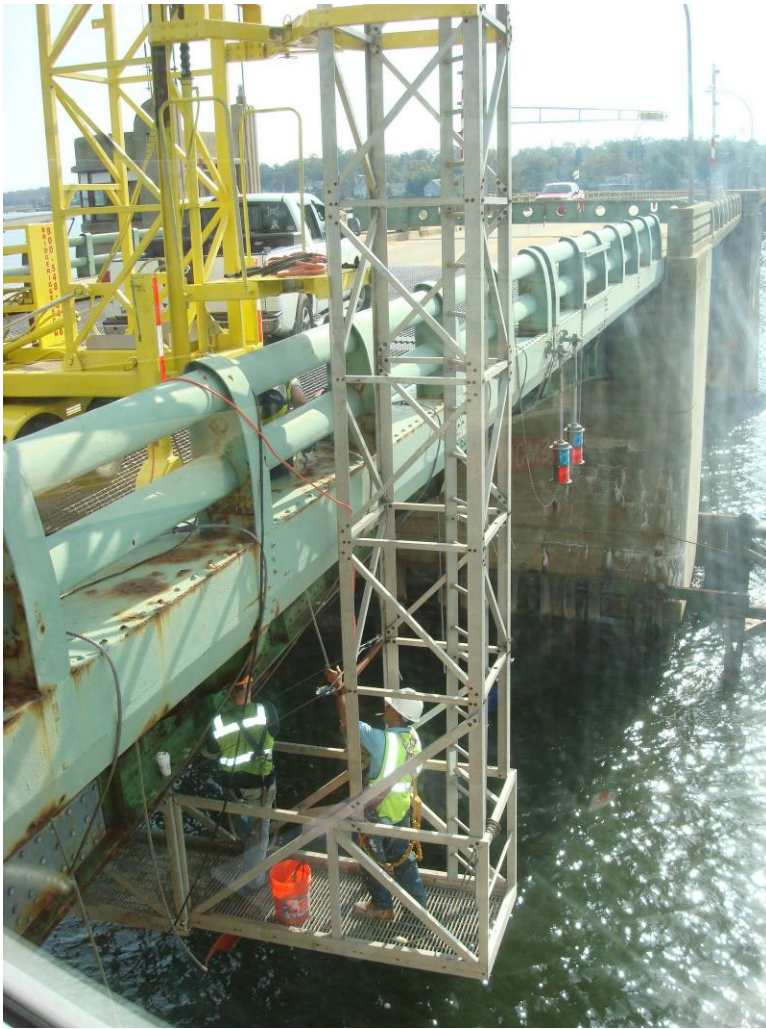
Photo 5: Installation of temporary work platform.

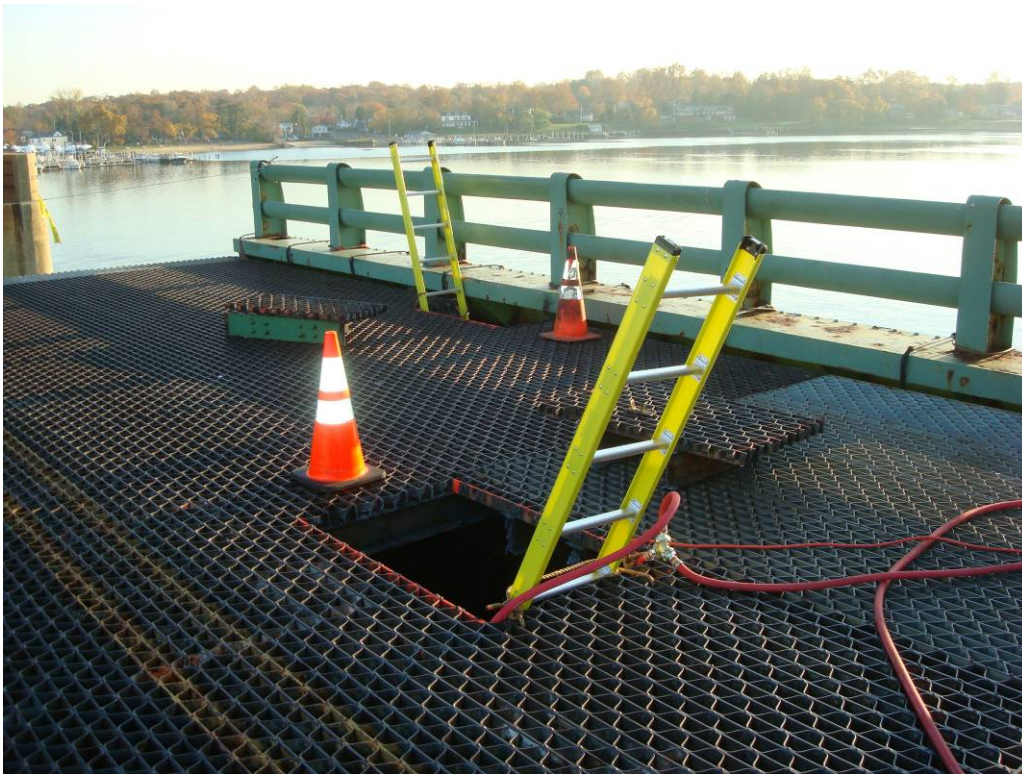
Photo 6: Access openings in North leaf grating deck. Background opening accesses the west cantilevered brackets. Foreground opening accesses between the girders.

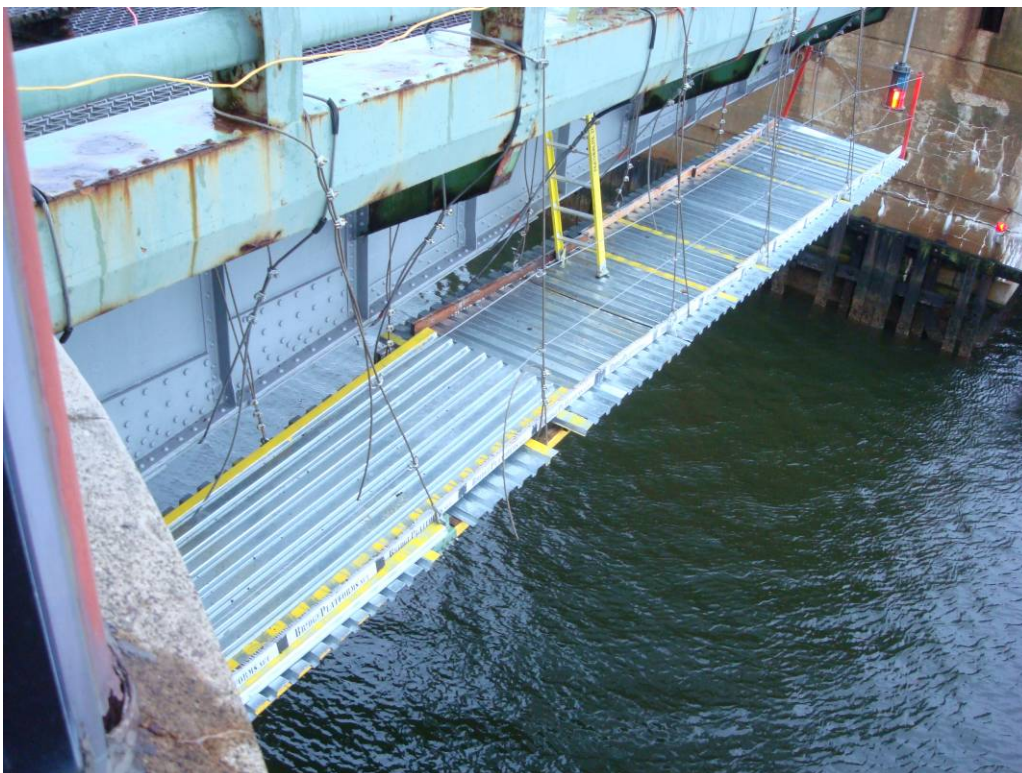
Photo 7: Temporary platform at West side of Bascule span under the cantilevered brackets. Note the bascule girder has been cleaned and primed.

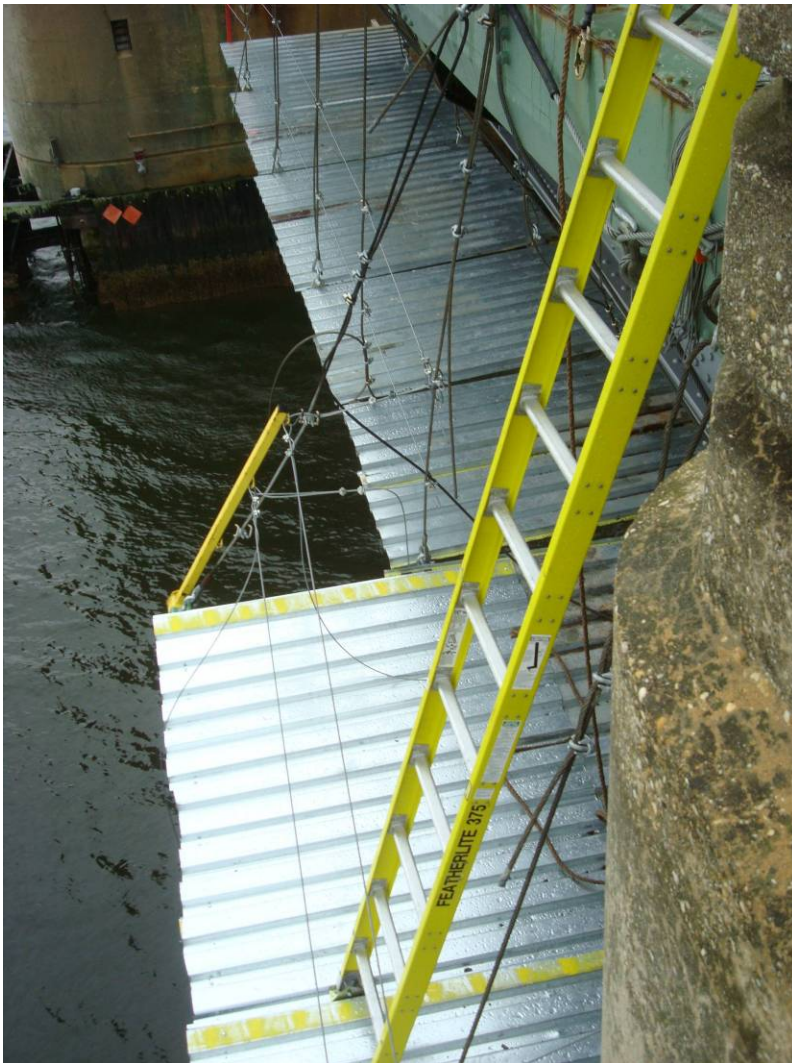
Photo 8: Temporary platform at East side of Bascule span under the cantilevered brackets. Note the bascule girder has been cleaned and primed.

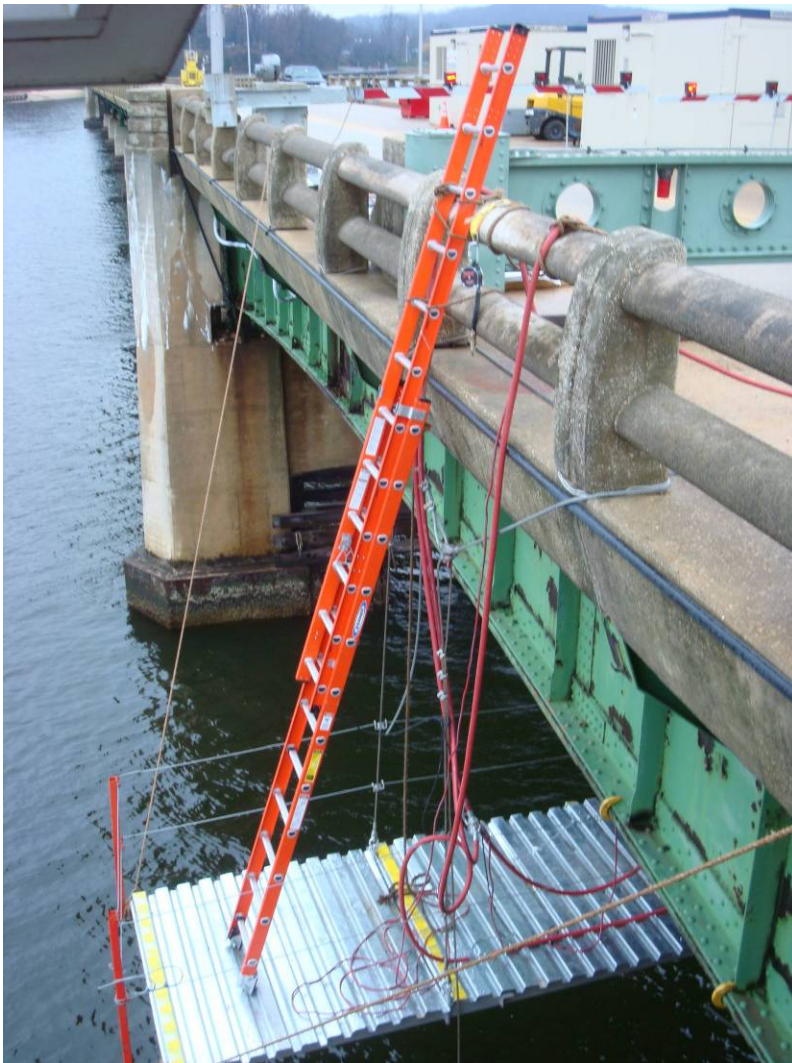
Photo 9: Temporary platform at West side of North Flanking span. Access required for Floorbeam FB5 strengthening and installation of temporary bascule span tie downs.

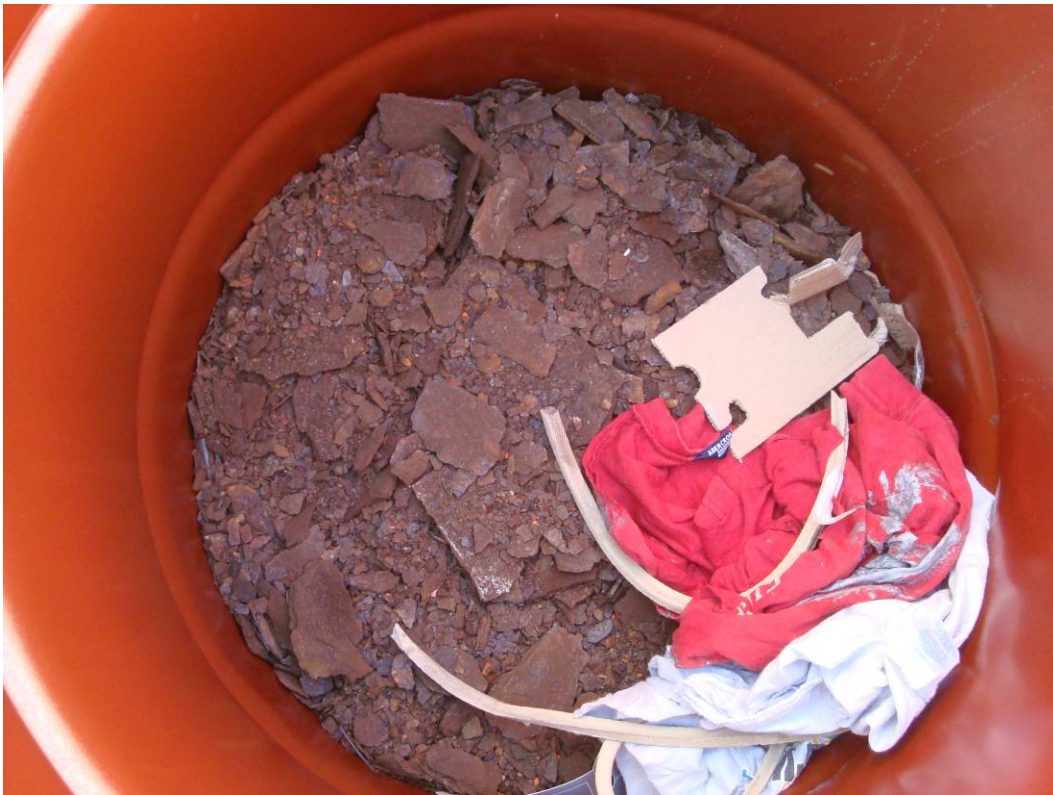
Photo 10: Collection of debris from the hand and power tool cleaning, approximately 7500# of rust has been removed to date on the north leaf and flanking span.

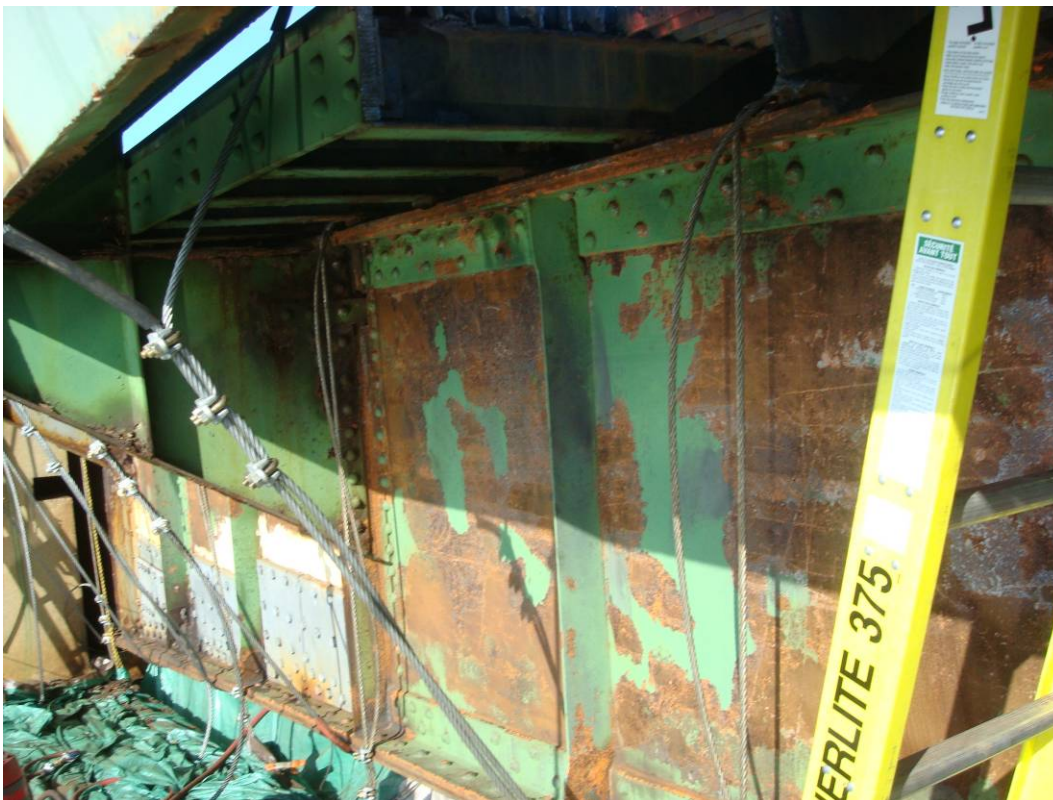
Photo 11: West bascule girder cleaned with hand and power tools. Looking North.

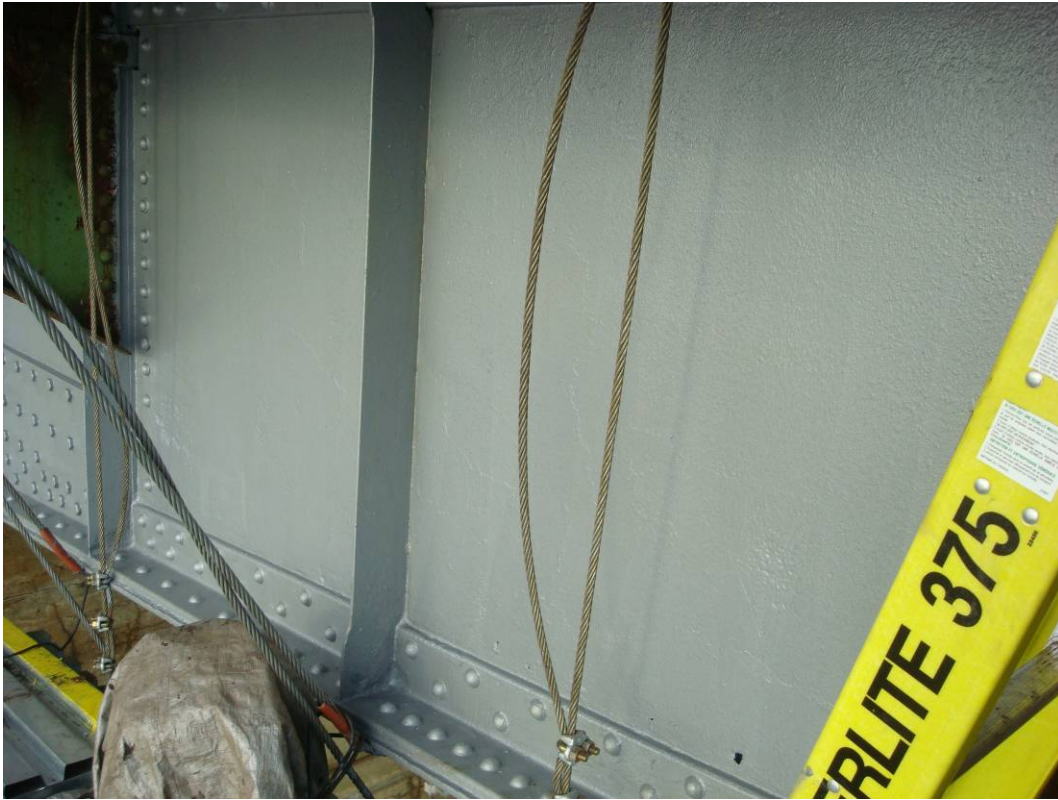
Photo 12: West bascule girder primed with Epoxy Mastic Aluminum.

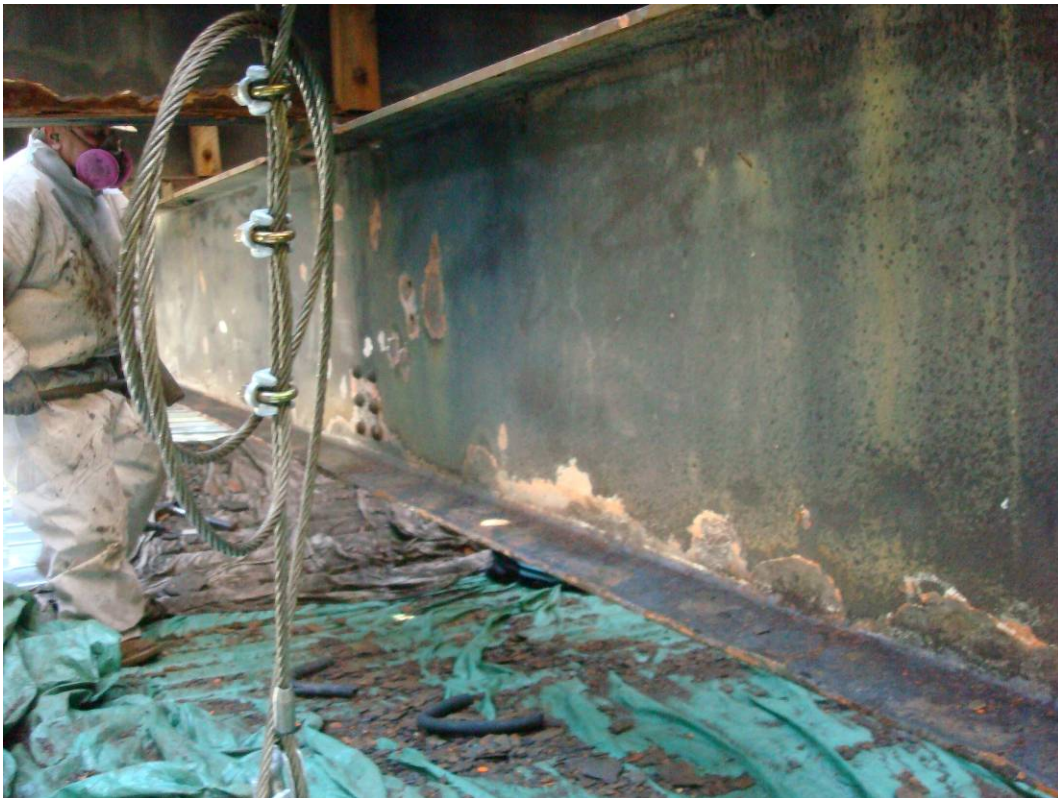
Photo 13: North face of Intermediate Floorbeam FB2 cleaned with hand and power tools.

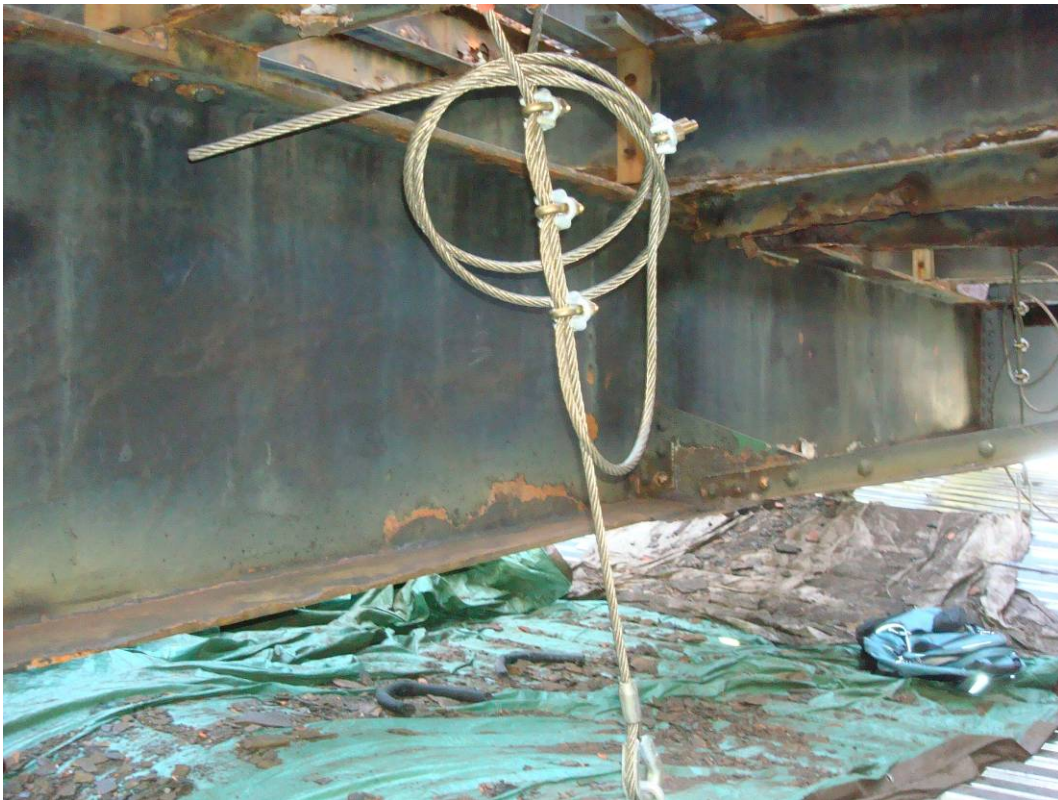
Photo 14: South face of Intermediate Floorbeam FB2 cleaned with hand and power tools.

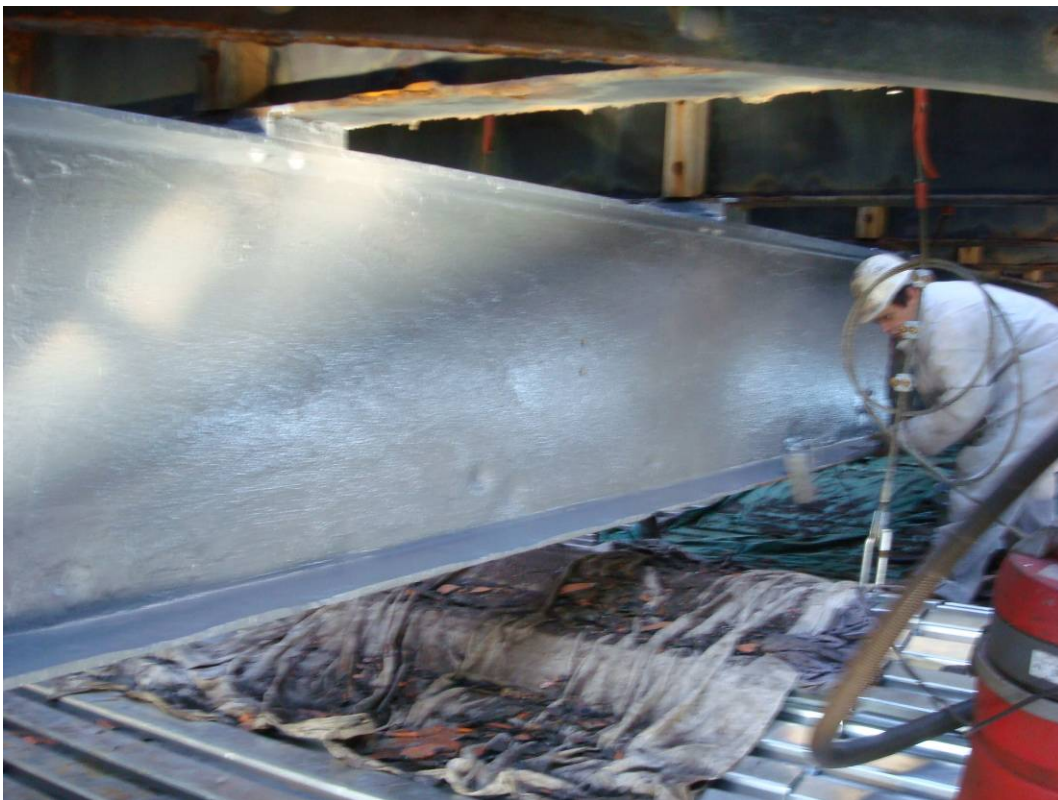
Photo 15: South face of Intermediate Floorbeam FB2 primed with Epoxy Mastic Aluminum.

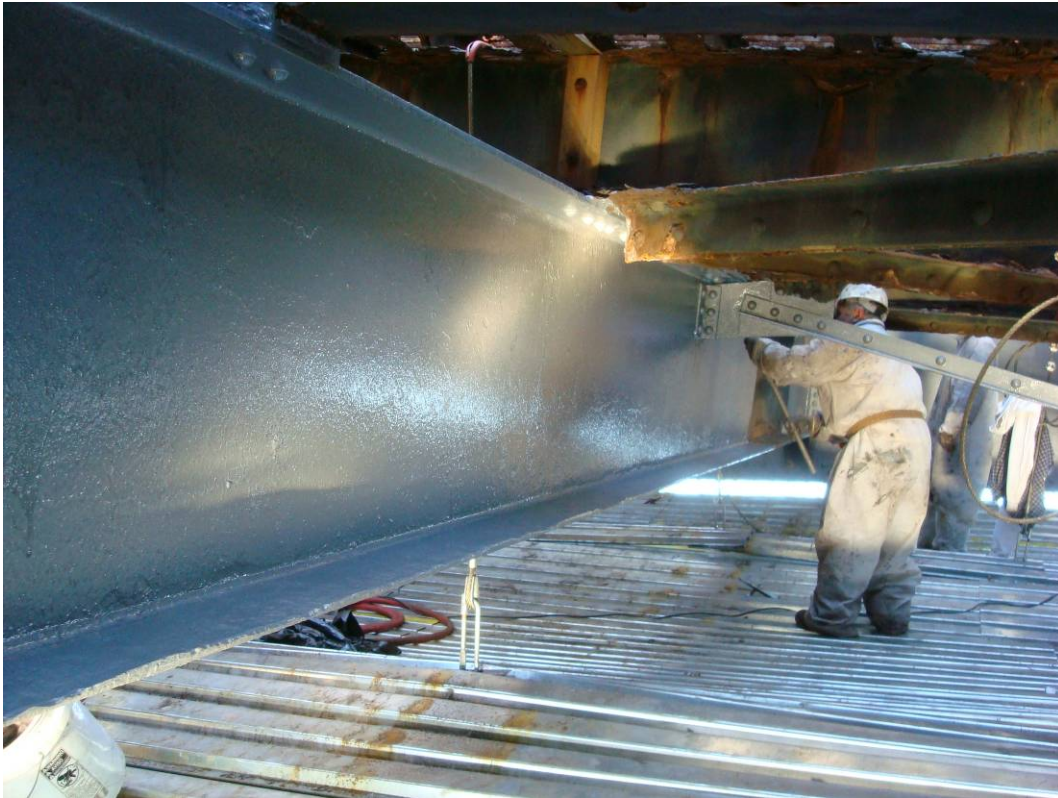
Photo 16: South Face of Intermediate Floorbeam FB3 primed with Epoxy Mastic Aluminum. Stringers and lateral bracing not painted to be replaced.

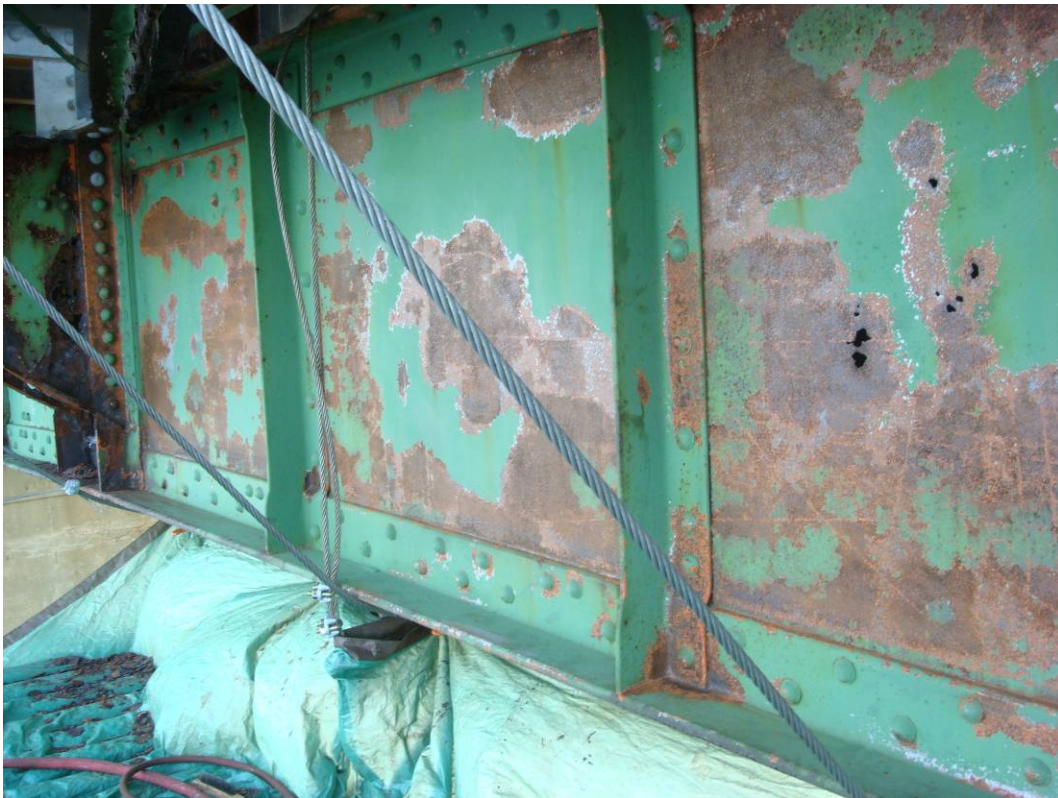
Photo 17: East bascule girder cleaned with hand and power tools. Looking South.

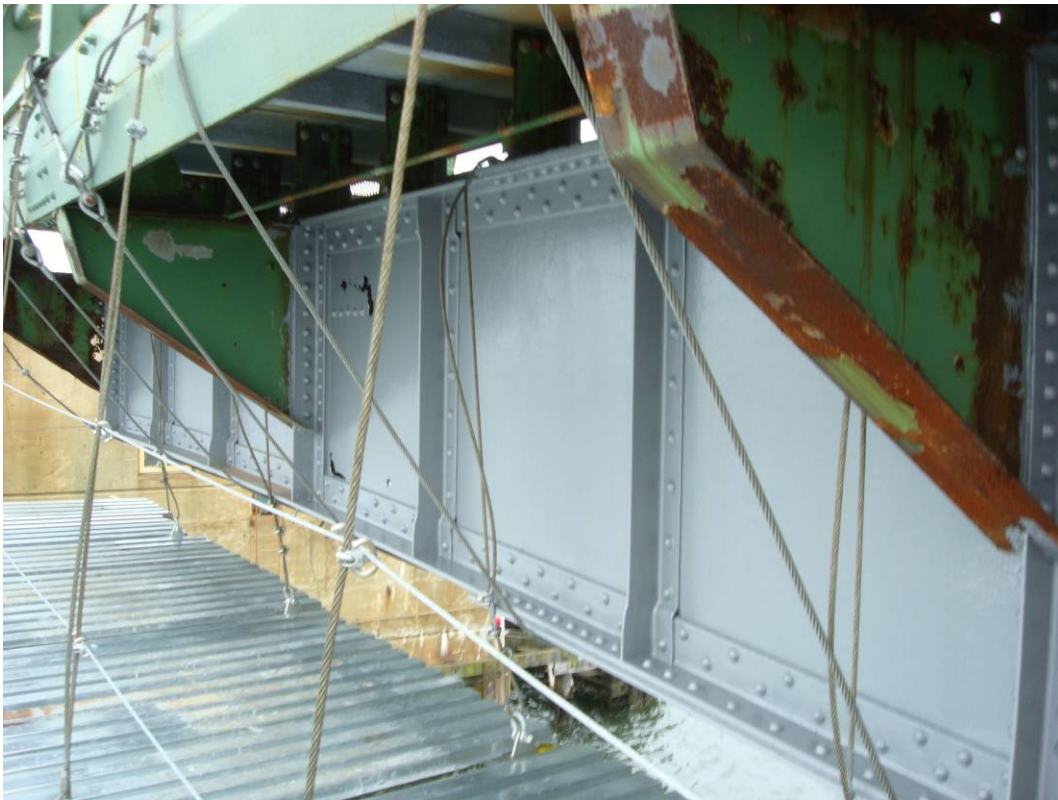
Photo 18: East bascule girder cleaned with hand and power tools. Looking South.

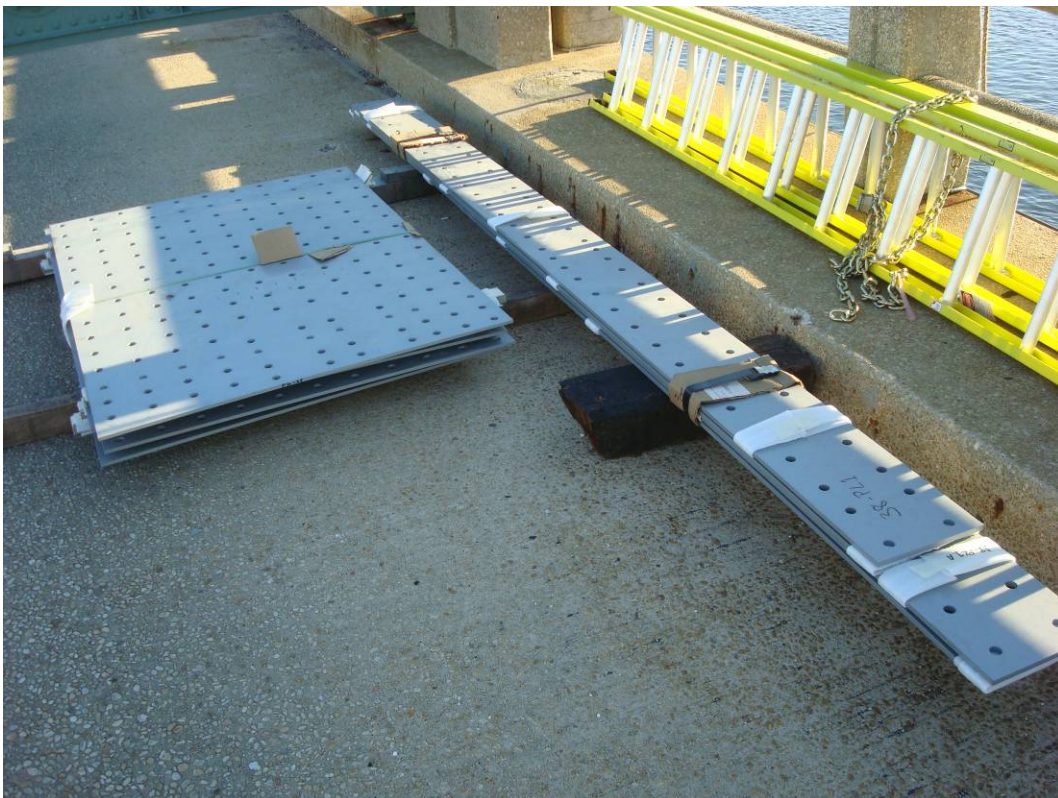
Photo 19: North and South Floorbeam FB5 repair components delivered to site.

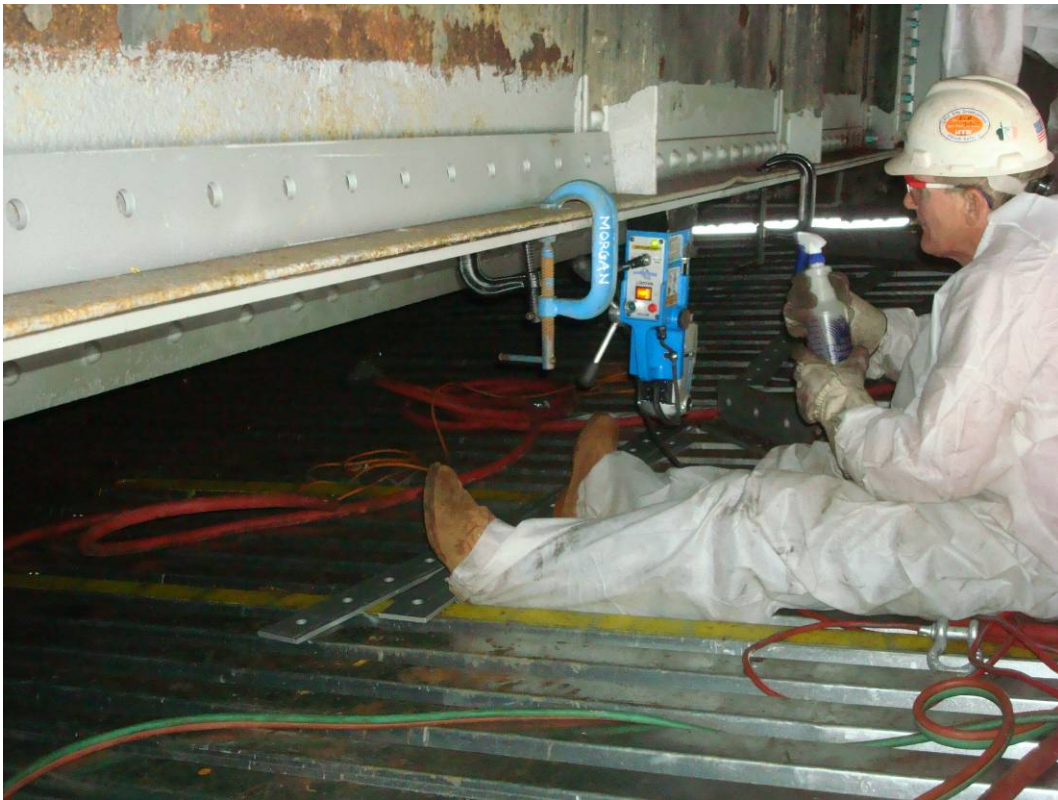
Photo 20: Floorbeam FB5, Field drilling of existing steel using the new cover plates as a template.

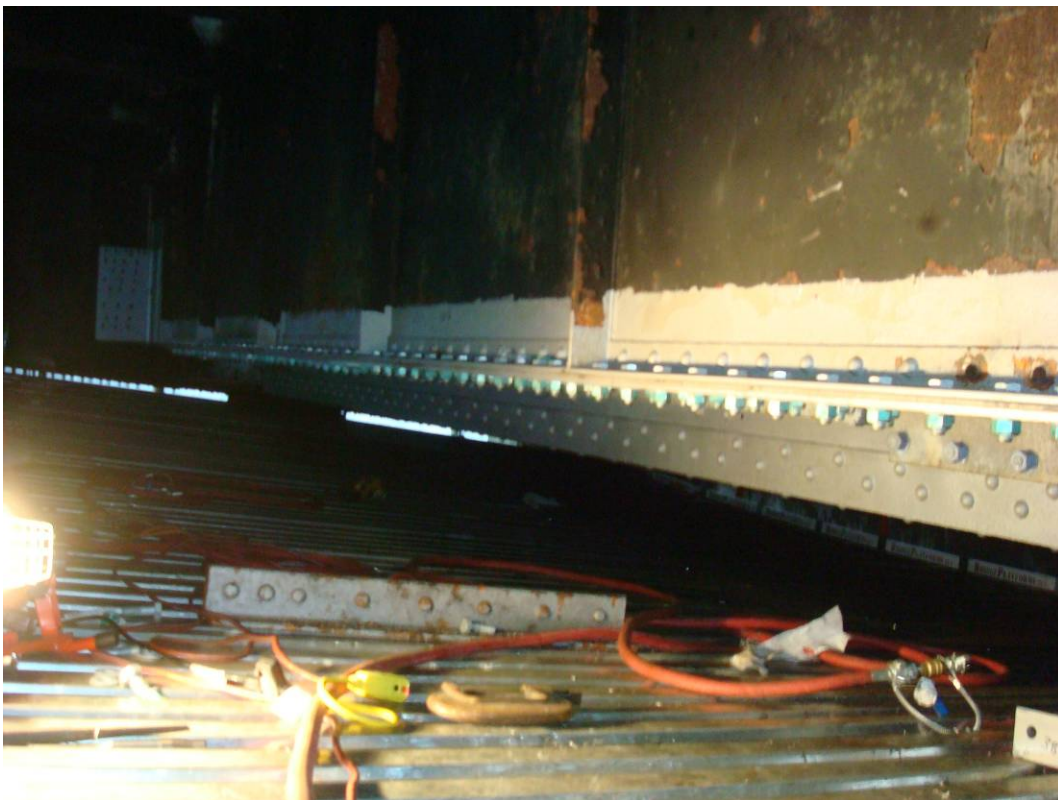
7. The installation of the bottom flange of floorbeam FB5 is approximately 95% completed. The bottom flange repair of Floorbeam FB5 requires 2 additional angles near the west bascule girder. The spacing of the shop-drilled holes in the new angles that were delivered did not match the spacing of the existing holes in the floorbeam. The location for the angle was field measured and re-ordered by the Contractor.

Photo 21: Floorbeam FB5, Bottom flange strengthening plate repair nearly completed.

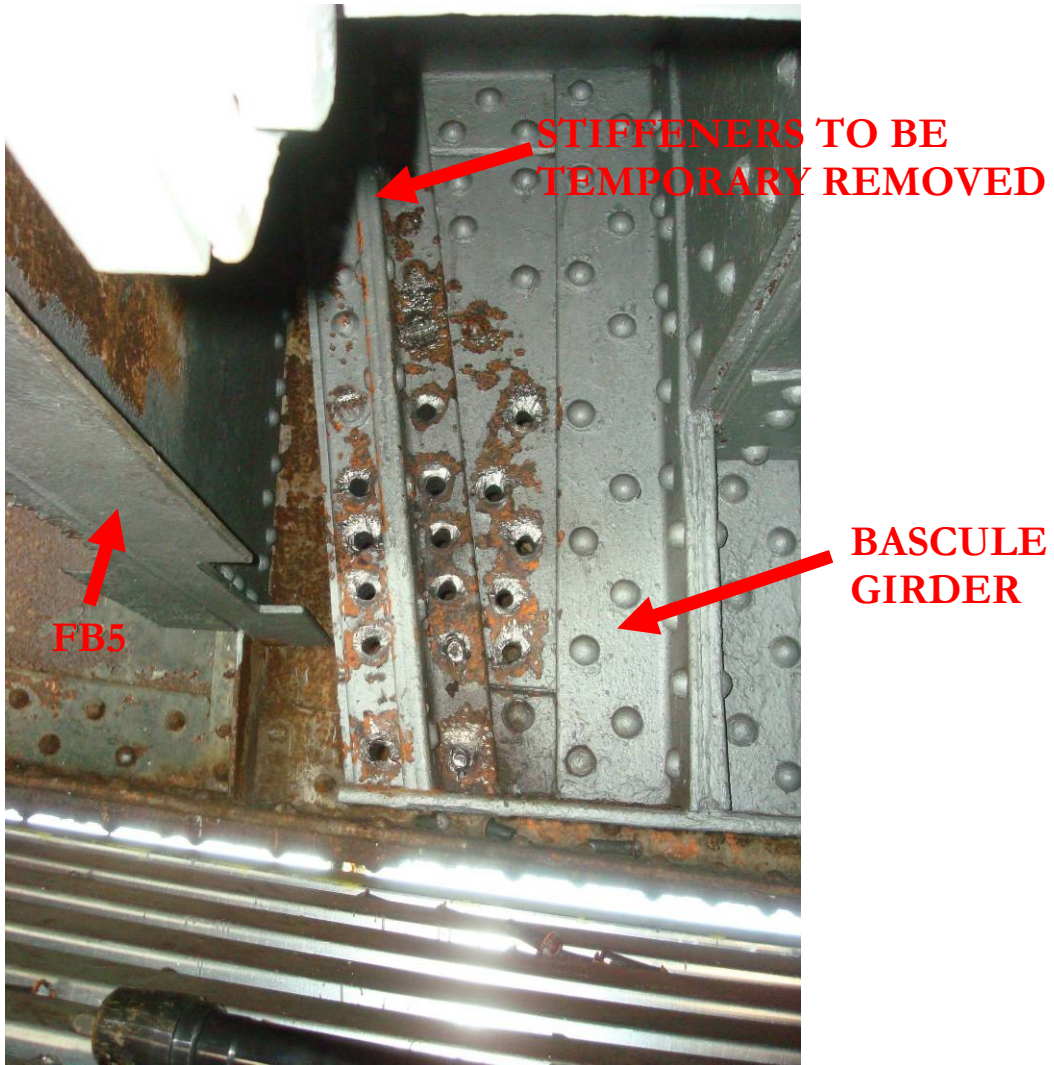
Photo 22: East Bascule girder and Floorbeam FB5, Removal of existing rivets and vertical stiffener angles required for temporary tie down. West Bascule girder similar.

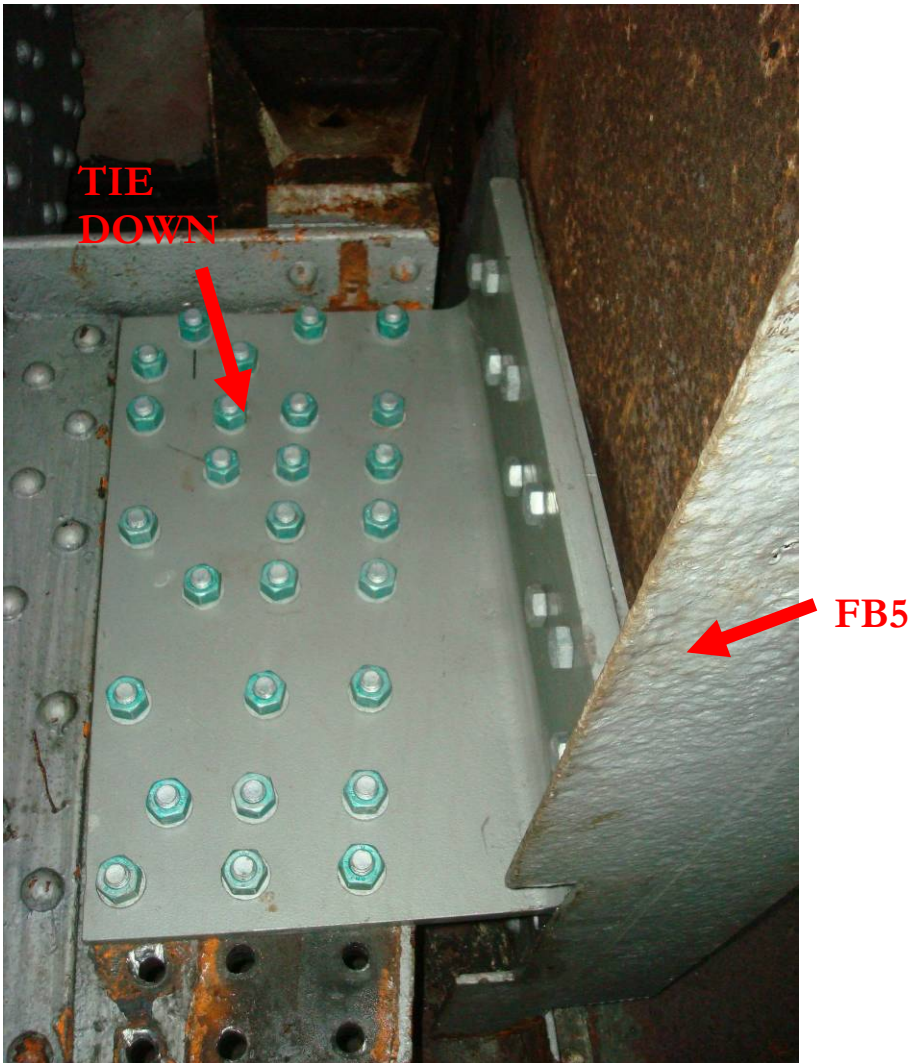
6. Installation of the Temporary Tie downs is approximately 95% complete. The specific length H.S. Bolts required to complete the temporary tie downs were delivered on 11/23/11 and will be installed prior to the removal and replacement of the heel Floorbeam FB4.

Photo 23: West Bascule girder and Floorbeam FB5, Temporary tie down in position and bolted to FB5 and the Bascule girder. East bascule girder similar.

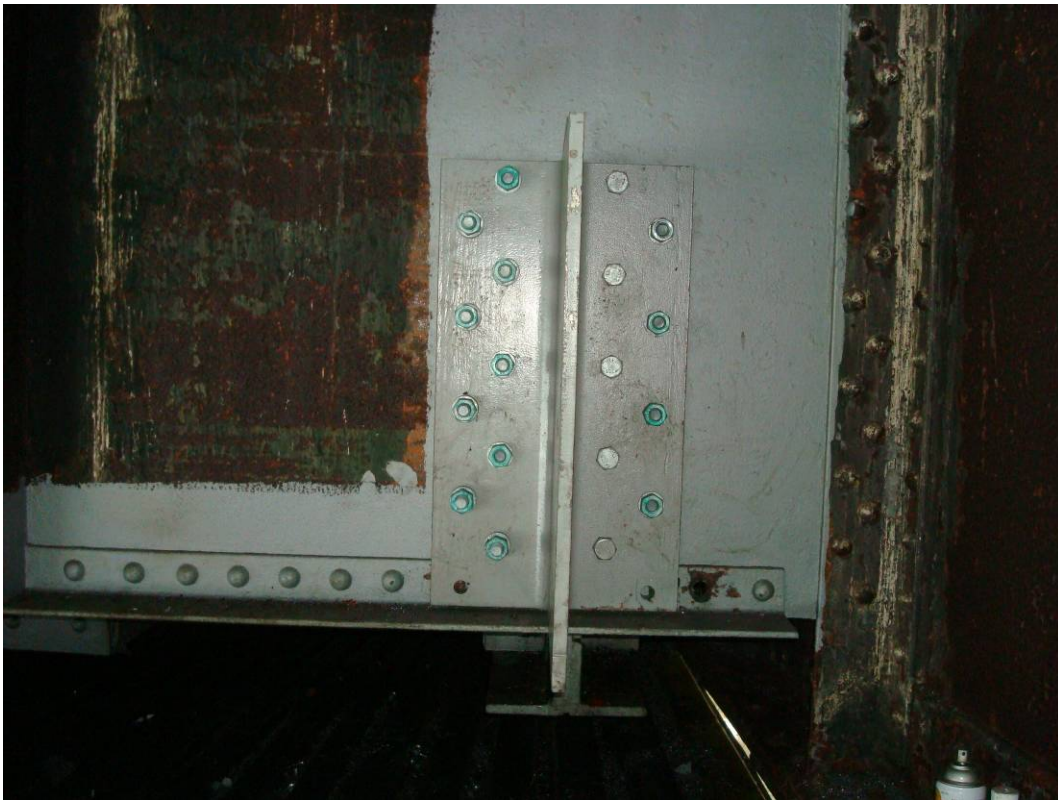
Photo 24: West Bascule girder and Floorbeam FB5, Temporary tie down in position and bolted to FB5 and the Bascule girder. East bascule girder similar. H.S. Bolts between FB5 and Bracket to be replaced with the correct length prior to bascule span FB4 replacement.

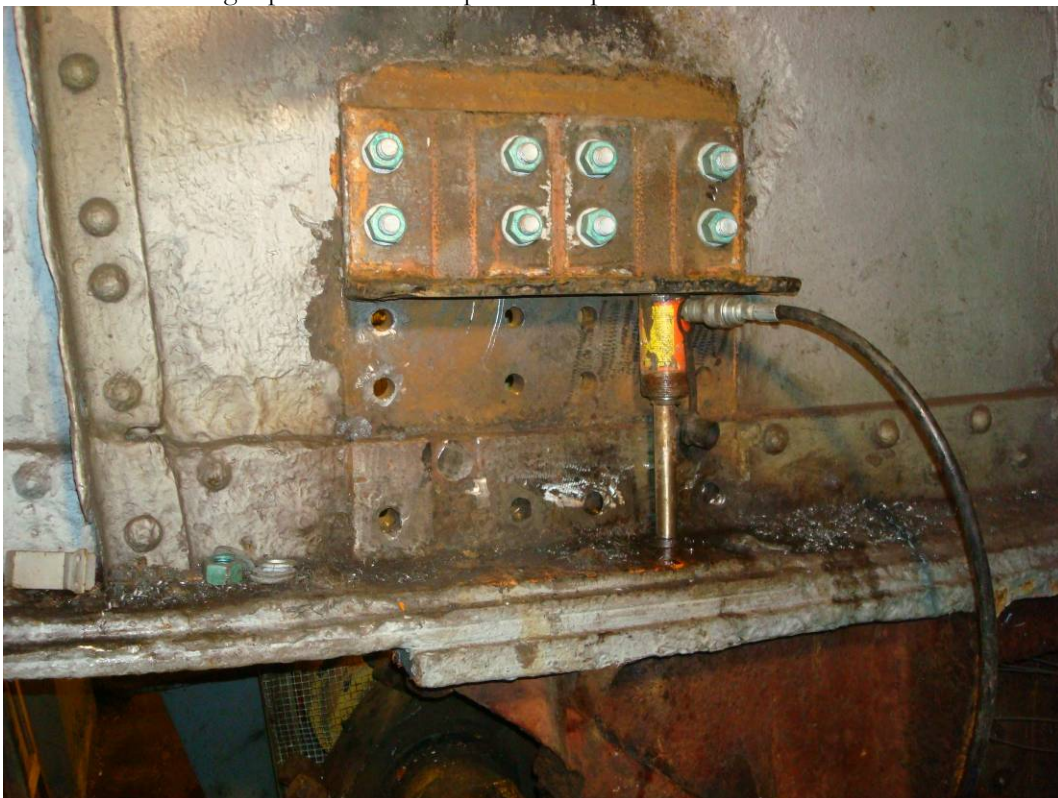
8. The Installation of the bascule span side rack stiffeners is approximately 40% complete with the existing rack stiffeners being removed. Progress is slowed due to the heavily corroded conditions in the rack area and the number of plies of steel plates that the existing rivets and 1-9/16" diameter rack bolts were originally driven through. This work will continue.

Photo 25: West Bascule girder at the span side rack stiffeners. Stiffeners have been removed and a temporary angle with a hydraulic press is being used to remove the remaining portion of the rack bolts from the bottom flange.

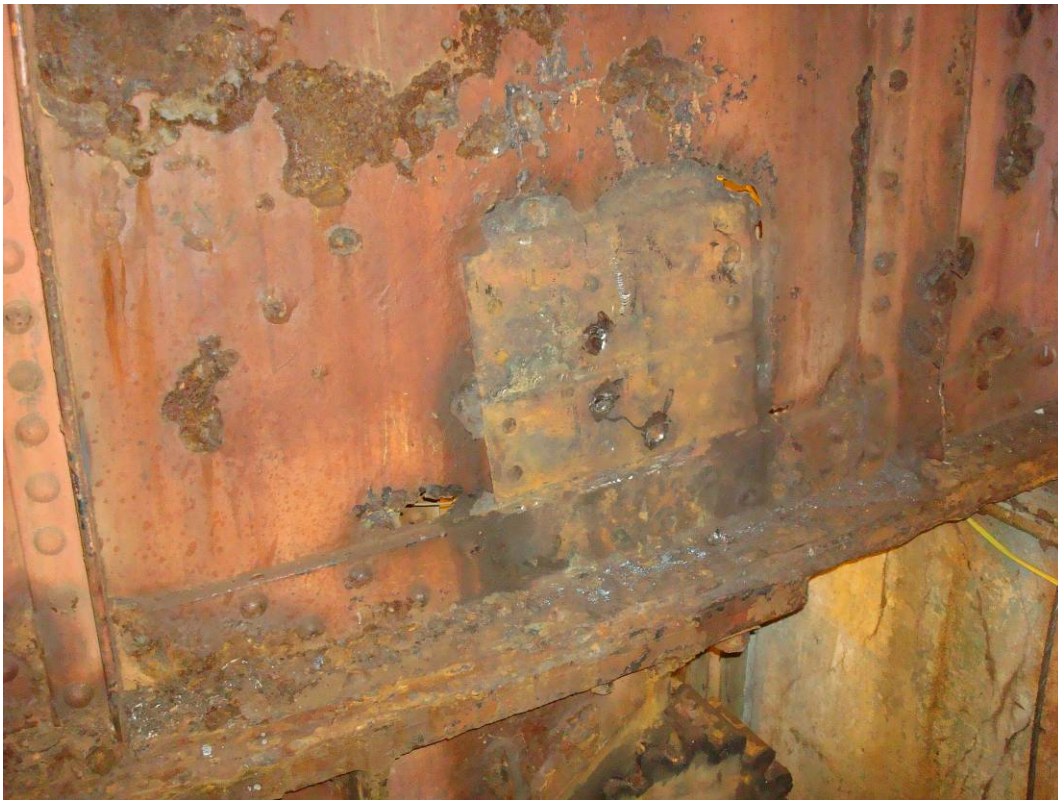
Photo 26: East Bascule girder at the span side rack stiffeners. Stiffeners have been removed from one face only since three rivets remain to be removed as well as the remaining portion of the rack bolts within the bottom flange. Iron workers moved to the west girder while this section of the bascule girder will be hand and power tool cleaned and primed by the Painters.
