**FROM:** James Bager, Resident Engineer: (917) 826-8002

**DATE:** October 17, 2011 to November 23, 2011

**RE:** Project Status

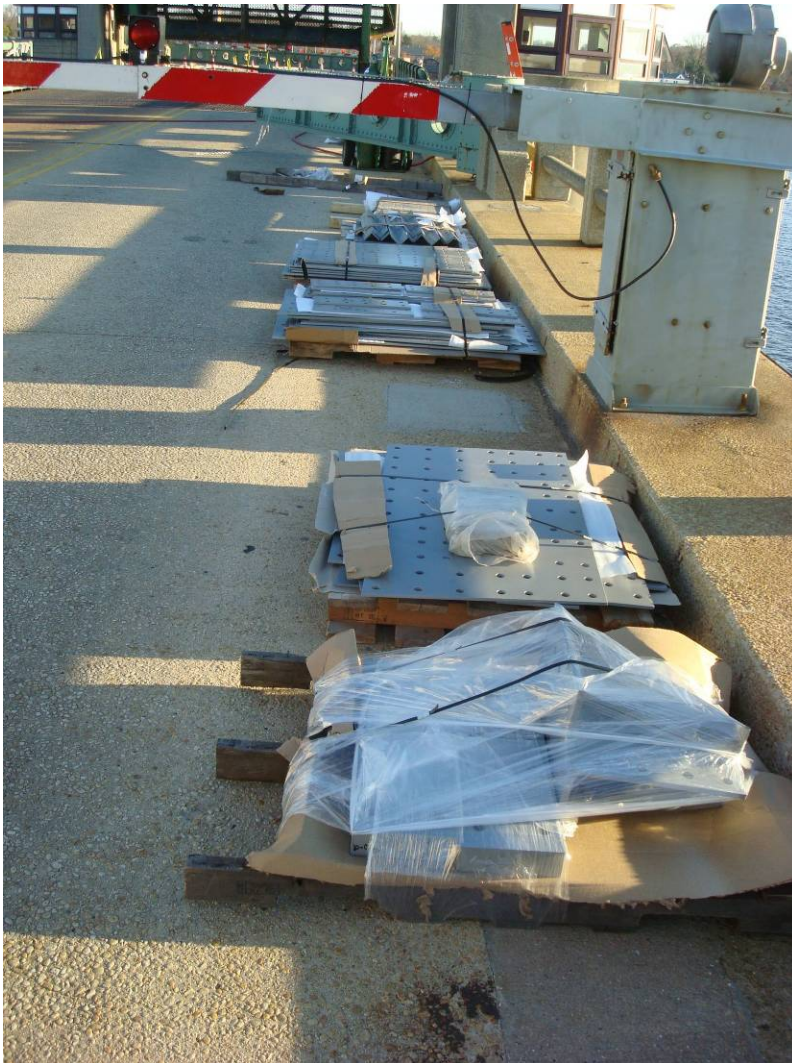
Photo 27: 2<sup>nd</sup> Steel Delivery- 6 pallets consisting of 90% of the bascule girder repair plates for both the north and south leafs.

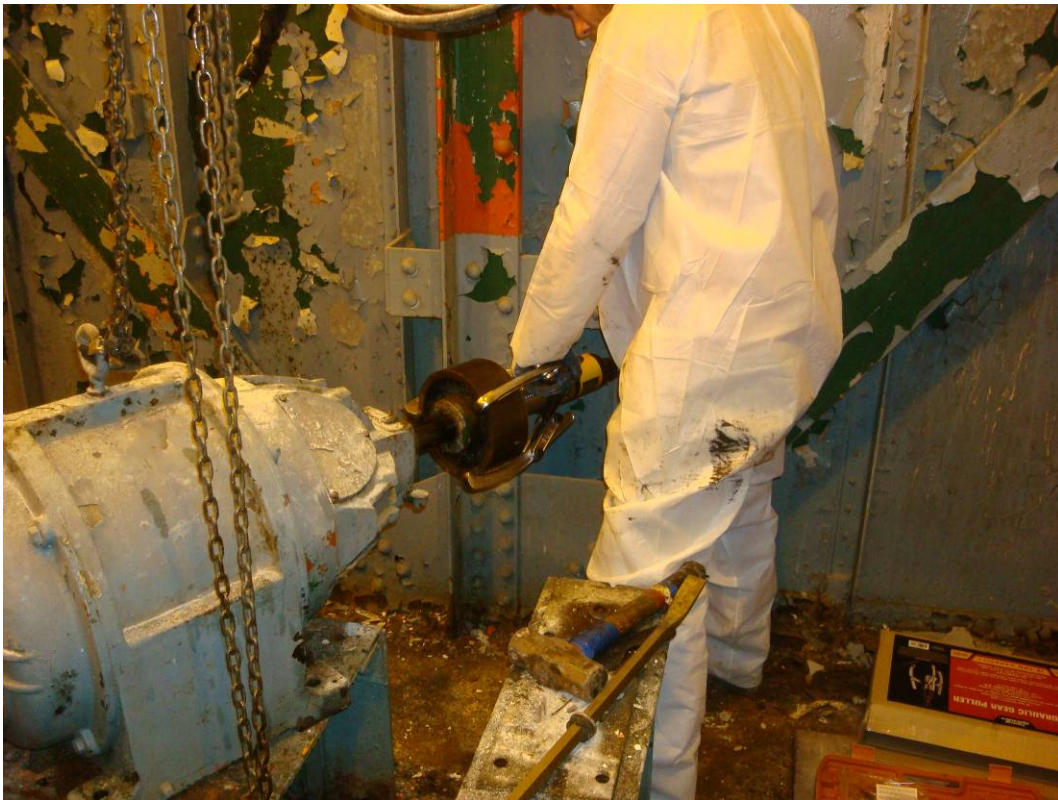
Photo 28: North leaf machinery components; machinery and motor brakes, couplings and brake hubs have been removed.

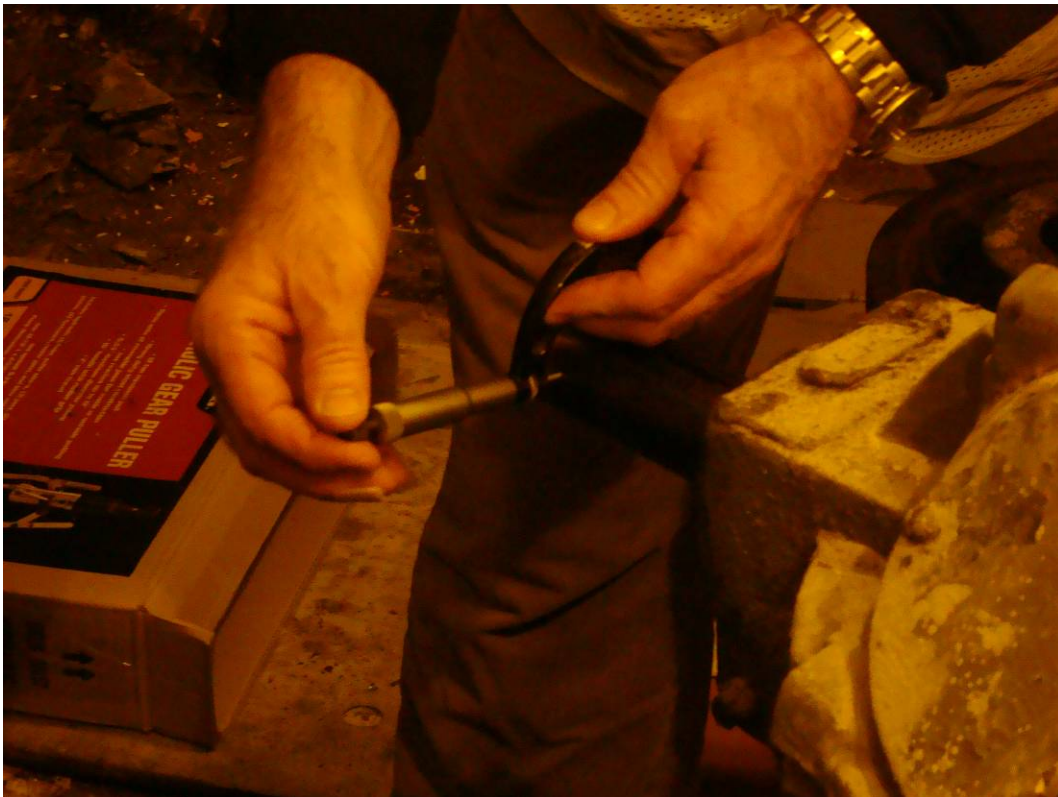
Photo 29: North leaf machinery components- The Contractor field measured the shaft diameters of the main electric and auxiliary gas motors, auxiliary reversing unit and the main differential reducer so that the openings of the new components will sized correctly.

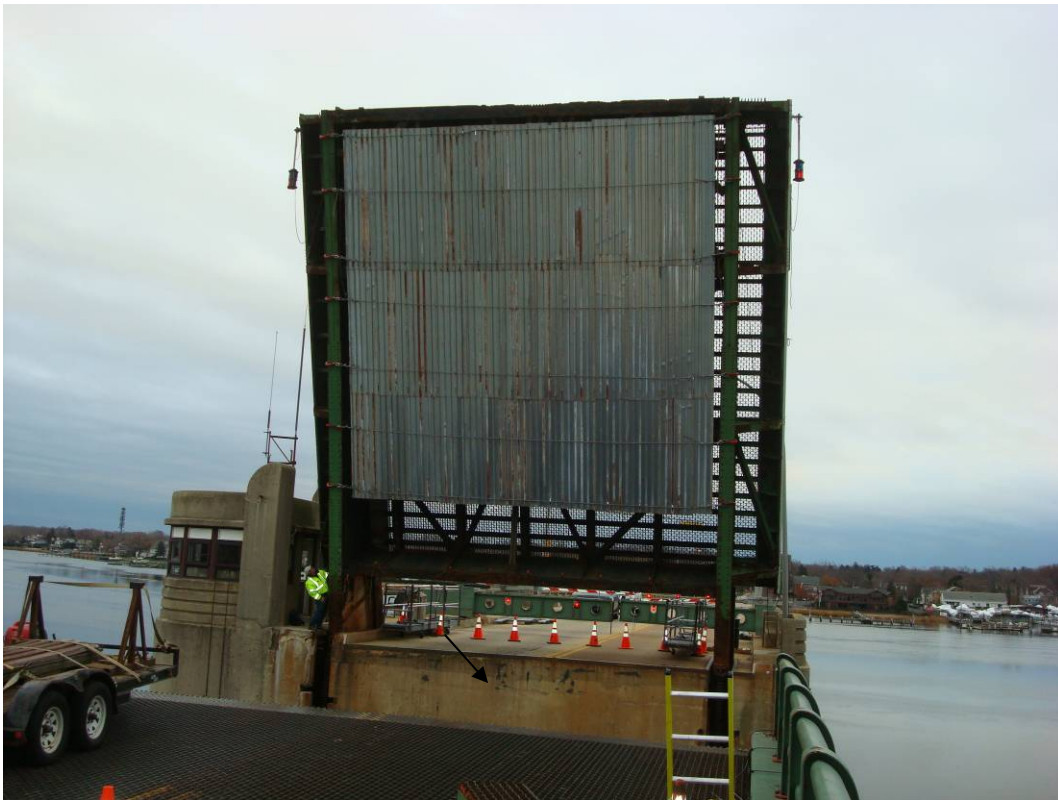
Photo 30: South Leaf –Temporary Platform.

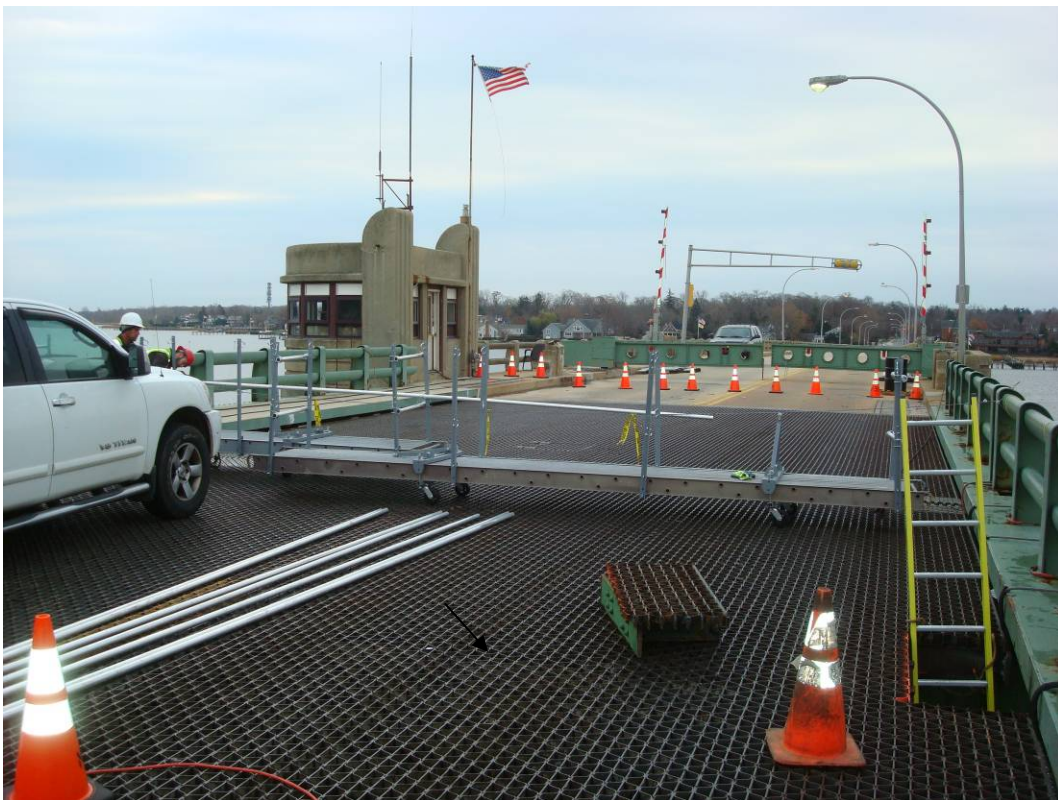
Photo 31: Swing stages to facilitate FB1 replacement.
