HIGH FLOW MANAGEMENT OBJECTIVES FOR NEW JERSEY NON-COASTAL WATERS

**A Study of the Delaware, Saddle, Whippany, and
Musconetcong Rivers and Flat Brook**

**Delaware River Basin Commission
West Trenton, NJ**

August 2000

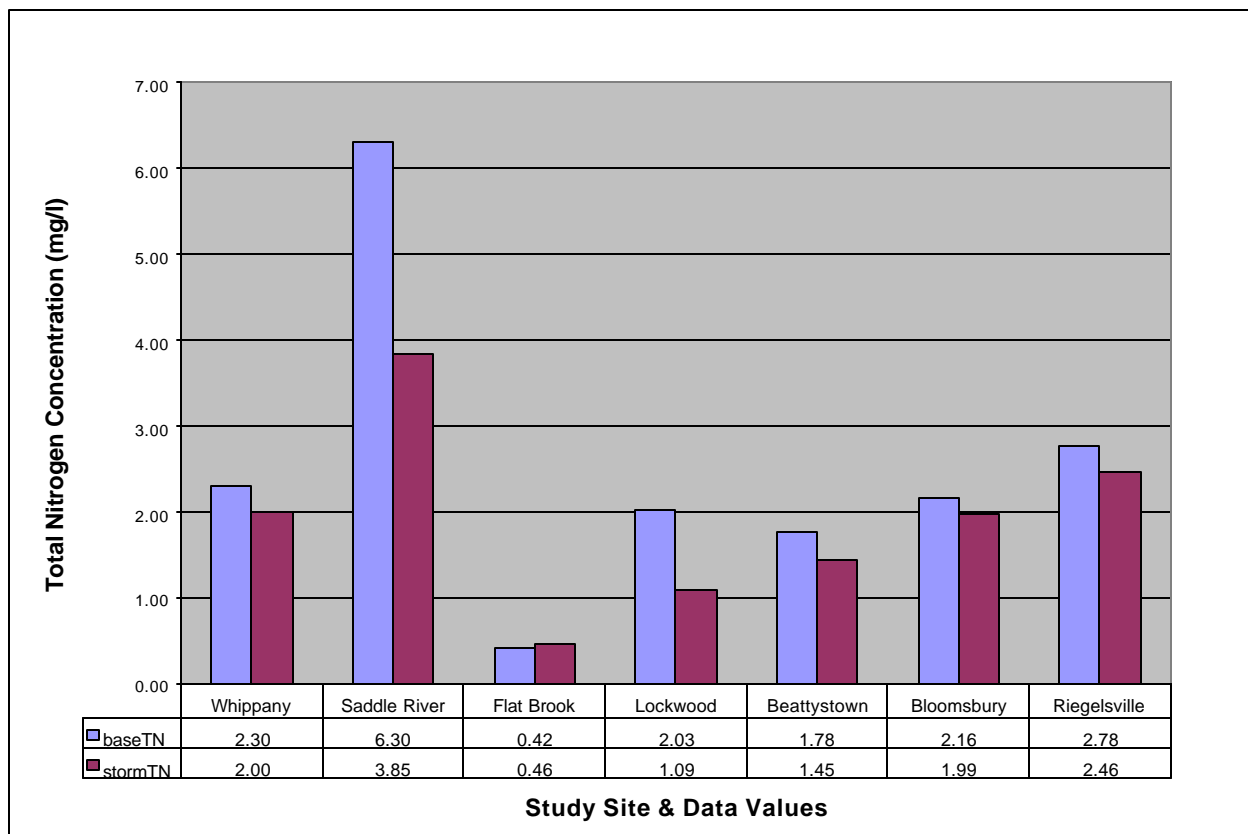
Total nitrogen concentrations (Figure 2) suggest that stormwater-related sources of total nitrogen are not as important as base flow contributions. At every location, base flow TN concentrations were higher than stormwater concentrations. It appears that the high flow (more water) dilutes the total nitrogen that is observed during lower flows.

Figure 2. Total Nitrogen Concentrations under Baseflow and Stormflow Conditions.

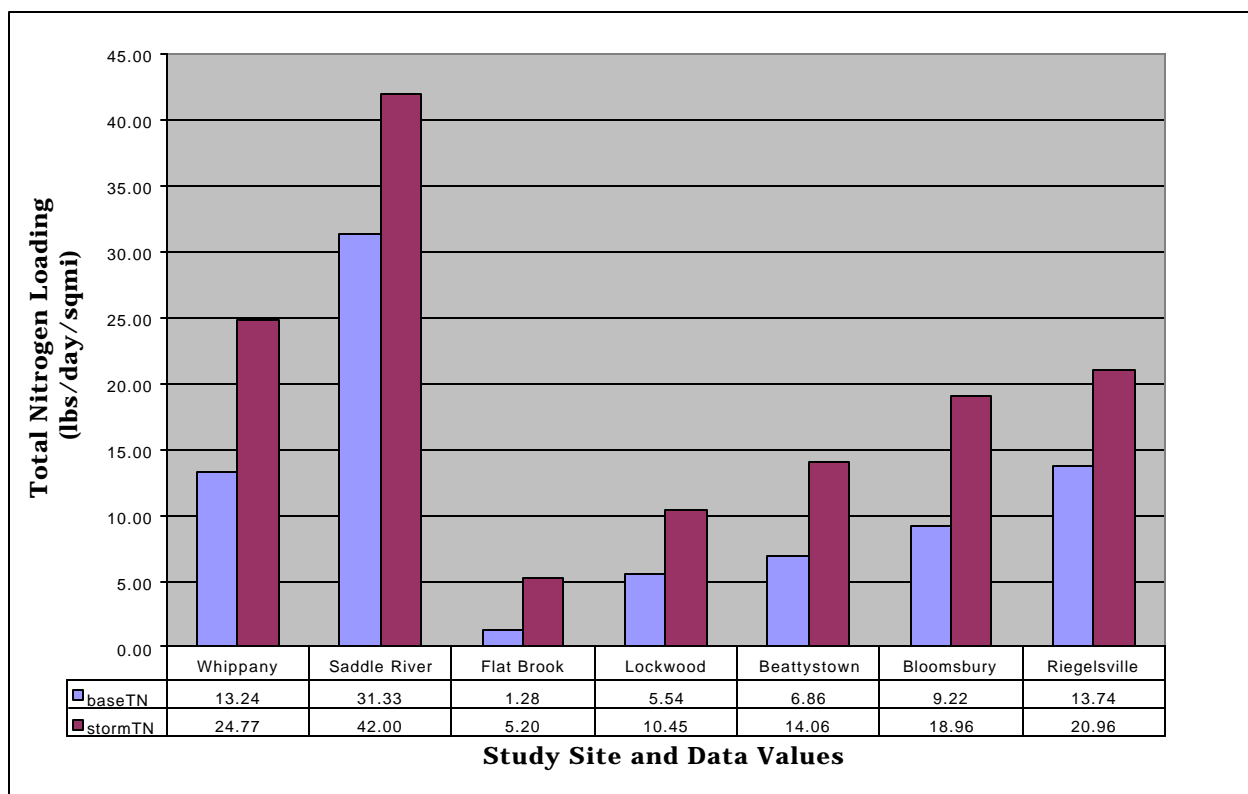
Figure 3. Total Nitrogen Loadings under Baseflow and Stormflow Conditions.

Looking at total nitrogen from a yield or loading basis (Figure 3), it is readily apparent that the loading of total nitrogen is greater during high flow runoff events than during low flow. These data could represent a higher amount of nitrogen in the system – an amount that is still, however, not enough to overcome the dilutive effect of higher water levels.

Loading is a function of water as well as pollutant concentration¹. It was observed that an increase in the amount of water flow increased loading irrespective of pollutant additions. In this situation, the fact that concentrations are lower during stormwater events is much more significant than the higher loadings observed.

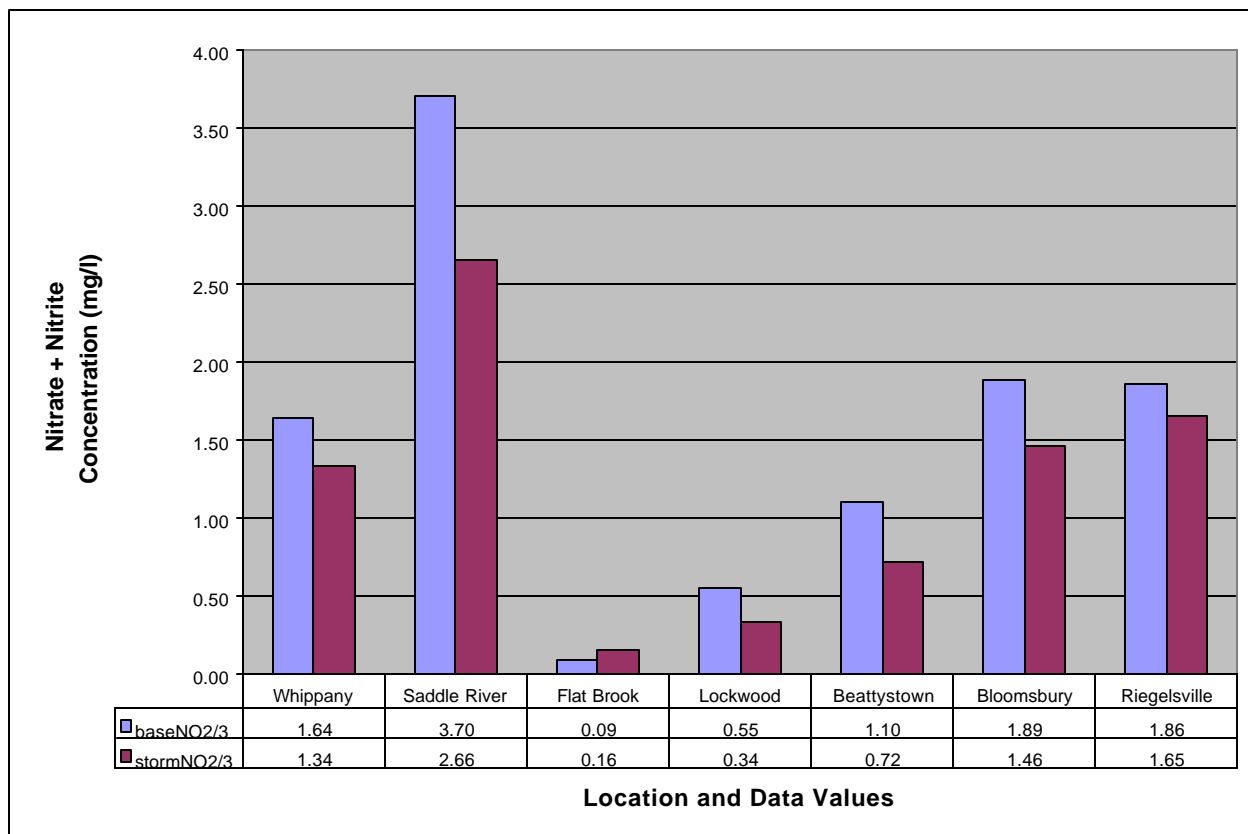
Two components of total nitrogen are nitrate and nitrite, commonly measured as one value. In the study streams, nitrate plus nitrite concentrations and loadings generally follow the same pattern discussed previously for total nitrogen (Figures 4 and 5). Of particular note are the high values at Saddle River, the exceptionally low values at Flat Brook, and the increasing values from upstream to downstream in the Musconetcong as previously noted.

Figure 4. Nitrate plus Nitrite Concentrations under Baseflow vs. Stormflow Conditions.

Two exceptions are evident. Nitrate plus nitrite base flow loads for Saddle River are somewhat of an anomaly when compared with the concentration data. The other exception is a much more significant increase in nitrate plus nitrite concentrations in the lower reaches of the Musconetcong than that observed for total nitrogen. This increase undoubtedly reflects agricultural sources, especially fertilizer. Loading data suggest that nitrate plus nitrite runoff becomes significant upstream of Bloomsbury.

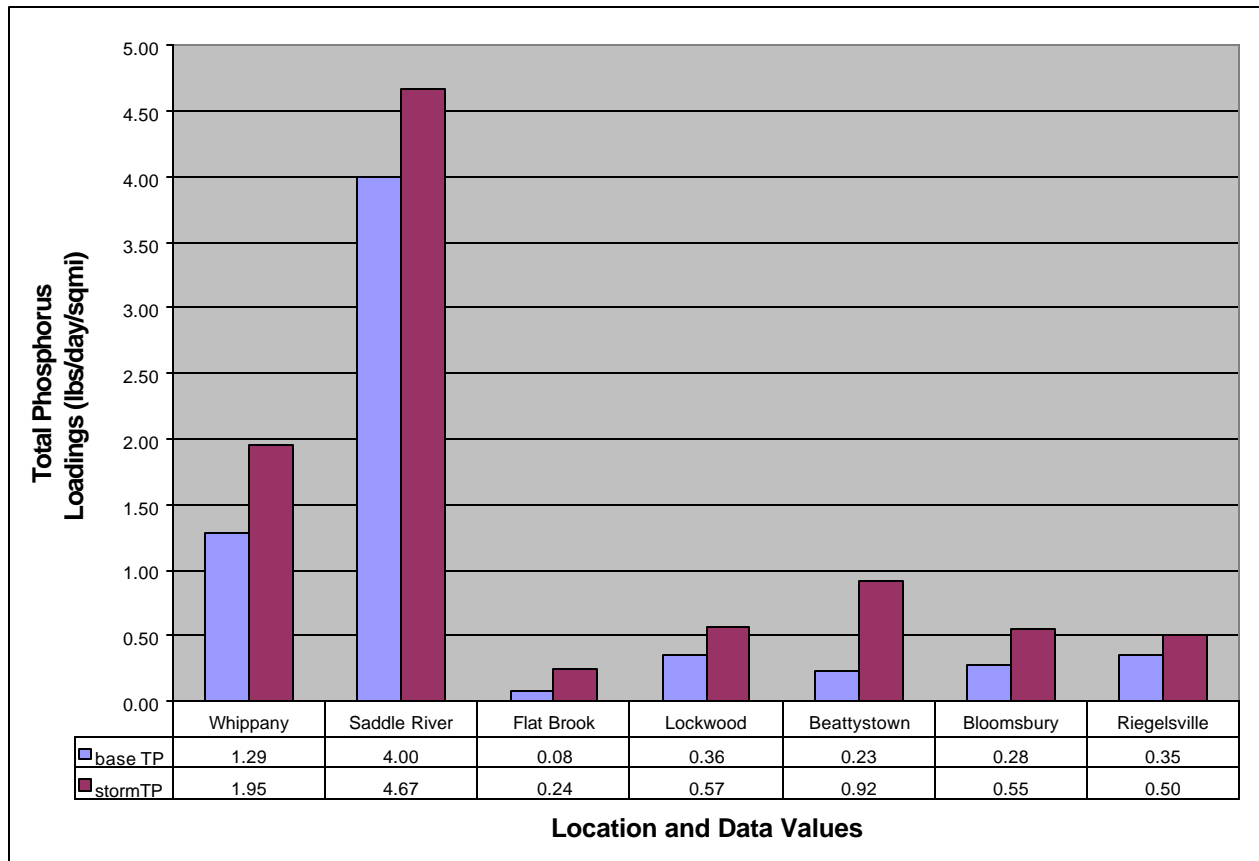
Data for total phosphorus (Figures 6 and 7) show high values for the Whippany River, even higher values for the Saddle River, and exceptionally low values at Flat Brook. In addition, base flow concentrations are higher than stormwater concentrations. These patterns were also seen for nitrogen parameters.

Figure 7. Total Phosphorus Loadings, Baseflow vs. Stormflow Conditions.

Unlike nitrogen, however, total phosphorus in the Musconetcong shows no major increases from upstream to downstream with the exception of a minor loading increase at Bloomsbury. Even this increase is not reflected in the concentration data.

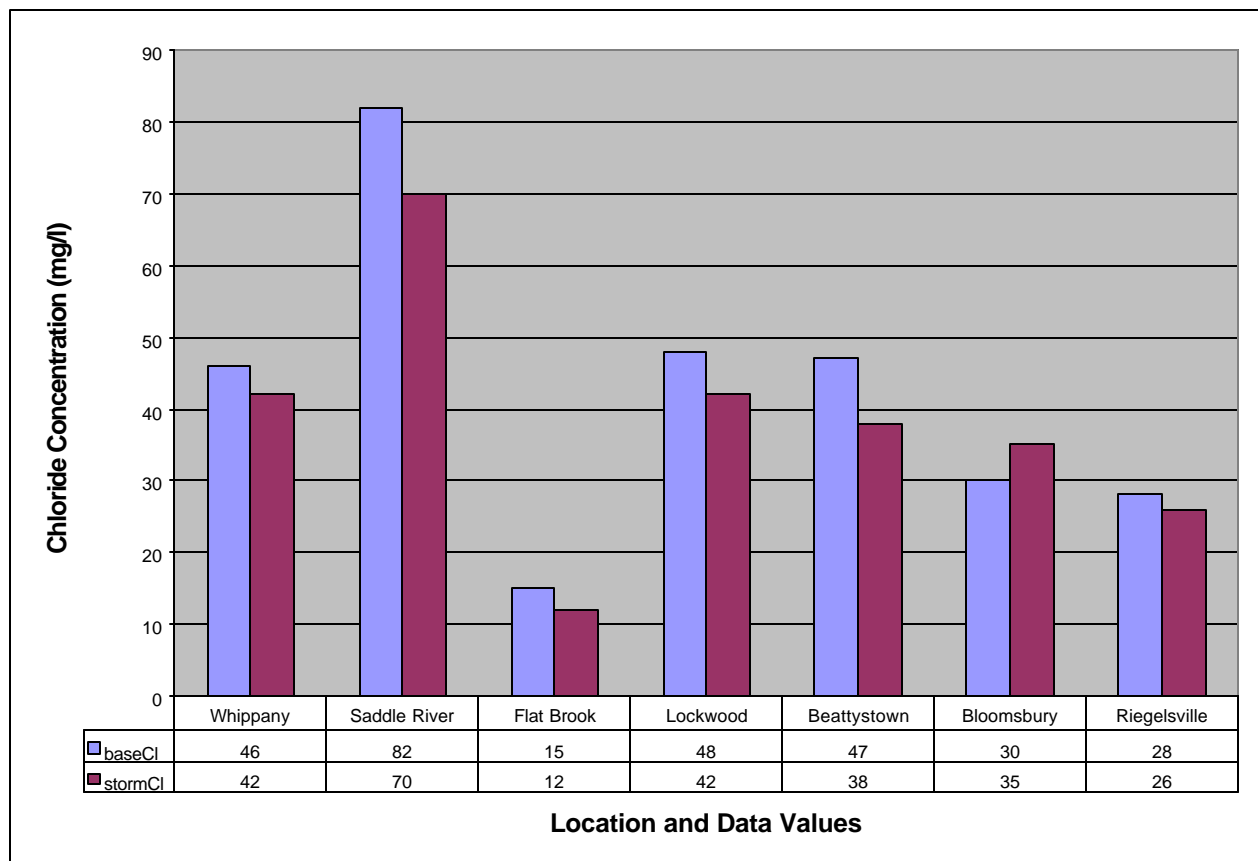
Chlorides are an indicator of human activity and wastes. Human waste effluents (wastewater treatment plants, septic tanks, etc.) and salts used on roadways are two sources of chloride contamination in streams, either directly or via ground water. Data for chlorides (Figures 10 and 11) show high values for the Whippany River, even higher values for the Saddle River, and exceptionally low values at Flat Brook. This pattern was seen elsewhere, particularly with total nitrogen. However, unlike total nitrogen, chloride concentrations decrease from upstream to downstream in the Musconetcong River. The Musconetcong River pattern may reflect the unusual complex of highways that converge upstream of the Lockwood site at Netcong, NJ. Interstate 80 and interchanges, U.S. Route 206, U.S. Route 46, and numerous secondary roads intersect here. From the Musconetcong chloride concentration patterns, one could speculate that chlorides entering the system upstream of Lockwood could influence concentrations in the river to below Beattystown during low flow and all the way to Riegelsville during high flow.

Figure 10. Chloride Concentrations, Baseflow vs. Stormflow Conditions.

It is likely that the Whippany and Saddle Rivers reflect a level of chlorides associated with human activity including road salt usage that is typical of urban and suburban development. The Flat Brook Watershed contains few inhabitants and few roadway miles subject to winter salting.

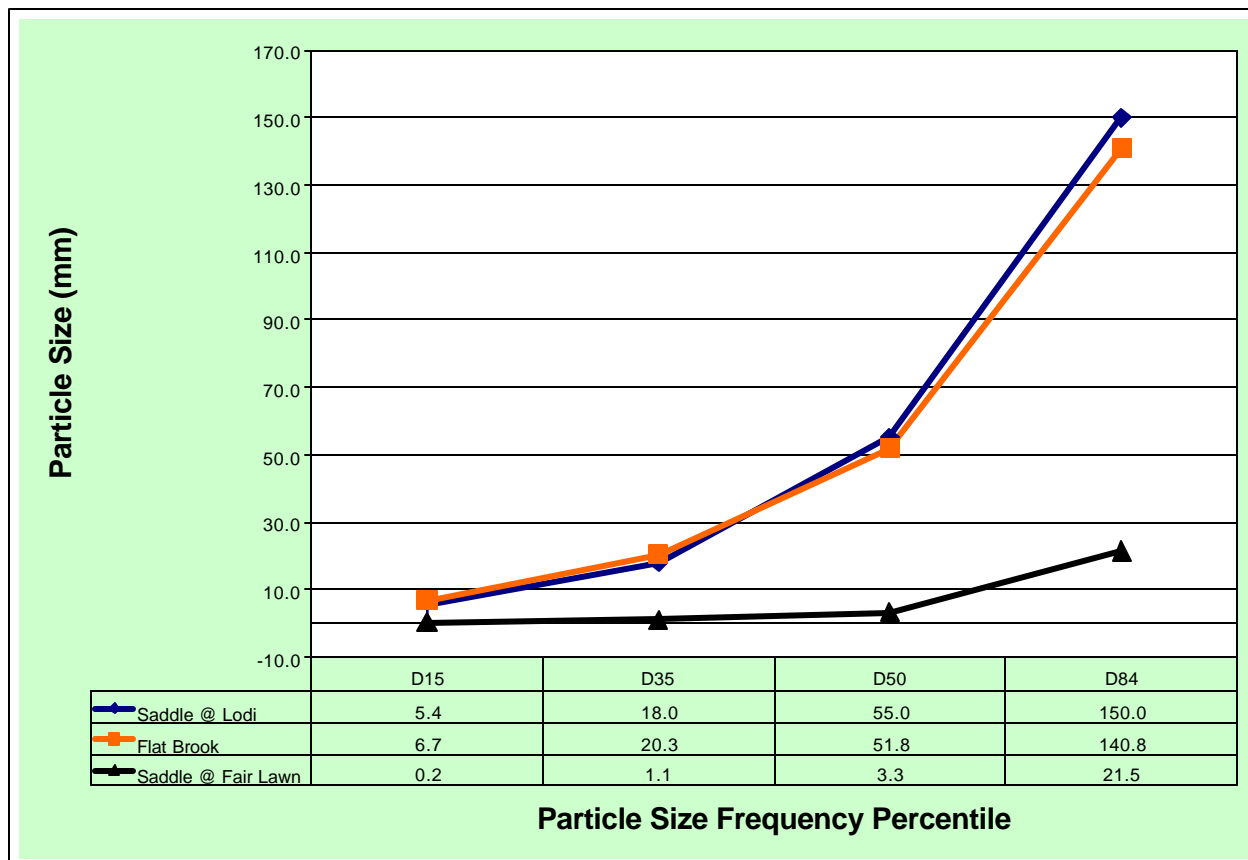
Figure 12 compares bottom substrate data distribution from the Saddle River at Lodi (test site), the Saddle River at Fair Lawn (test site highly impacted by fine sediment deposition) and the Flat Brook (reference site). The Lodi and Flat Brook results are nearly identical, showing ideal particle size distribution, as opposed to the Fair Lawn site where 74 percent of all particles were sand or silt.

Figure 12. Comparison of particle size distributions sampled from the Saddle River at Lodi, NJ; Saddle River at Fair Lawn, NJ; and the Flat Brook reference reach.

Unlike the Saddle River Fairlawn location with its large deposits of sediment, pebble count data collected immediately downstream from the Saddle River Lodi stream gage are suggestive of a natural condition. In fact, bottom substrate data for the Saddle River at the Lodi site is similar to that seen in the Flat Brook, the reference stream. In this reach, the percentage of sand and silt is 11 percent; reasonably comparable to the 14 percent observed at Flat Brook.
