# Monmouth County Bridge S-17

On County Route 10, West Front Street over the Swimming River

## Public Information Center #4 & 5

## Scoping Study for Improvements Monmouth County Bridge S-17

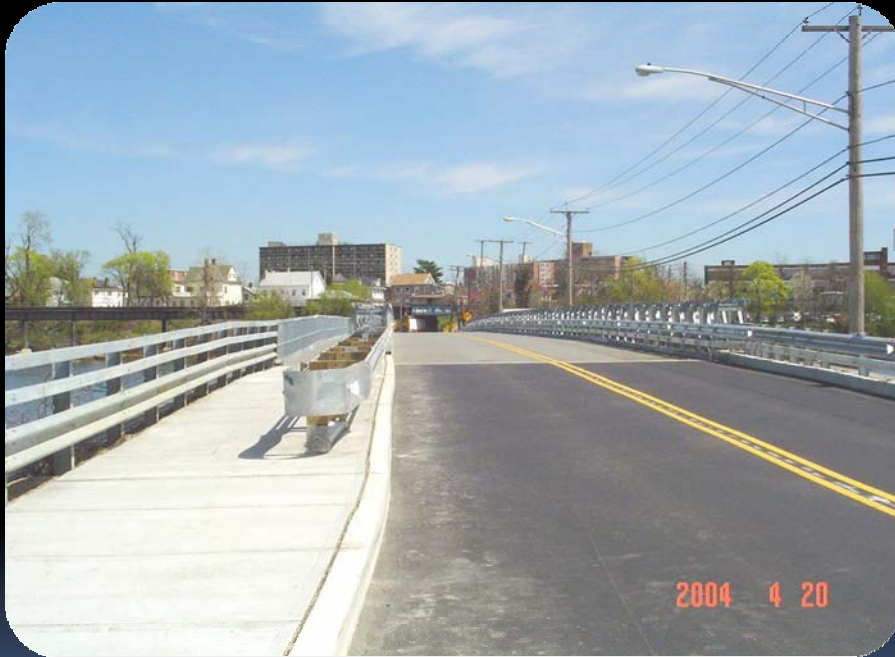
## **Recently Constructed Acrow Panel Superstructure**

- Consists of six (6) 55' prefabricated steel Acrow panel truss units.
- Rehabilitation of the existing steel girders would have cost approximately the same amount as Acrow Panel truss rehabilitation.

- Benefit is the County now owns the trusses for future re-use upon replacement of existing bridge.
- The geometric inadequacies on the bridge that existed before the Acrow bridge was installed are still present – the Acrow bridge, although slightly wider than the original (deck width from 21 feet to 24 feet) does not meet geometric standard (30'). The SI&A Form for the present bridge will still define the bridge as “Functionally Obsolete” due to substandard geometry.

- The replacement trusses could not be widened to meet standard geometric widths due to limitations of the existing superstructure.
- The Acrow Panel bridge has a service life of 25+ years depending on environmental exposures and use.

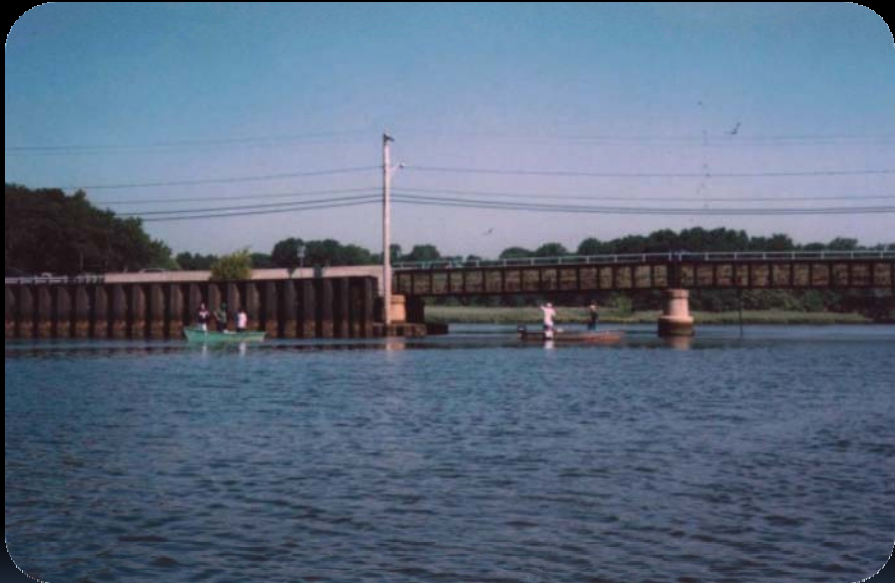
### **South Side of Bridge (prior to Superstructure Replacement in 2004)**

Note: Boating, Fishing and Crabbing Activities

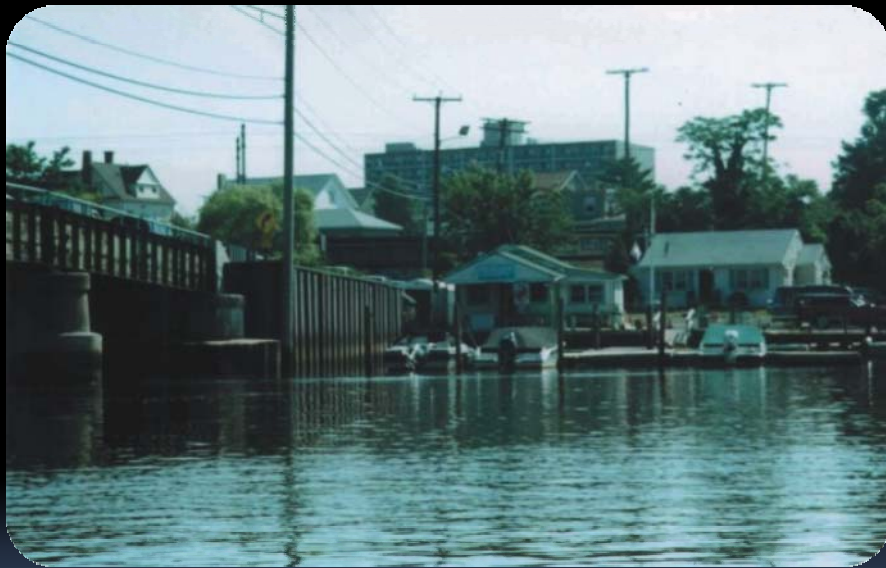
### **Sea-Land Marina at the Southeast Corner of the Bridge Approach Roadway**

Note: Existing utility poles, boat slips, newly constructed approach roadway steel sheeting bulkhead, and closeness of properties to West Front Street.

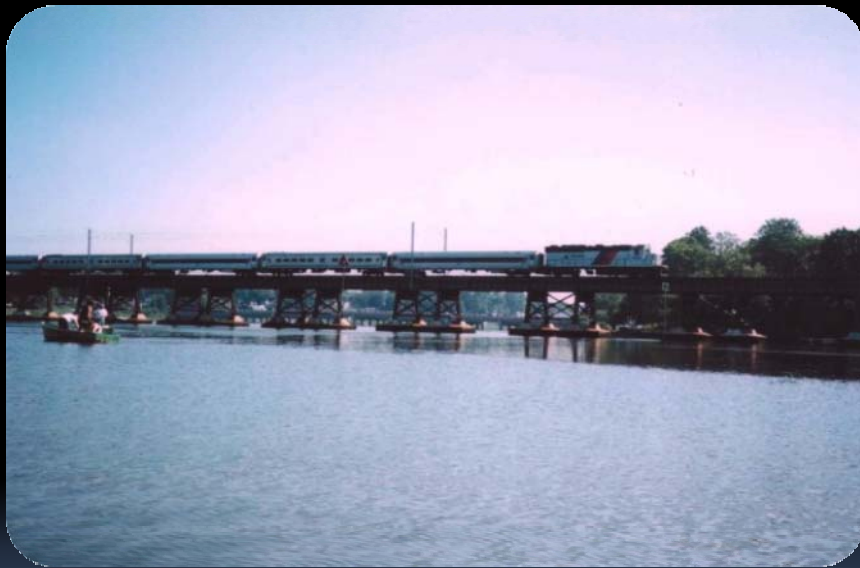
### **NJ Transit trestle northeast of the bridge.**

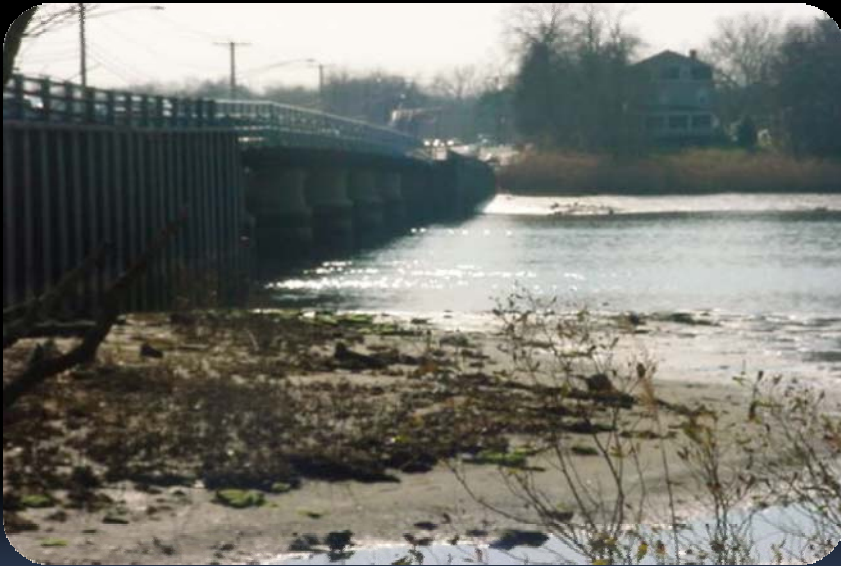
**Looking west, north side, Monmouth  
County Bridge S-17. Scheme A will  
construct a new bridge  
at this location.**

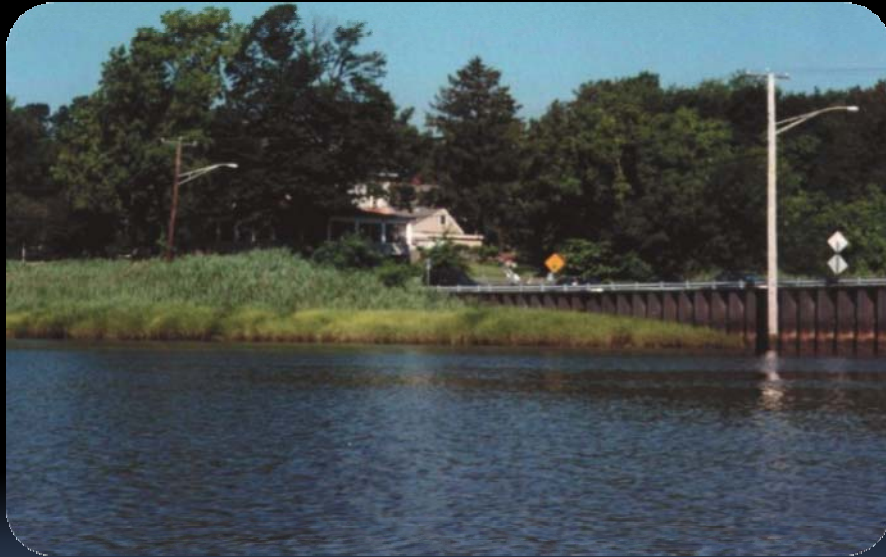
**Wetlands at the southwest corner of the bridge approach roadway.**

**Note: Existing utility poles and lighting adjacent to steel sheeting.**

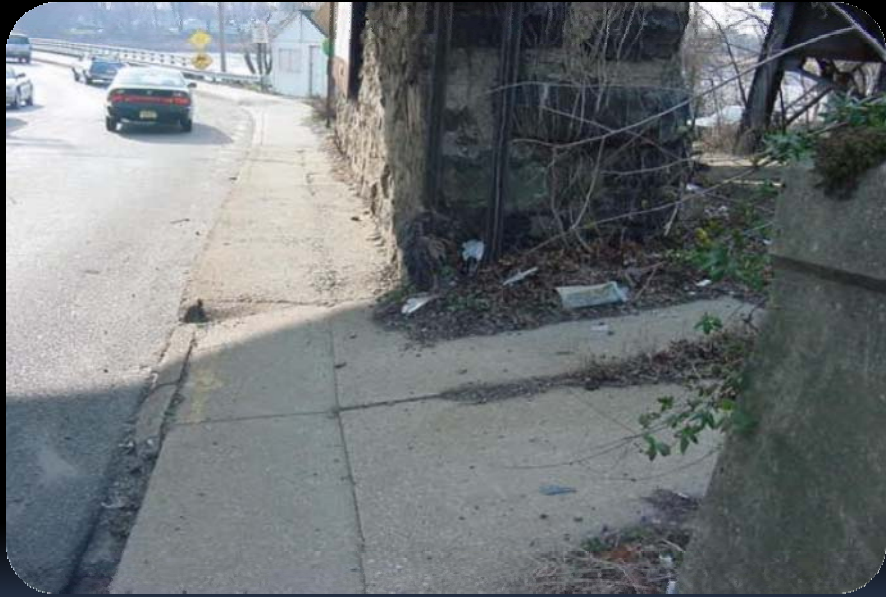
**Looking west at New Jersey Transit  
Bridge.**

**Note: Opening between pier and  
retaining wall.**

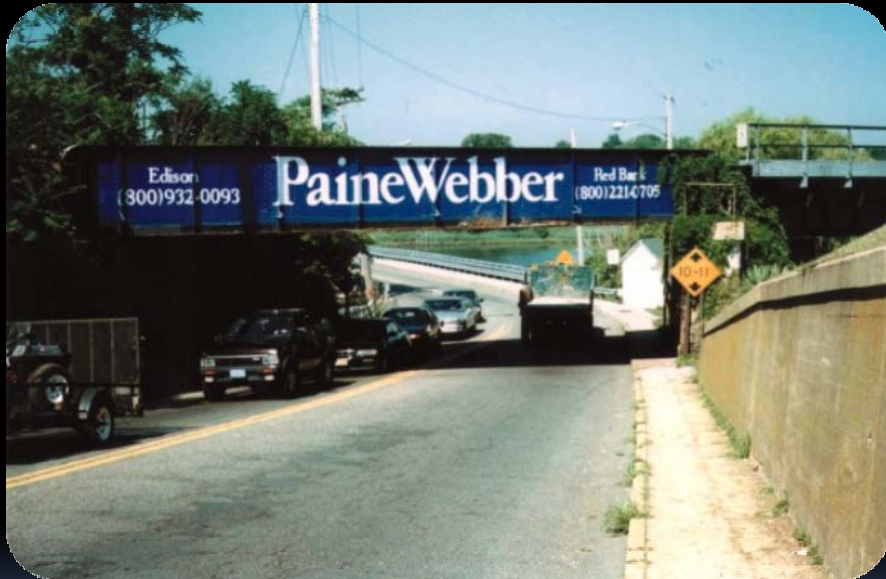
**West Front Street east approach.**

**Note: 10"-11" vertical clearance at  
railroad bridge/geometrics.**

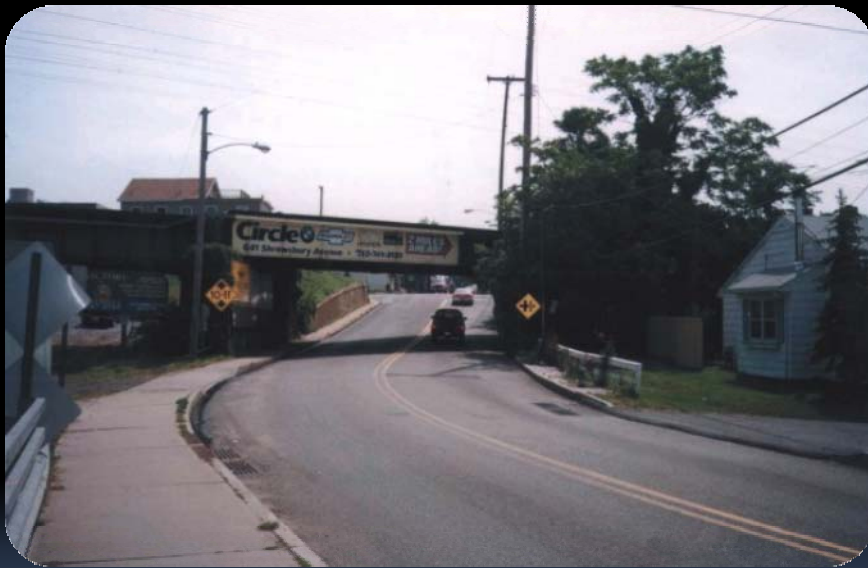
**West Front Street looking east.  
Note: Driveways to Sea-Land  
Marina properties.  
Right turn slot after railroad  
bridge abutment.**
