**MONMOUTH COUNTY S-31 BRIDGE
OCEANIC BRIDGE
COUNTY ROUTE 8A OVER THE NAVESINK RIVER
TOWNSHIP OF MIDDLETOWN
BOROUGH OF RUMSON**

Scoping Study
September 2011

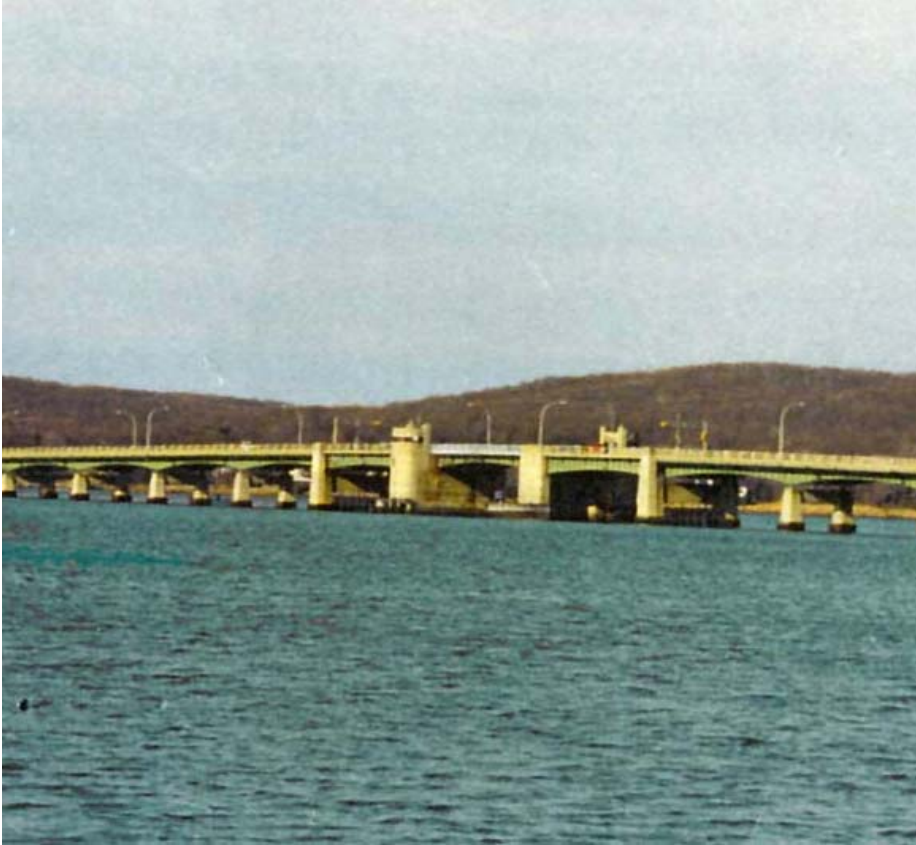
- Constructed 1939
- Modern Architectural detailing
- Double-leaf bascule span
- Concrete operator's houses
- Rounded railings with Streamline profiles
- Representative example of prominent design firm's work (Ash-Howard-Needles & Tammen) the most prolific designers of movable span bridges in the late 1920's and 1930's in New Jersey

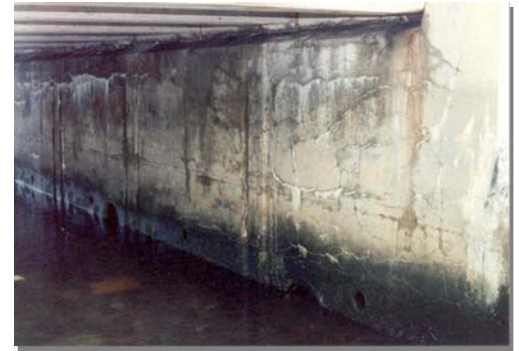
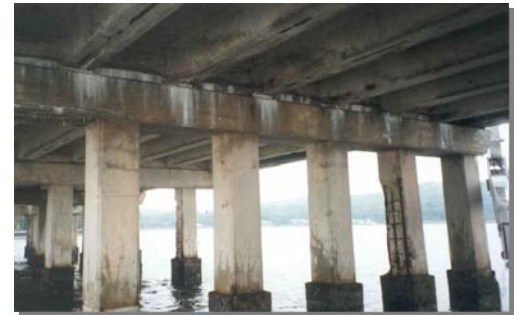
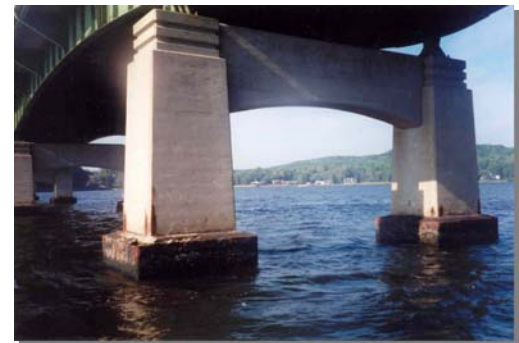
Substructure

- **Abutments - *Poor Condition***
 - Widespread Fine to Medium Horizontal Cracks W/ Efflorescence and Hollow Sounding Concrete (Incipient Spalling and De-lamination)
- **Concrete Pile Bents - *Serious Condition***
 - Advanced Column Spalling
 - Widespread Spalls and Cracks in Cap Beams
 - Cap Beams Do Not Rate for HS-25 Design Loading
- **Concrete Piers - *Serious Condition***
 - Footing Seal Slab Deterioration at Piers 14 to 18 Found in 1991
 - Many Supporting Timber Piles Subjected to Marine Borer Damage
 - ***50% Reduction in Original Pile Diameter***
 - Anticipate Pile Capacity Exceeded for HS-25 Design Loading
 - Footing Voids Filled With Tremie Concrete in 1993

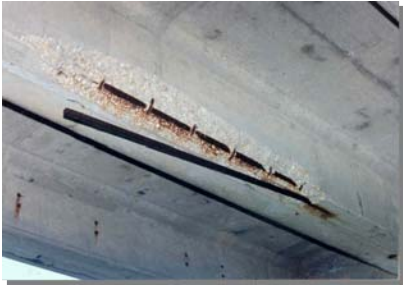
- Concrete T-Beam Spans – **Poor** Condition
 - Several Large Spalls and Debonded Reinforcing
 - T-Beams Do Not Rate for HS-25 Design Loading

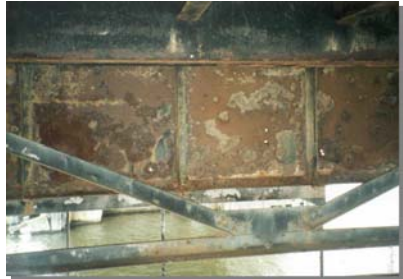
- Steel Deck Girder Spans - **Poor** Condition
 - Paint System Generally Failed on All Members
 - Many Bearings Leaning and Frozen
 - Widespread Material Losses, Connection Losses and Impacted Rust
 - Suspended Girders, Floorbeams and Flanking Span Stringers Do Not Rate for HS-25 Design Loading

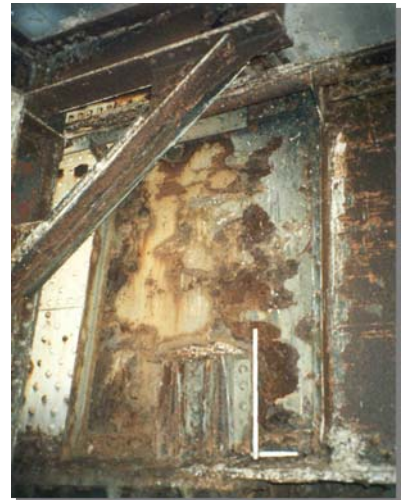
- Bascule Span - **Serious** Condition
 - Paint System Generally Failed on All Members
 - Extensive severe section loss with holes in all Bascule Span Structural Steel Components Jeopardize the Structural Integrity
 - Girders and Stringers Do Not Rate for HS-25 Design Loading

- Continuing Deterioration of the Steel Members on the Bascule. Analytical Modeling and State of the Art Technology to Assess the Actual Remaining Capacity of Similar Bridge Structures.

- Rehabilitation of Bascule Span – Includes Removal of Existing Grid Deck, Roadway Purlins, Stringers, Designated Floor Beams, Catwalk and Span Lock Machinery
- Construct New Grid Deck, Stringers, Floor Beams, Supporting Steelwork, Catwalk, Structural Steel Strengthening Repairs, Mechanical/Electrical Repairs, Hand/Power Tool Cleaning, and Painting Existing Bascule Pan Steel.

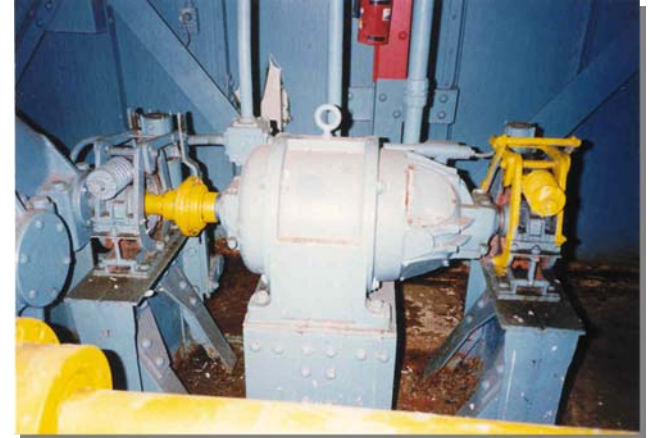
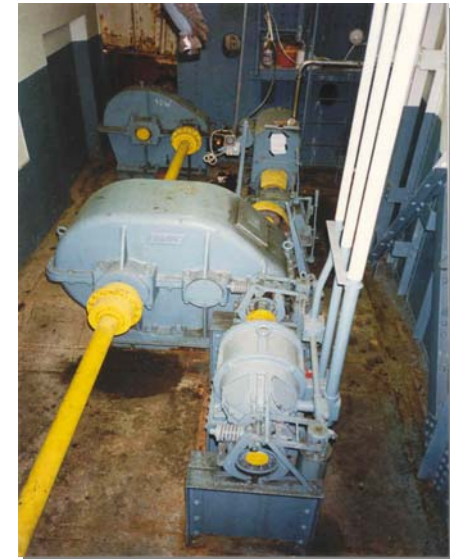
Mechanical System

- **Bearings**
 - Extensive Corrosion
 - Web Holes at Bearing Housing Supports
- **Couplings**
 - Obsolete Design
- **Open Gearing**
 - Light to Heavy Corrosion at Racks and Pinions
- **Speed Reducers**
 - Significant Corrosion at Interface of Structural Supports and Concrete
- **Span Motors**
 - Significantly Undersized Per AASHTO Power Requirements
 - Major Mechanical Components Do Not Meet Standards with a Motor Sized to Present AASHTO Requirements
- **Trunnion Assemblies**
 - Corrosion Adjacent to Bascule Girders
 - Trunnions and Trunnion Bearings Significantly Overstressed

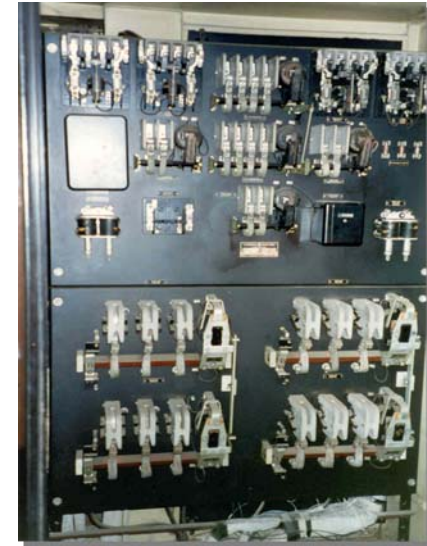
Electrical System

- **Electric Service**
 - Liquid Filled Transformers Exhibit Signs of Leakage and Aging (Possible PCBs)
- **Power Distribution and Control**
 - Original to Bridge
 - “Live” Front – Danger to Operators and Maintainers
- **Control Desk**
 - Obsolete, Inoperable and Unreliable Components
- **Span Motors**
 - Obsolete, Inefficient Design
 - Design Lives Exceeded
- **Brakes**
 - Obsolete, Replacement Parts No Longer Available
- **Lock Motor and Brake**
 - Extensive Signs of Aging and Physical Distress
- **Limit Switches and Transmitters**
 - Original to Bridge, Exhibit Device Failure and/or Have Been Defeated

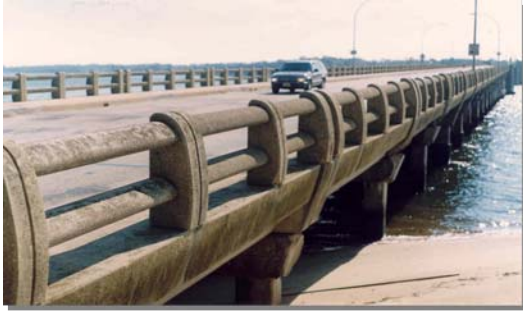
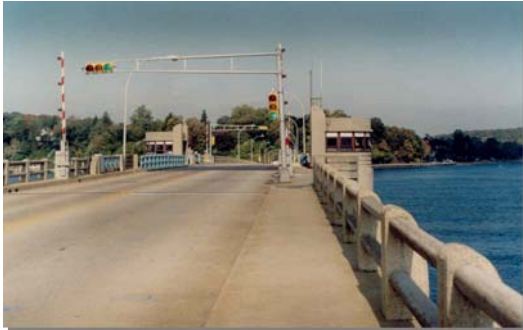
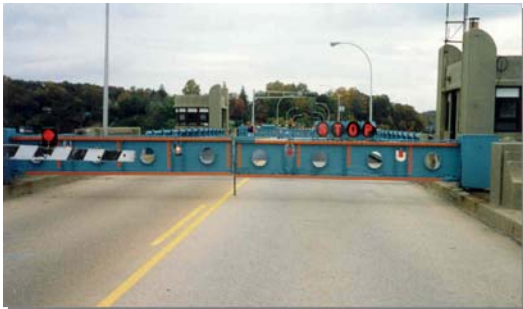
Safety Features

- **Bridge Railings**
 - Inadequate as Vehicular Railings
 - Geometrically and Structurally Insufficient
 - Inadequate as Pedestrian and Bicycle Railings
 - Insufficient Height and Rail Openings Larger Than Permitted
- **Traffic Gates and Lights**
 - Operational, But in Poor Physical Condition
- **Resistance Barriers**
 - Manually Operated – Requires Second Person for Operation of Bridge
