MONMOUTH COUNTY
Local Preliminary Engineering Phase for Monmouth County Bridge S-32
on Rumson Road (CR520) over the Shrewsbury River
Borough of Rumson and Borough of Sea Bright, Monmouth County, NJ

STAKEHOLDERS FOCUS GROUP MEETING
Rumson Road & Ward Avenue Intersection Improvements, Cul-de-sac
MEETING REPORT

DATE: Thursday May 21, 2015
TIME: 6:00 p.m. – 8:00 p.m.
LOCATION: Bingham Hall, 40 Bingham Avenue, Rumson, NJ
ATTENDEES:

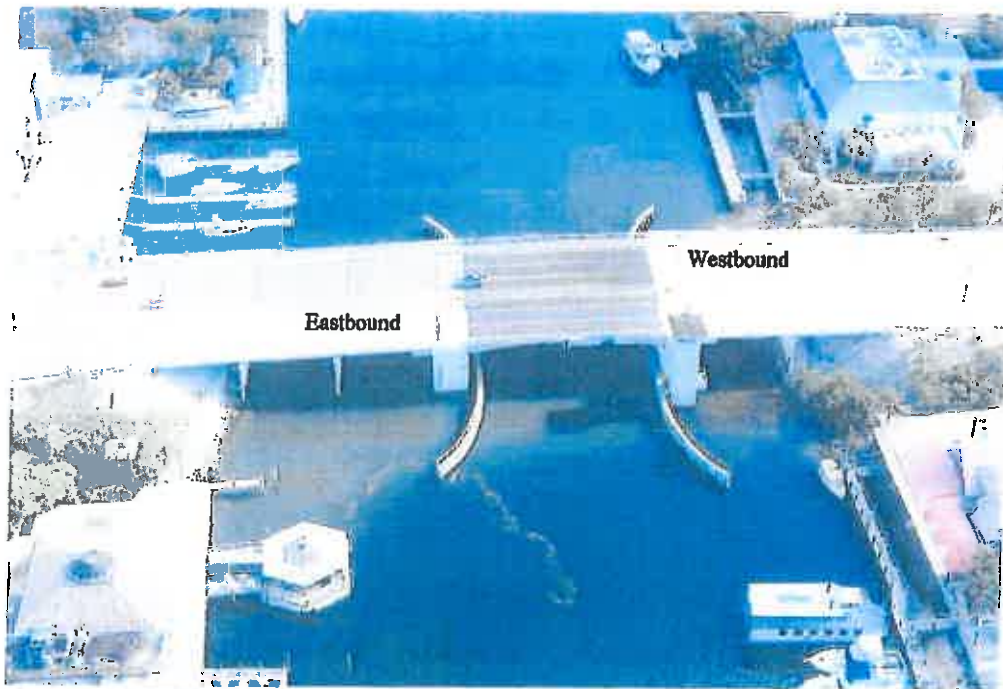
The PGA Boulevard Bascule Bridge Rehabilitation Project in West Palm Beach, Florida involves two existing three lane bridge structures that are side by side (Figure 1). The owner of the bridge is the Florida Department of Transportation, District Four. The Engineer of Record for the design is Hardesty and Hanover, LLP. The project commenced in April 2005 and is scheduled to be complete in March 2007. The westbound bridge is scheduled to receive minor structural modifications and repairs, while the eastbound bridge will be systematically demolished down to water level and reconstructed. The demolition will consist of both eastbound bascule leaves, both bascule piers and both eastbound flanking spans. The PGA Blvd Bascule Bridge has four bascule leaves and five fixed approach spans. Currently, the existing eastbound bridge has been demolished and the new eastbound bridge is being reconstructed. Listed below are some of the major items of work:

Figure 1: PGA Blvd. Bascule Bridge

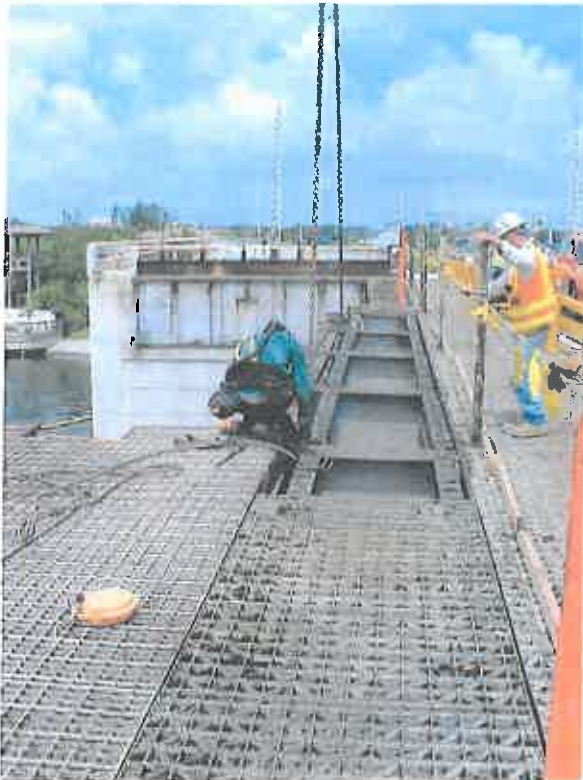
demolishing one leaf at a time. The process began on the west bascule leaf, where the roadway grating and structural steel was pre-cut by demolition crews in preparation of installing the leaf tie down system. This was required so that the leaf would not rotate once the steel on the forward side of the trunnion was removed. The first priority here was to demolish the leaf back to floorbeam four. At that point we were out of the navigable channel and did not disrupt the flow of marine traffic.

Figure 2: Demolition of Bascule Leaf

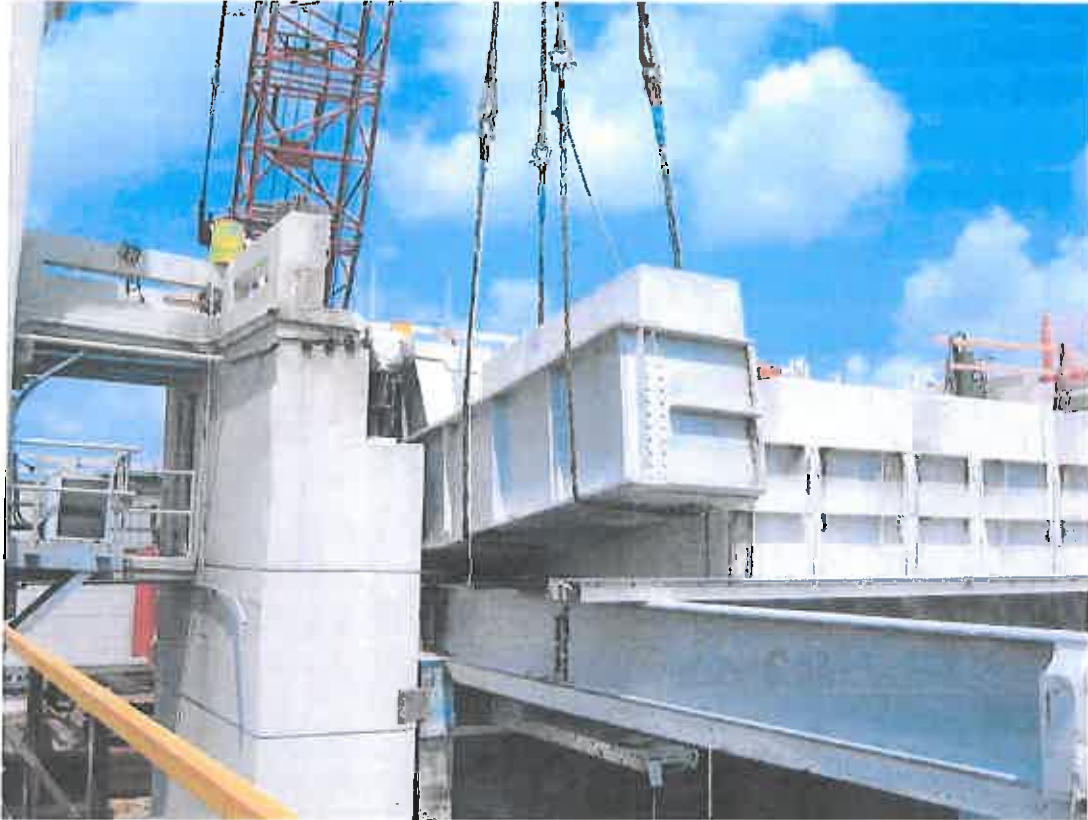
Temporary shoring beams were then placed beneath the counterweight for support while the large concrete section was wiresaw cut into seven pieces. Steel posts were installed on the back wall of the pier and existing flanking span beams were used as temporary shoring beams for the counterweight removal. The counterweight was shimmed to rest on the temporary beams and a series of holes were cored through the concrete section for rigging and placement of the diamond laced wiresaw strand. The coring of the holes for the counterweight removal was performed 24 hours a day for approximately four days. Following that was the wiresaw cutting process that was performed 24 hours a day for approximately eight days. Depending on the location of the cut, the durations varied due to cutting through steel. Wiresaw cutting is designed for concrete cutting and anytime the cut has to go through steel, the process is prolonged. The placement of the cut was determined based on the size of the counterweight section that could be safely removed by our crane. Based on previous experience, the density of older counterweight concrete varies greatly. We did not want to have a situation where the actual weight of a section was significantly larger than the calculated weight and our crane would not have the capacity to remove the section. We also had to be careful not to make the sections too large for the removal process on the material barge. The plan for removing the sections at the artificial reef site was to place a large long reach excavator on the material barge and push the counterweight sections off the barge. We had to ensure that the sections were not too large and could be pushed off with the excavator. As a result, we

added a cut on the counterweight to reduce the size and weight to ensure the sections could be safely removed. The counterweight was cut into seven sections, which averaged 23 tons each.

Figure 4: Counterweight section being removed.

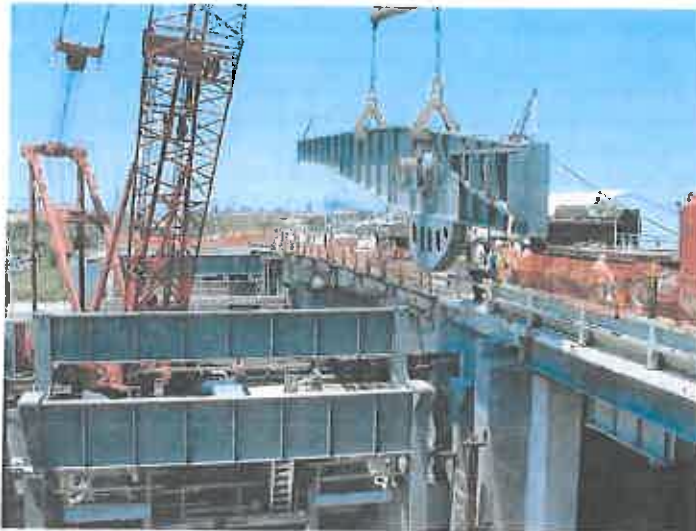
pier, but rather than wait for the east pier to be completed before moving on to the west pier, additional crews were brought in to begin the west pier construction directly following the demolition. This accelerated our schedule by approximately four weeks. The east bascule pier was completed and ready for structural steel erection within eight weeks after the first concrete pour.

The main support for the bascule leaf was structural steel columns erected within the bascule piers. The unique column design was connected with trunnion and forward columns. The anchor bolts for the steel columns were cast deep within the concrete and placement of the bolts was critical. Survey layout was completed prior to placing the bolts and was verified throughout the placement of concrete and structural steel. The survey for the entire bridge had to be complete to ensure the two bascule leaves would operate correctly with each other and with the existing westbound bridge.

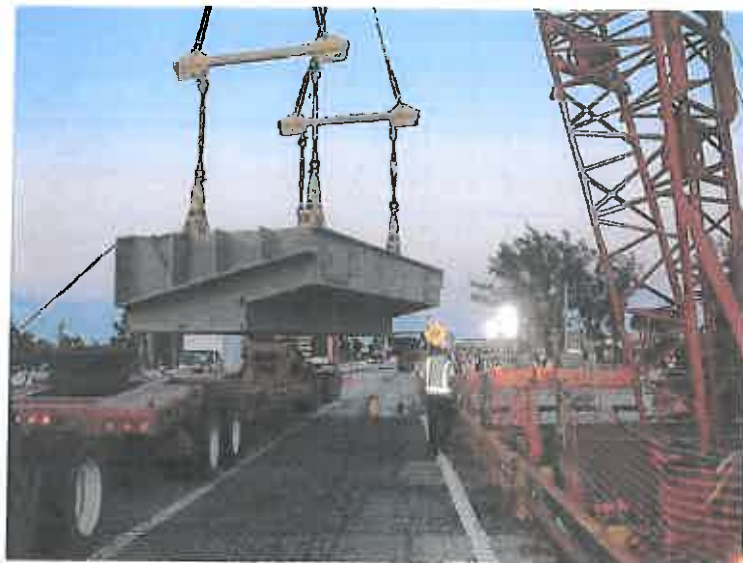
Following the installation of the bascule pier steel, the leaf structural steel was erected. A great deal of planning and coordination was required for the installation of the bascule girders and counterweight. For the leaf installation activities, a larger crane was obtained due to the very large weight of the steel counterweight box. The largest possible crane for our barge was used to set the bascule girders and counterweight box during a complete bridge and channel closure. The first girder was delivered to the bridge on a special delivery dolly and prepared for the installation. All of the delivered loads of the bascule girders and counterweight boxes were trucked to the site with the use of special permits that restricted the travel times and routes that were made. Communication with the delivery contractor was vital to ensure the material was on site for the scheduled closure dates. The girders weighted around 84,000 lbs and were well below the capacity of the crane. The highly anticipated first bascule girders were set on the east pier. Floorbeam four was then installed to add some rigidity to the girders and allow for the counterweight box. The counterweight, which was delivered on a special low level, wide load trailer, was then moved into place. The steel box consisted of mostly 2 inch thick

material and weight over 130,000 lbs. The process of installing the box was very intense due to the critically heavy pick. Not only did the crane have to pick the large counterweight box, it had to hold the box for a lengthy period of time before being bolted to the girders. The entire process of erecting the two bascule girders and the counterweight box took approximately 12 hours. Within the following week, the remainder of the floorbeams were installed, followed by the stringers and all of the miscellaneous steel support members. The roadway grating was then welded to the leaf and sidewalk railing was installed.

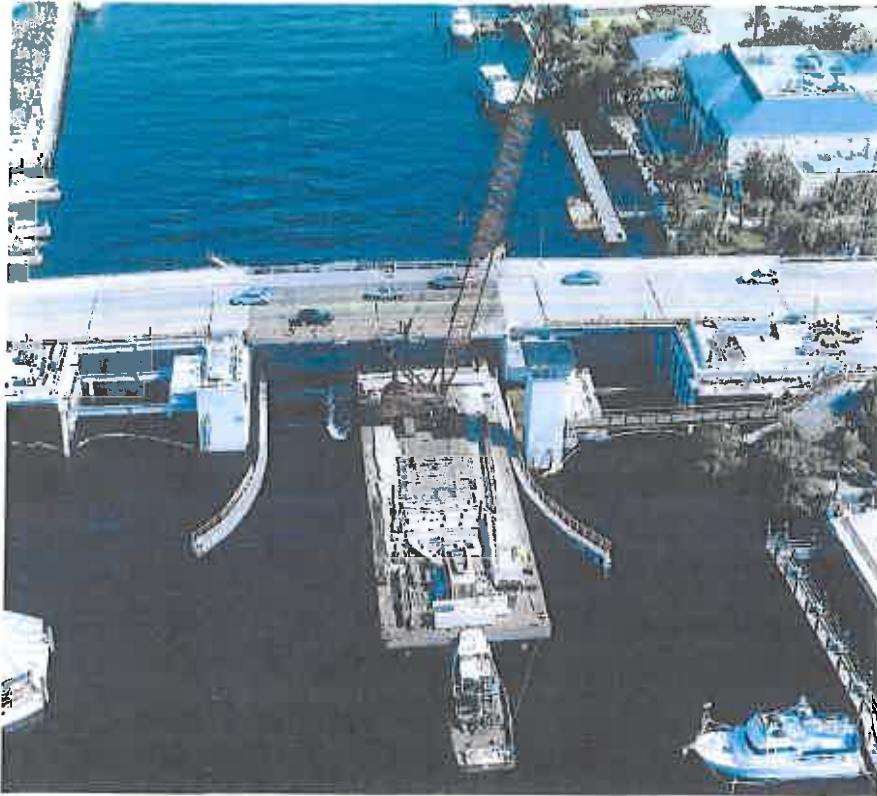
When the reconstruction phase of the project began, the Manitowoc 4100 Series II crane no longer had the capacity to perform all of the required picks. We then demobilized the 4100 Series II crane and acquired a Manitowoc 2250 Series III, a 330 ton crane. This much larger crane posed serious concerns throughout the project team. The physical size of the crane was significantly larger than the previous crane

and the largest crane we have had on a 54 feet wide barge. There was a time period in which the crane operator and workers had to adjust to the size of the crane and its capacities. The crane, for example, had to be boomed down or the massive counterweight sections would cause the barge to list. Once the crews were adjusted to the new crane, the picks were made efficiently and safely.
