LAN ASSOCIATES

**CONDITIONS ASSESSMENT
& RECOMMENDATIONS
FOR THE
HOMINY HILL CLUBHOUSE (BUILDING 1301)
HOMINY HILL GOLF COURSE
COLTS NECK, NJ**

LAN REFERENCE #2.2882.2
August 11, 2008

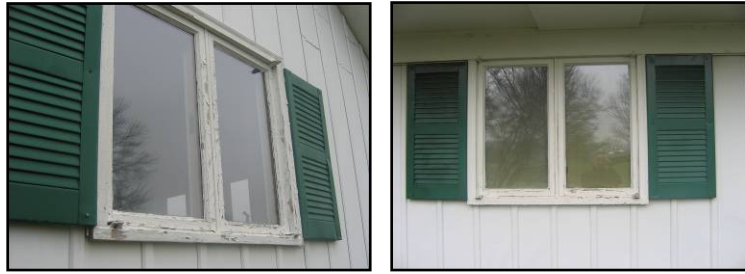
The first floor windows consist of what is believed to be original casement windows as manufactured by Andersen. The exterior finishes for the windows consist of painted wood which is in poor condition. It was noted that there is significant condensation water damage at the interior lower sills of the window panels indicative of poor thermal performance. It does not appear that the windows are thermally double glazed and/or insulated resulting in the excessive condensation. The hardware for these windows is difficult to operate and latching mechanisms are stiff and difficult to operate. The overall condition of the windows is fair and provisions for their replacement should be considered.

- Item 3-9:** Replace all original windows at the first level of the clubhouse. (See Plan & Elevations)

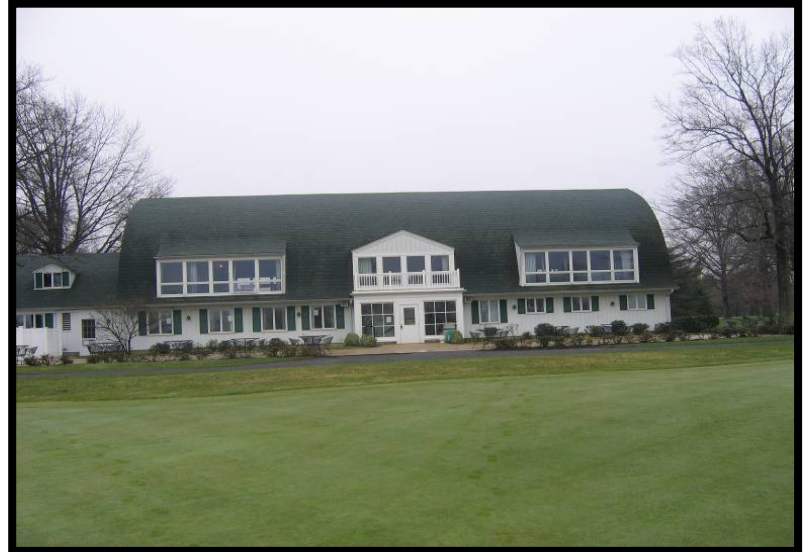
Photo No. 1

Depicts an overall view of the north elevation of the Club House overlooking the exterior patio including upper level dormer configurations.

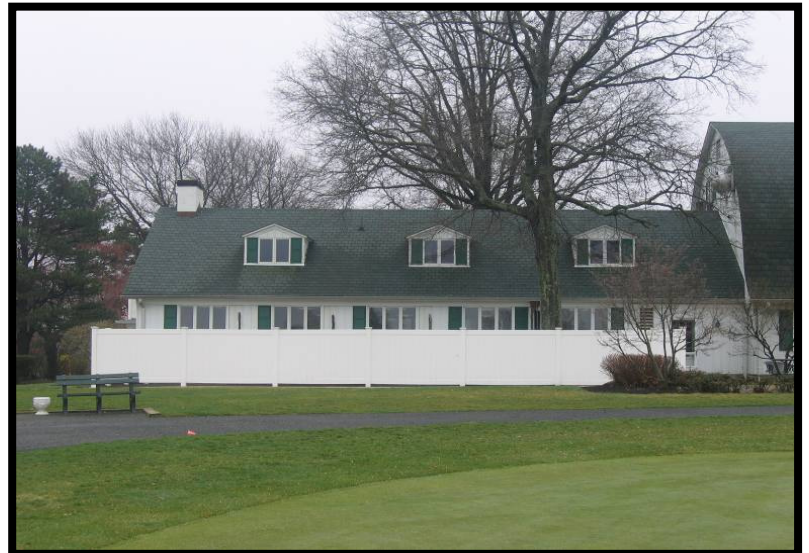
Photo No. 2

Depicts overall north elevation of Locker Room facility located along the east side of the Club House. The photo also depicts the vinyl HVAC equipment screen for ground mounted condensers and above ground fuel oil storage tank.

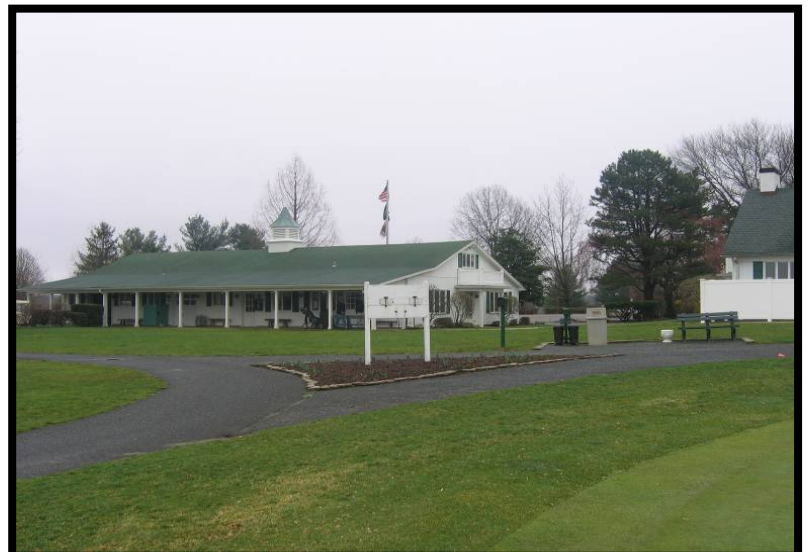
Photo No. 3

Taken from the north side of the Club House building panning east to the Pro Shop building. The east end of the locker wing is located along the right side of the photograph.

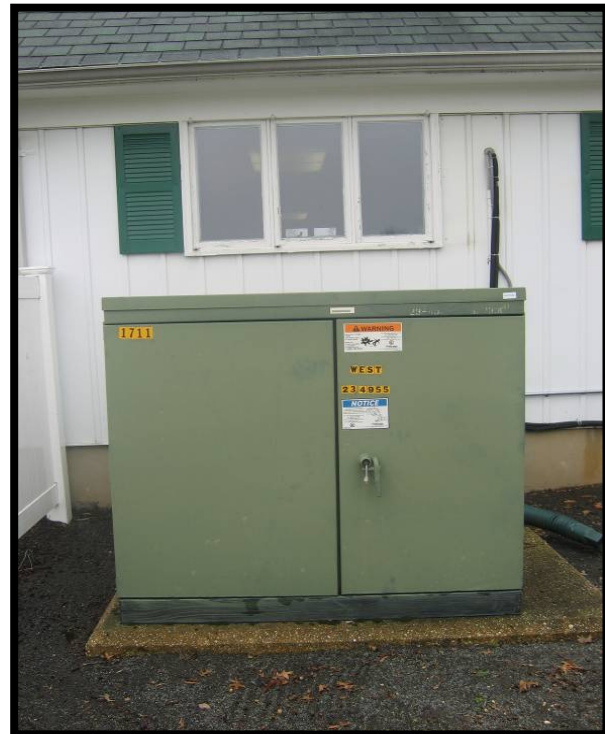
Photo No. 4

Depicts the exterior main electrical transformer located at the northeast corner of the building for the underground primary electric service.

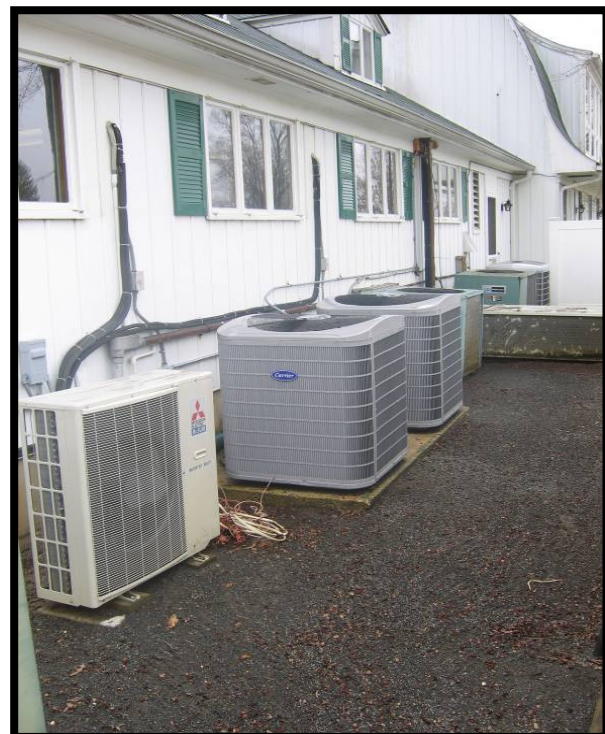
Photo No. 5

Depicts numerous condensers for split AC systems installed in the building. These units are located on the north side of the Men's Locker Room facility in the exterior HVAC enclosure.

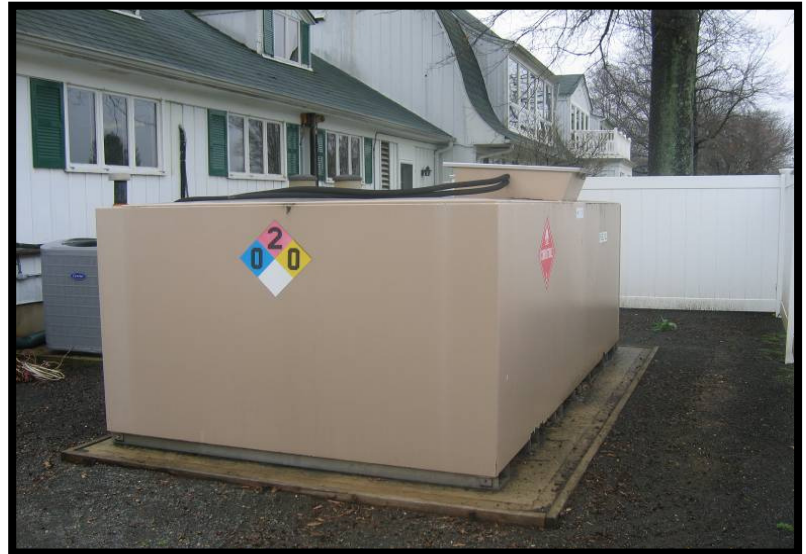
Photo No. 6

Depicts the above ground fuel oil storage tank for the facility. This tank is located on the north side of the Men's Locker Room in the exterior HVAC enclosure.

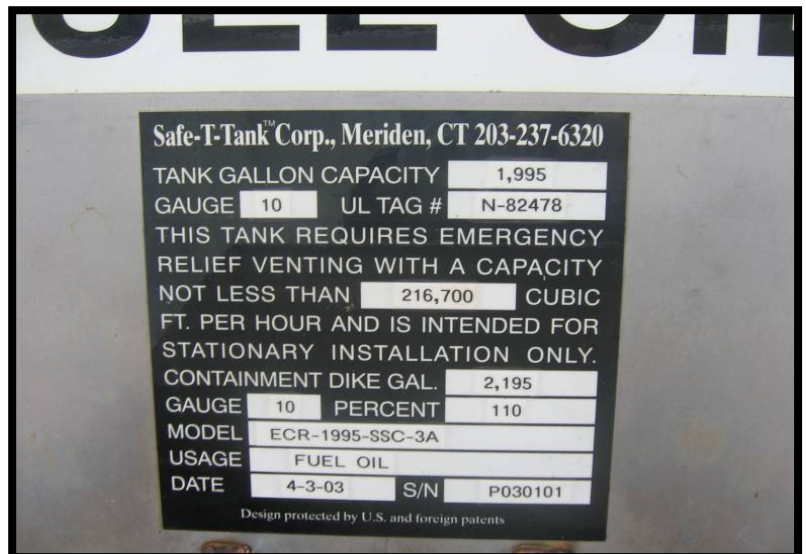
Photo No. 7

An overall view of the tank information. Note the tank capacity is 1,995 gallons and was installed in April 2003.

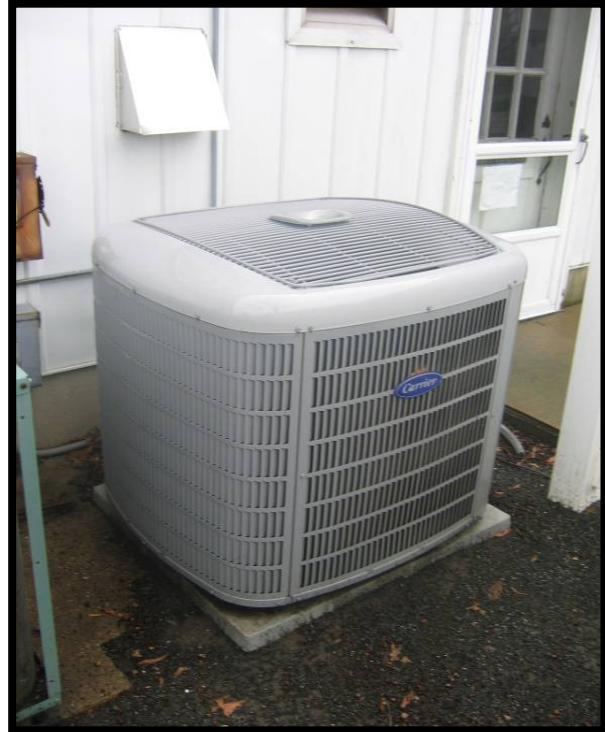
Photo No. 8

Depicts exterior condenser for air conditioning system for Snack Bar and Lounge area. This condenser is located on the north side of the rear Kitchen entry door.

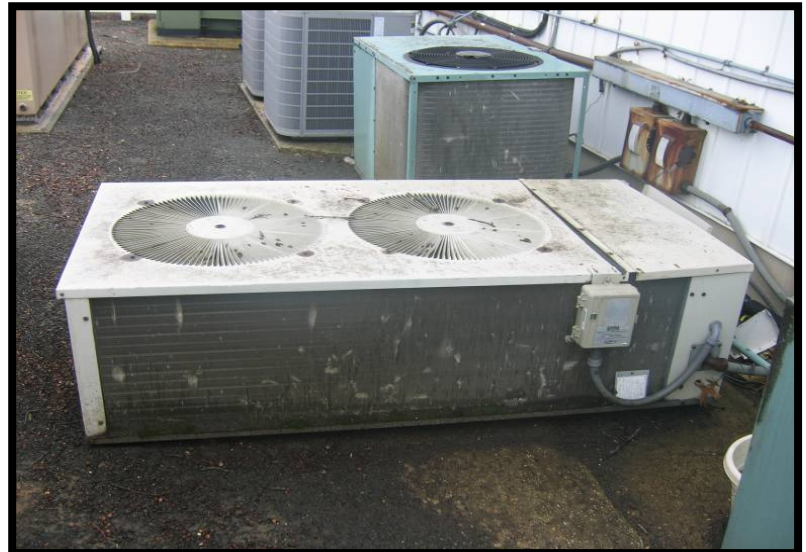
Photo No. 9

Depicts older condensers located on the north side of the Men's Locker Room which are no longer operational.

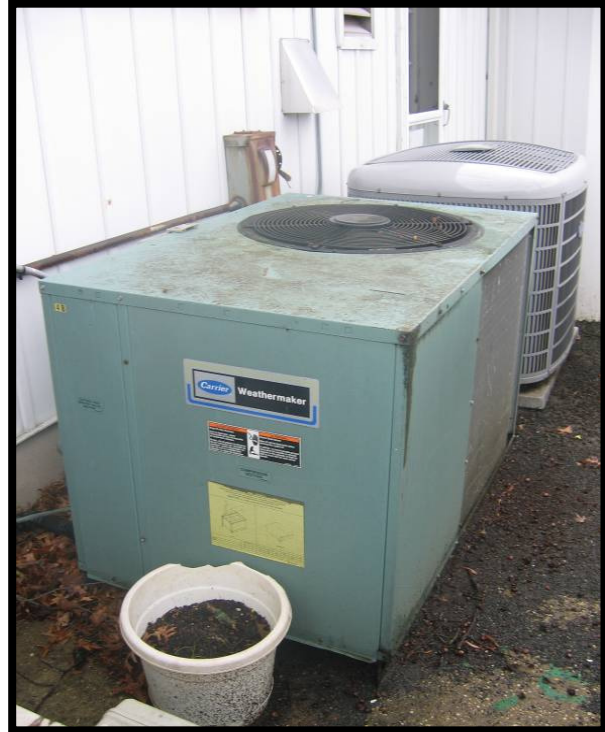
Photo No. 10

Depicts original HVAC condensers located on the north side of the Men's Locker Room.

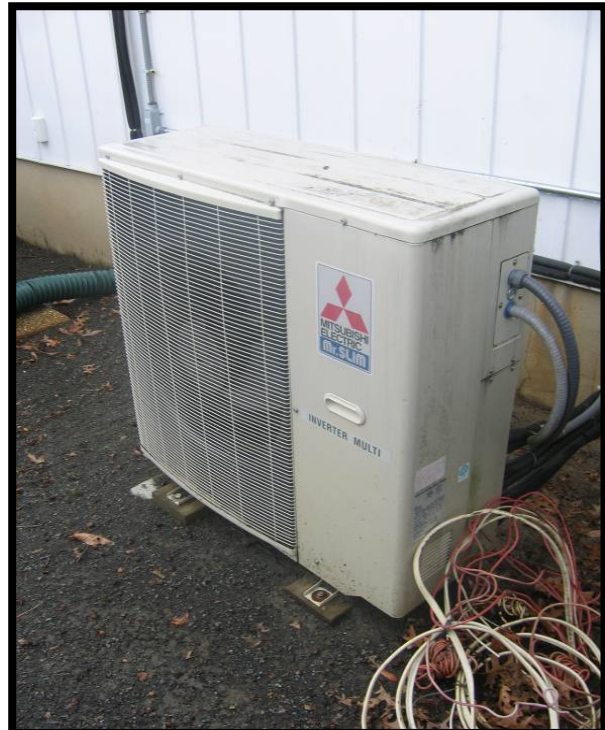
Photo No. 11

Depicts Mitsubishi split system condensers which provide air conditioning for the Men's Locker Room.

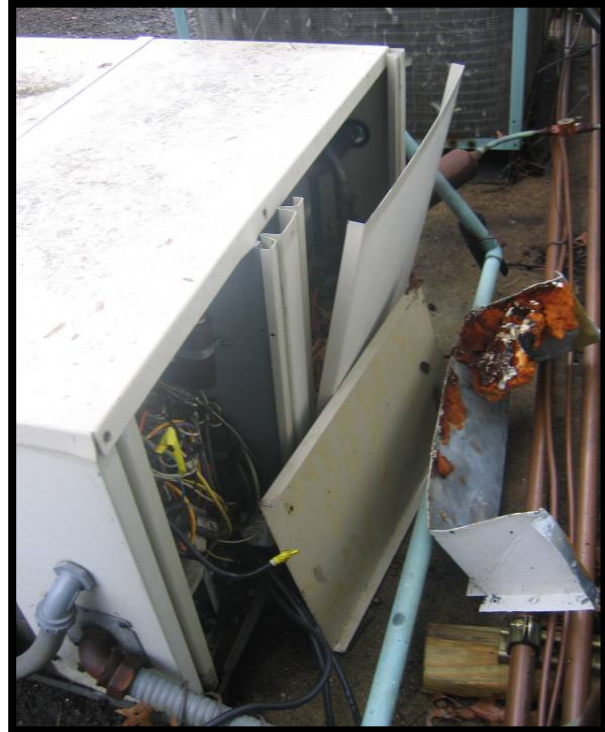
Photo No. 12

Depicts open panels at rear of abandoned condensers along with copper Freon and suction lines and electric conduit. Note copper piping is not insulated.

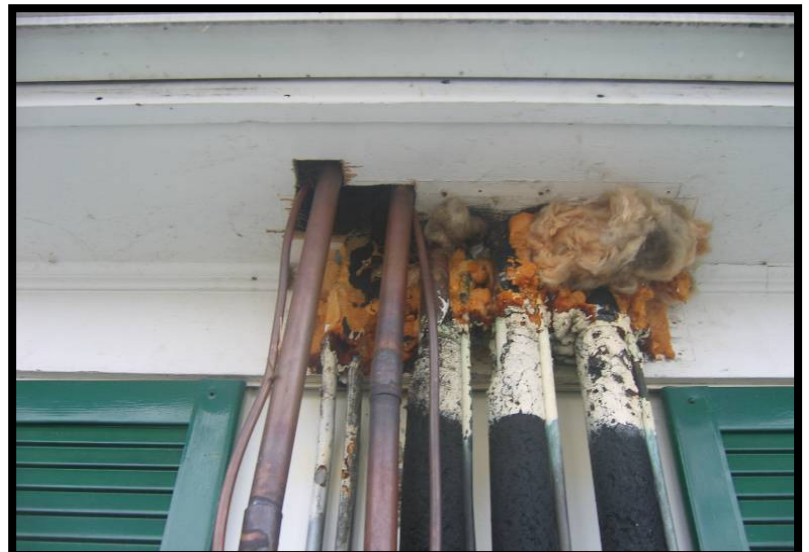
Photo No. 13

Depicts Freon supply and suction lines entering soffit at the north side of the Men's Locker Room. Installation is poor and not properly closed off.

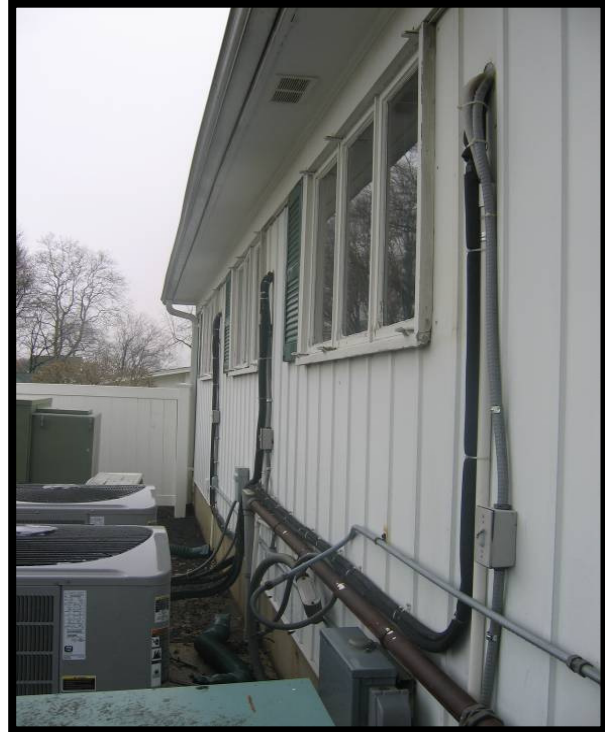
Photo No. 14

Depicts the Freon supply and suction lines for the three (3) Mitsubishi units running up the north elevation of the Men's Locker Room.

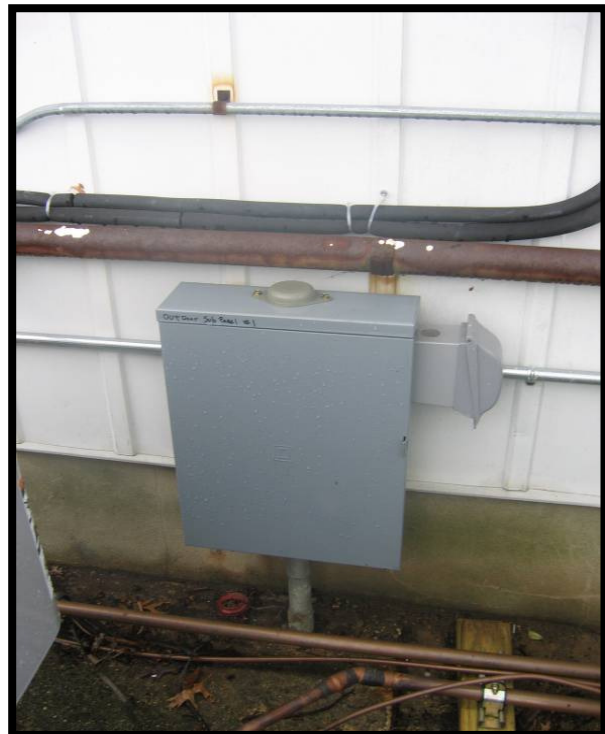
Photo No. 15

Depicts new electrical conduit and disconnect switches for new condensers.

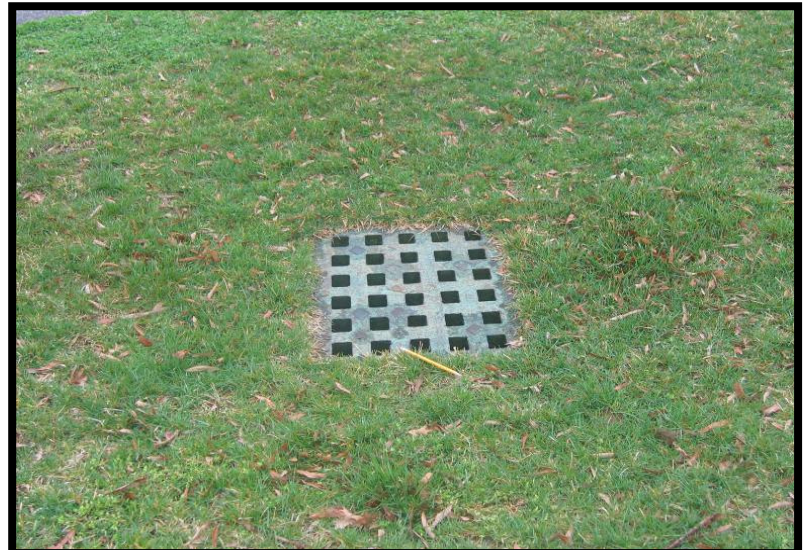
Photo No. 22

Depicts a yard drain located at the south side of the main Club House adjacent to the main entry loop drive.

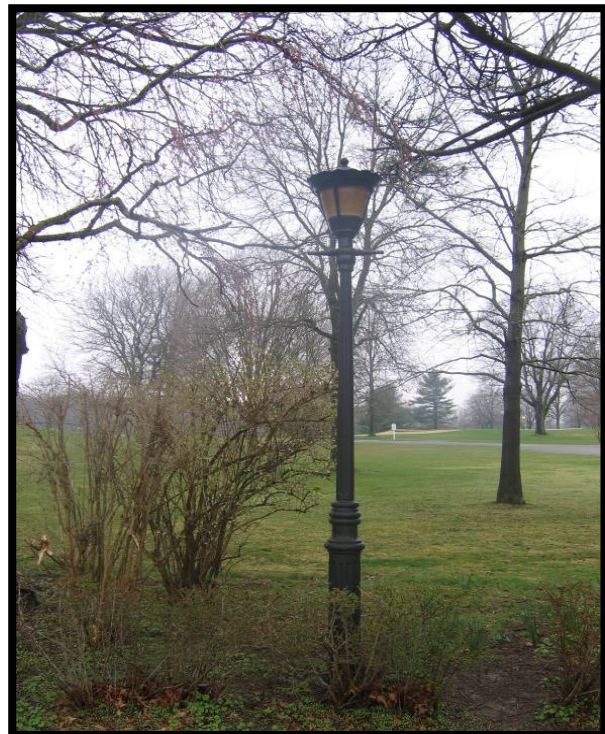
Photo No. 24

Depicts typical exterior light fixture for main parking lot. The overall condition of the light fixtures appears to be good.

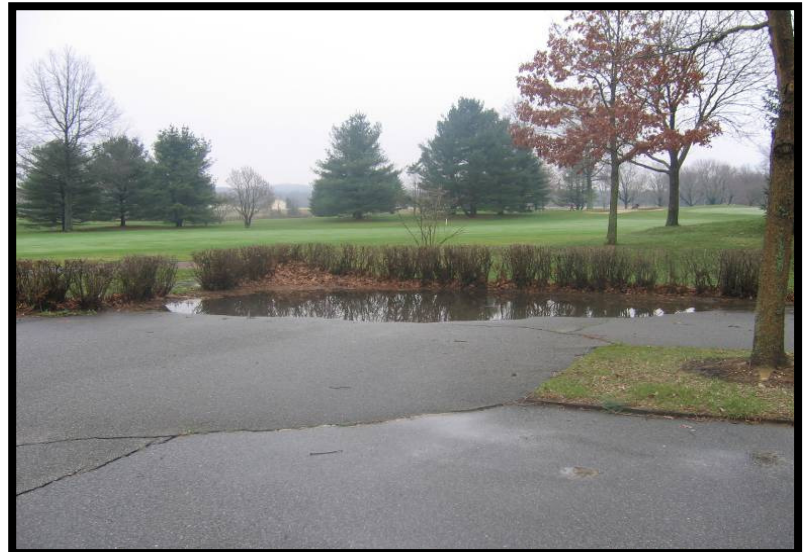
Photo No. 26

Depicts ponding of the main parking lot at the southeast corner.

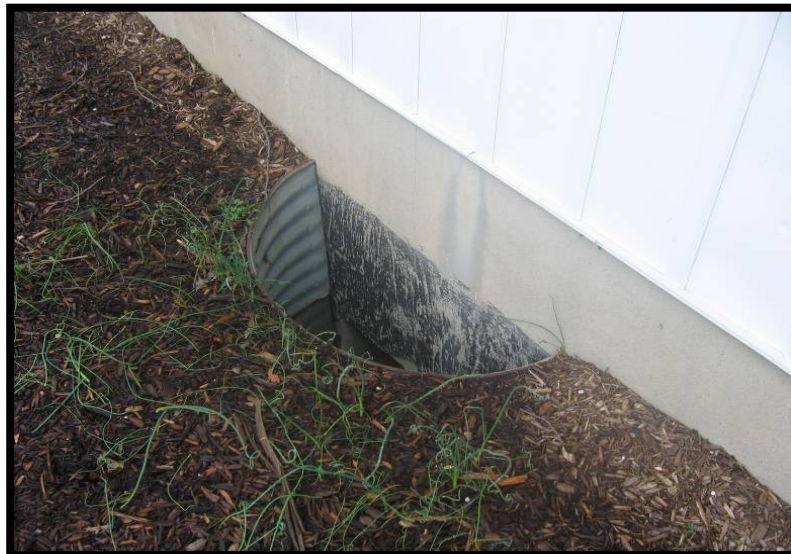
Photo No. 32

Depicts areaway for basement window located on the south side of the Locker Room wing. This opening provides limited combustion air and ventilation for basement Boiler Room.

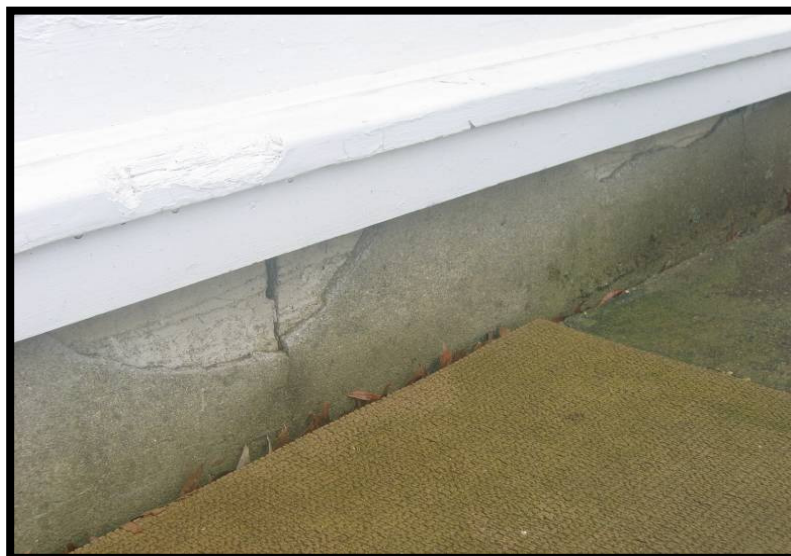
Photo No. 34

Depicts damage of cement parging at main north vestibule entry to Club House. Ditto Photo No. 53.

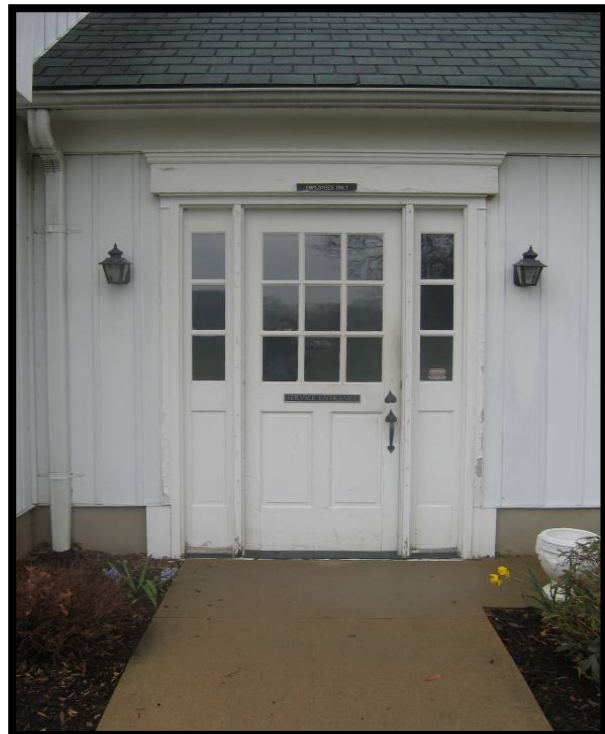
Photo No. 36

Depicts employee and service entry located at the south side of the Men's Locker Room wing. The door is in fair condition. Wood trim and lighting fixtures are in fair condition.

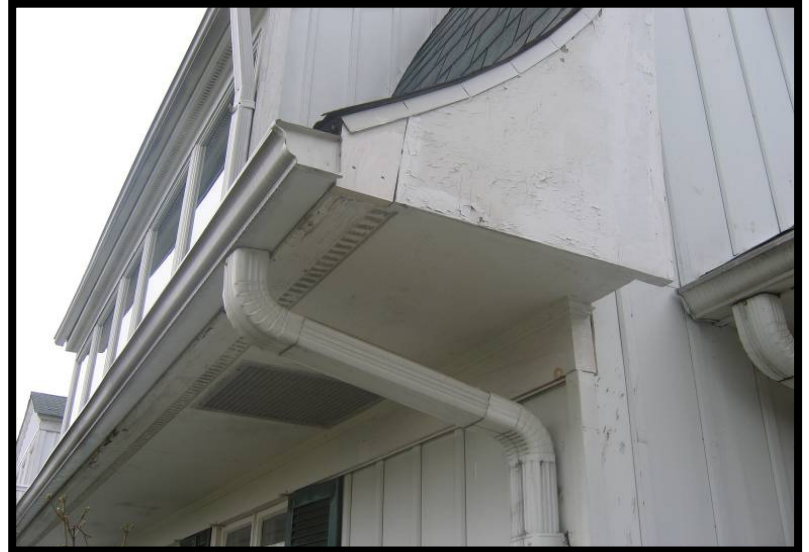
Photo No. 37

Depicts typical soffit finishes which consist of painted veneered plywood which is in fair condition. The photograph also depicts wood fascia and painted trim boards. Typical.

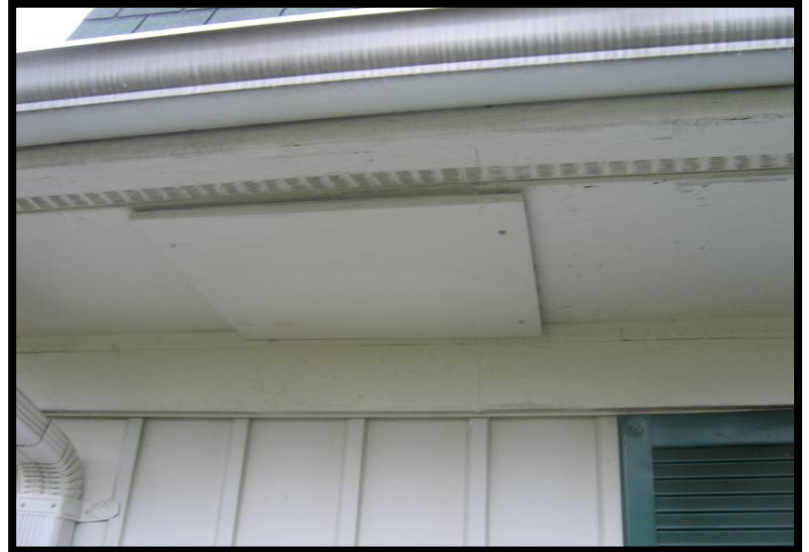
Photo No. 41

Depicts closed off louver located at the southwest corner of the building. This louver is believed to be an exhaust for exhaust outlet for the Ladies Locker Room.

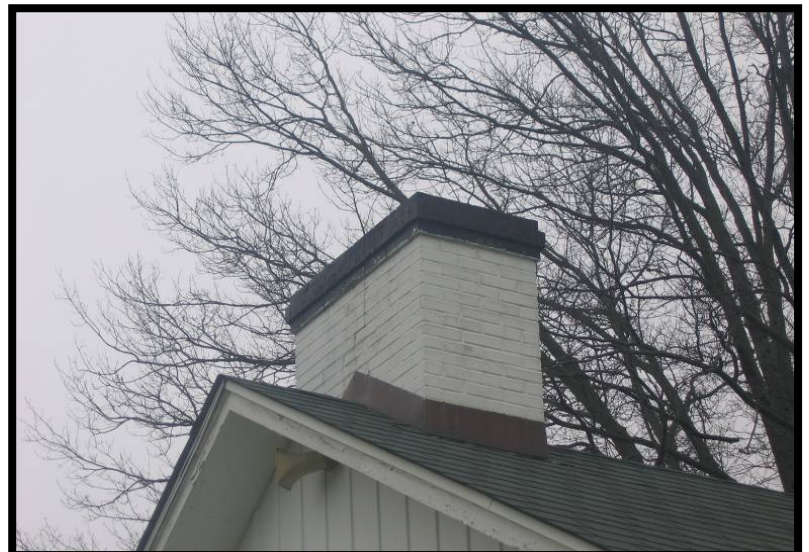
Photo No. 44

Depicts the main boiler flue located at the east end of the Men's Locker Room wing. The overall condition of the brick appears to be good. Flashings are also in good condition. Note that the flue proceeds down to the basement level and splits at the first level into two (2) separate flues.

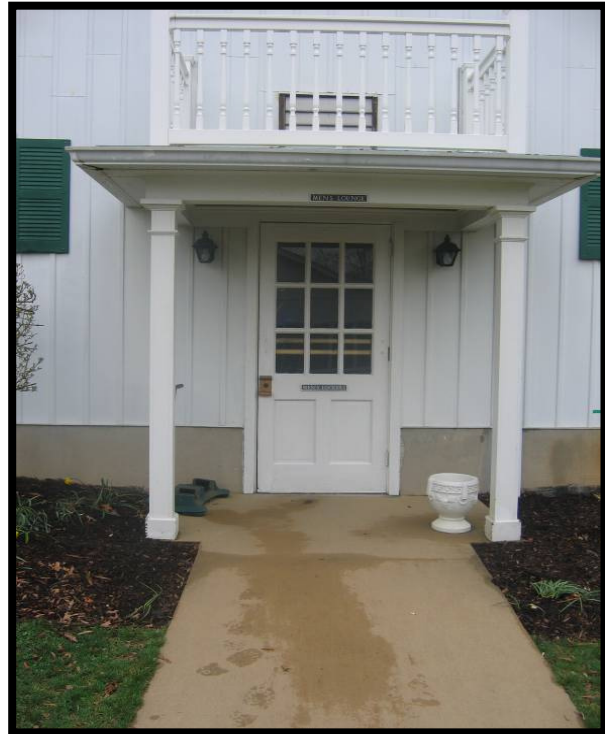
Photo No. 45

Depicts the main canopy cover over the Men's Locker Room entry located at the east elevation. Exterior door and wood trim is in fair condition. PVC railing at roof is decorative and in good condition.

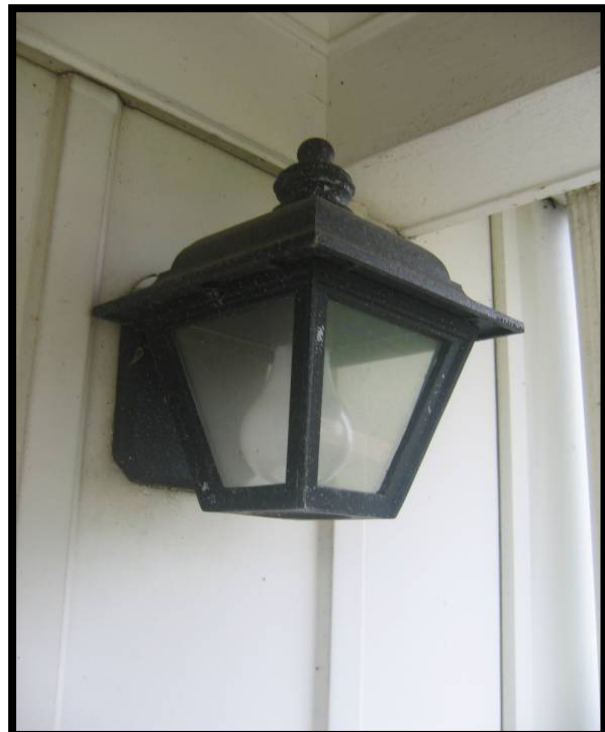
Photo No. 46

Depicts exterior incandescent light fixtures which are in fair condition. Typical.

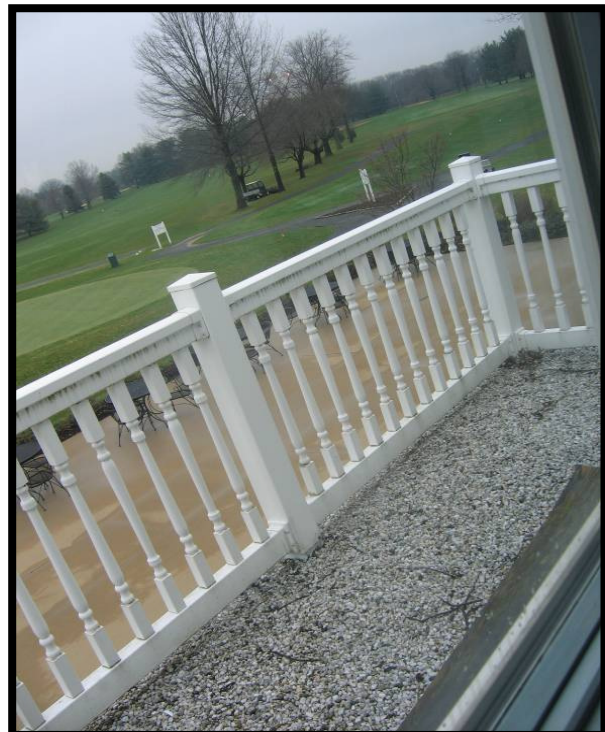
Photo No. 48

Depicts decorative PVC balcony baluster and built-up roofing above the main Club House entry at the north side of the building. The built-up roof appears to be in fair condition.

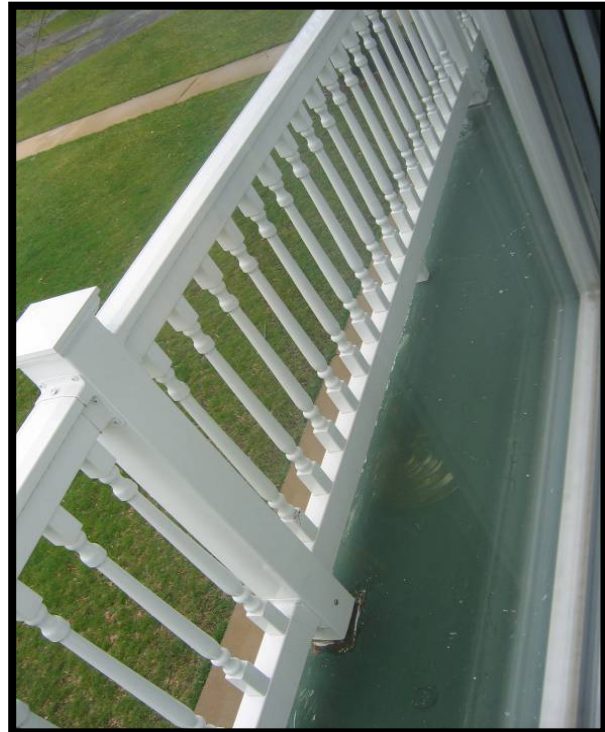
Photo No. 49

Depicts metal roofing for cantilevered balcony with decorative PVC balusters located at the west elevation above the Ladies Room Locker entrance. The roof appears to be in fair condition.

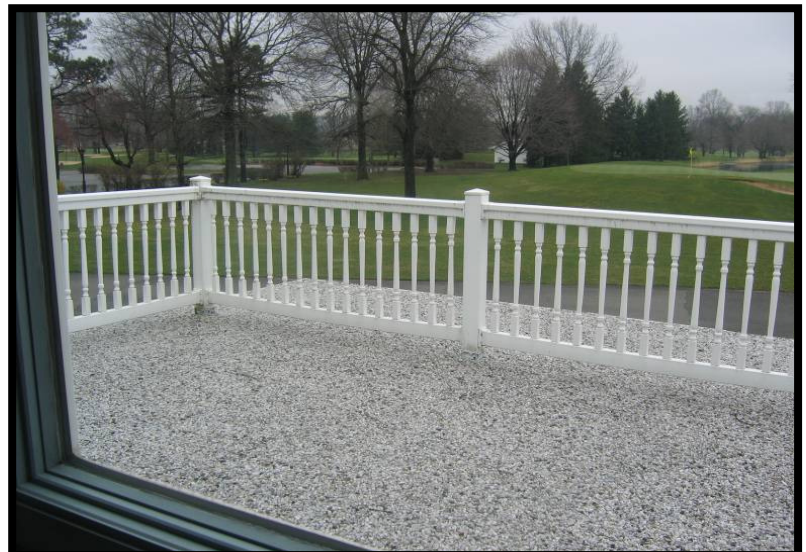
Photo No. 50

Depicts the built-up roof and decorative PVC balusters and balcony railing system above the main south foyer/vestibule Club House entry. PVC railings appear to be recently installed and in good condition. The built-up roof at this location appears to be in fair condition.

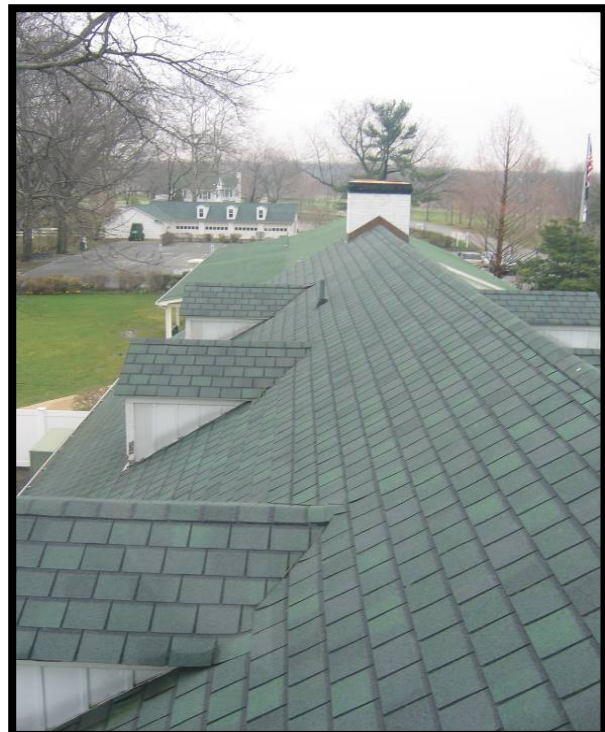
Photo No. 56

Depicts new asphalt roofing system installed at Men's Locker Room wing at the east side of the main Club House. Overall condition of the asphalt roofing is good.

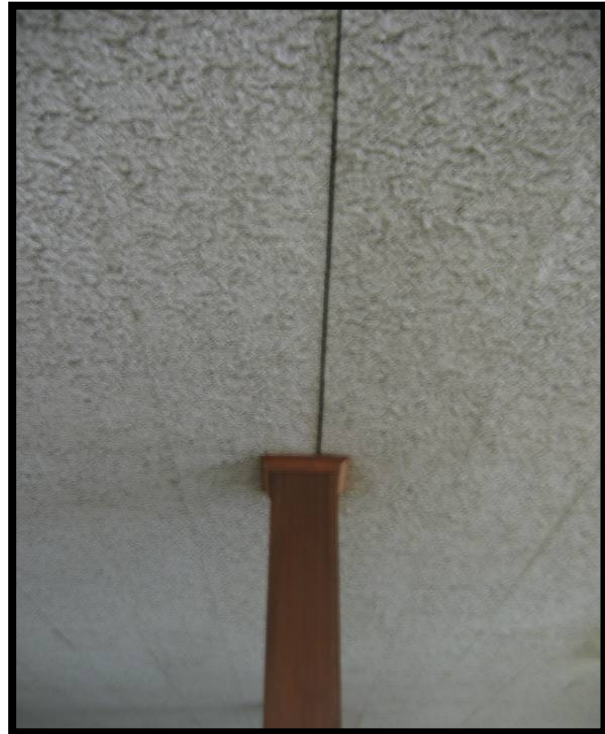
Photo No. 60

Depicts separation along the north side of the Men's Locker Room at the 12" x 12" acoustic ceiling.

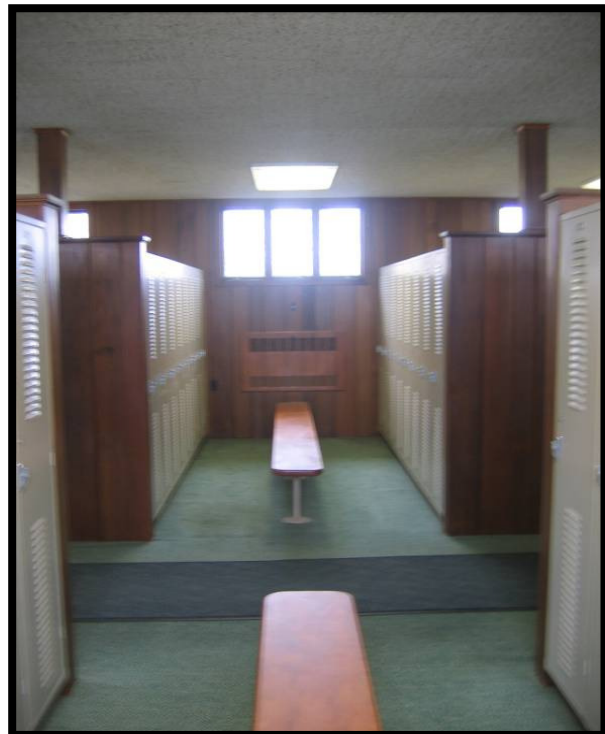
Photo No. 61

Typical Men's Locker Room bay depicting interior finishes, lockers, and bench configurations.

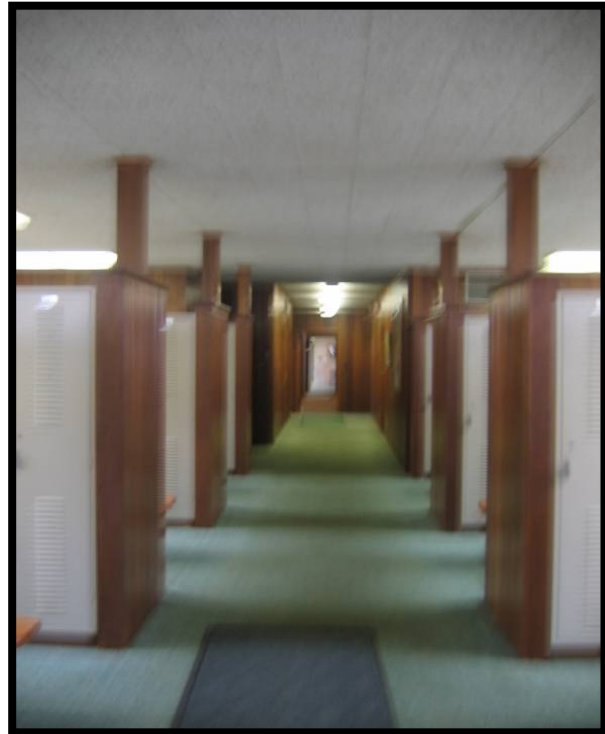
Photo No. 62

Depicts an overall view of the corridor in the Men's Locker Room as viewed from the east end of the Locker Room looking west towards the main Club House.

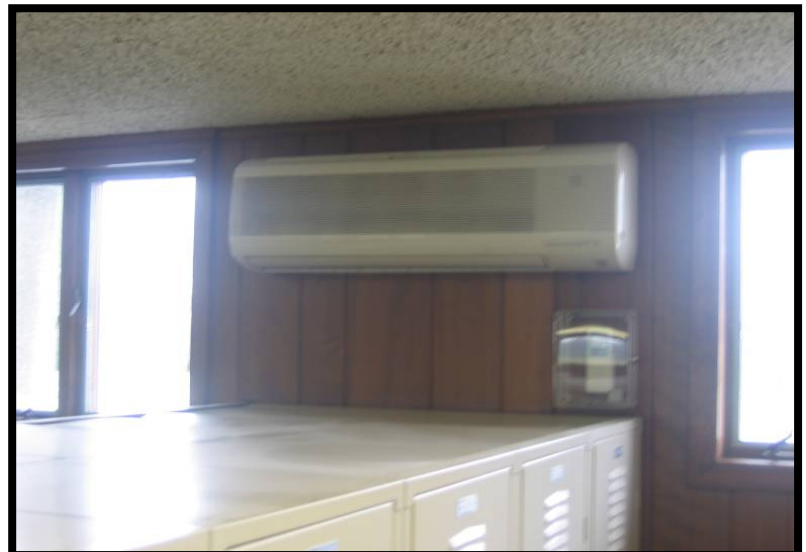
Photo No. 63

Depicts one (1) of three (3) Mitsubishi Mr. Slim HVAC units and enclosed automatic temperature controls installed on the north wall of the Men's Locker Room.

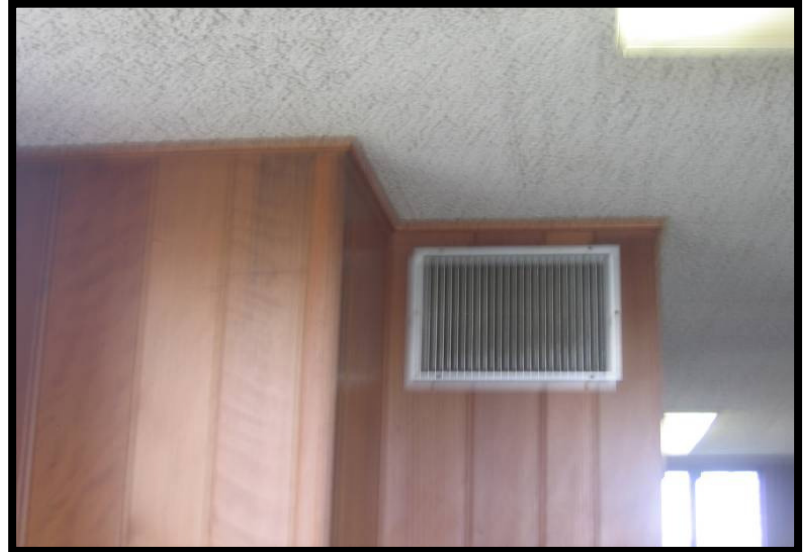
Photo No. 64

Depicts an exhaust louver located above the entry vestibule along the east end of the Men's Locker Room.

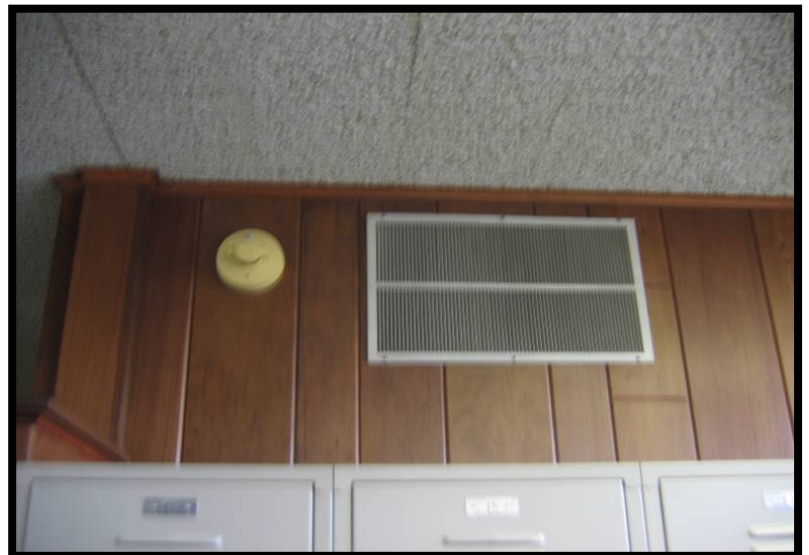
Photo No. 65

Depicts a fresh air intake louver located on the west wall of the Men's Locker Room. The photograph also depicts heat/smoke detector for existing fire detection system.

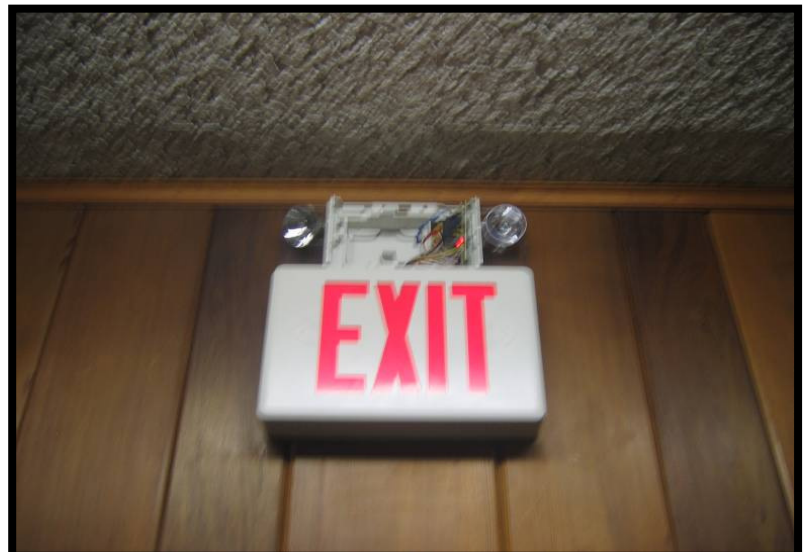
Photo No. 66

Depicts new emergency light fixture exit sign installed in corridor leading to Men's Locker Room. Note battery was removed and unit was being repaired.

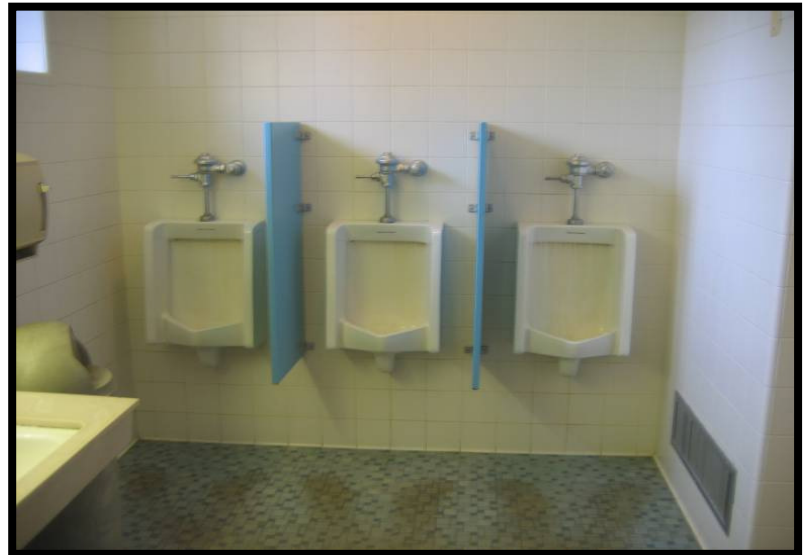
Photo No. 70

Depicts three (3) existing wall hung urinals and partitions which are in overall good condition. Provisions for handicap accessible urinal should be provided.

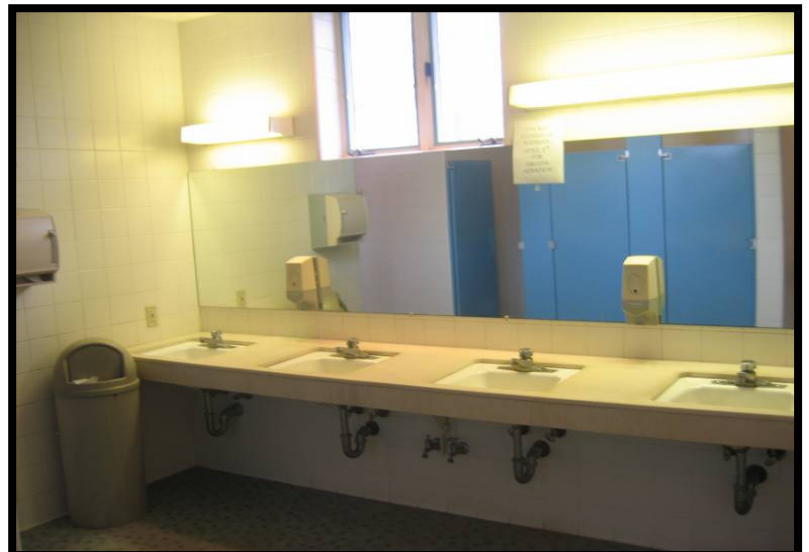
Photo No. 73

Depicts an overall view of the lavatory counter with mirror, paper towel and soap dispensers, and fluorescent wall mounted lighting.

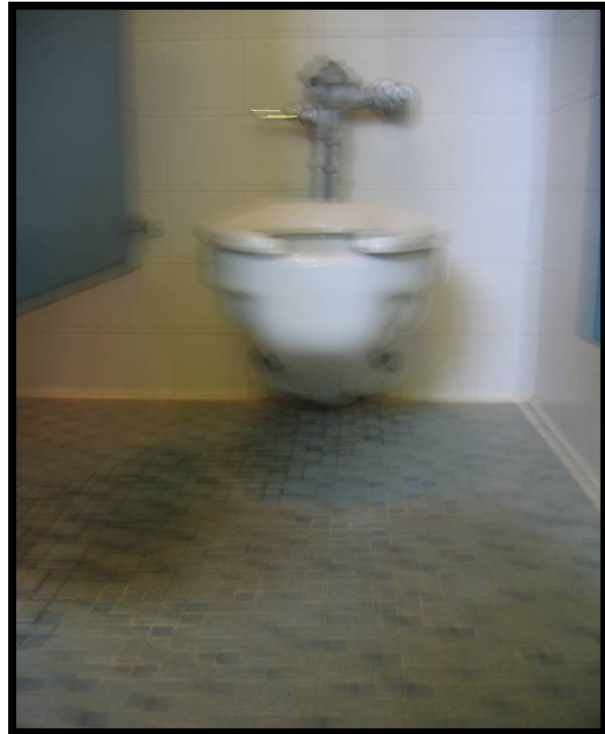
Photo No. 76

Depicts a typical water closet toilet partition configuration. Note the water closets are wall hung flushometers. Note that one (1) of the seals at the drain for the water closet has failed and is leaking water which should be repaired.

Ditto Photo No. 75.

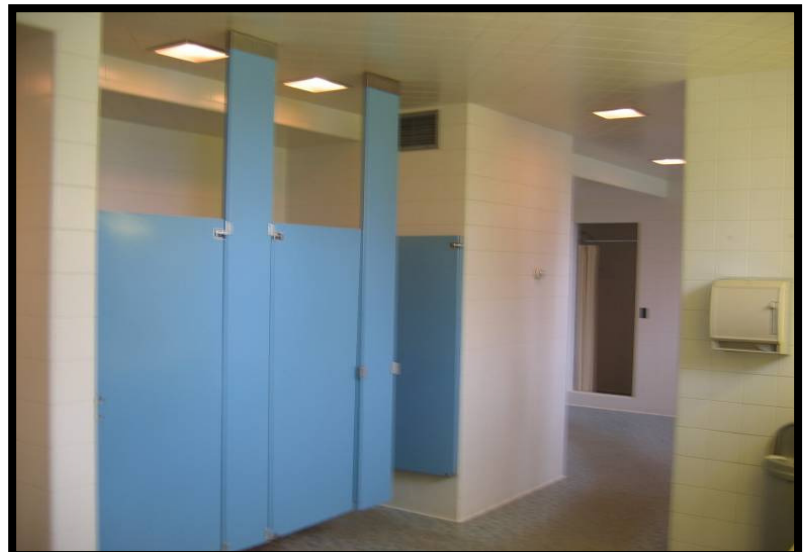
Photo No. 77

Depicts an overall view of the north wall of the Men's Locker Room including ceiling mounted toilet partitions, 6 x 6 wall ceramic and ceiling tile with recessed lighting. Typical.

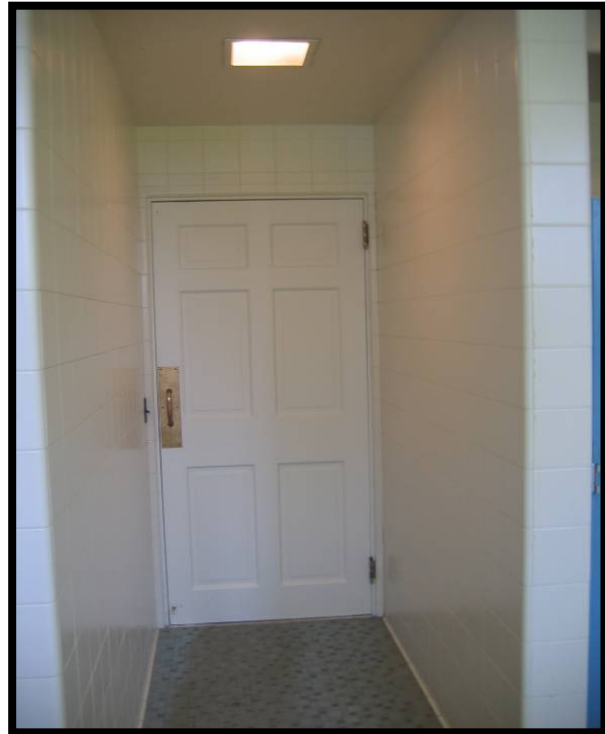
Photo No. 78

Depicts the west entry to the Men's Room along with interior tile finishes for wall, floor, and ceiling.

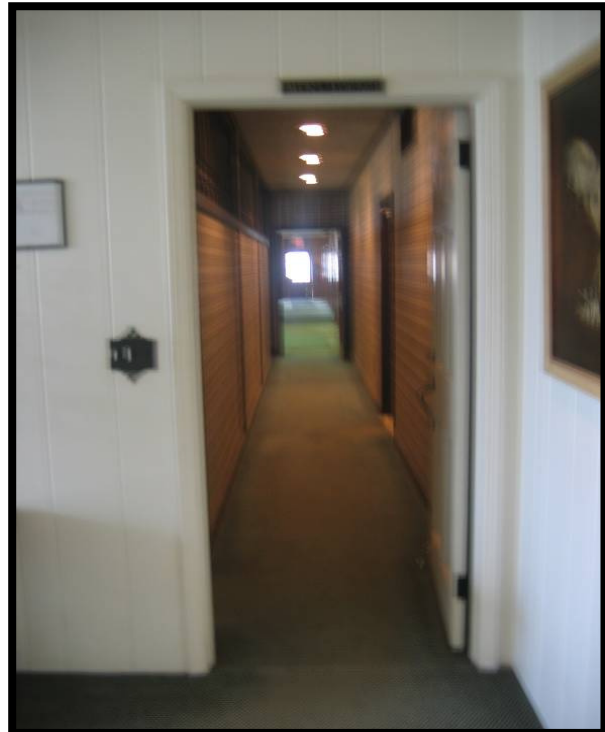
Photo No. 79

Depicts an overall view of the hallway from the main Club House hall looking east towards the Men's Locker Room.

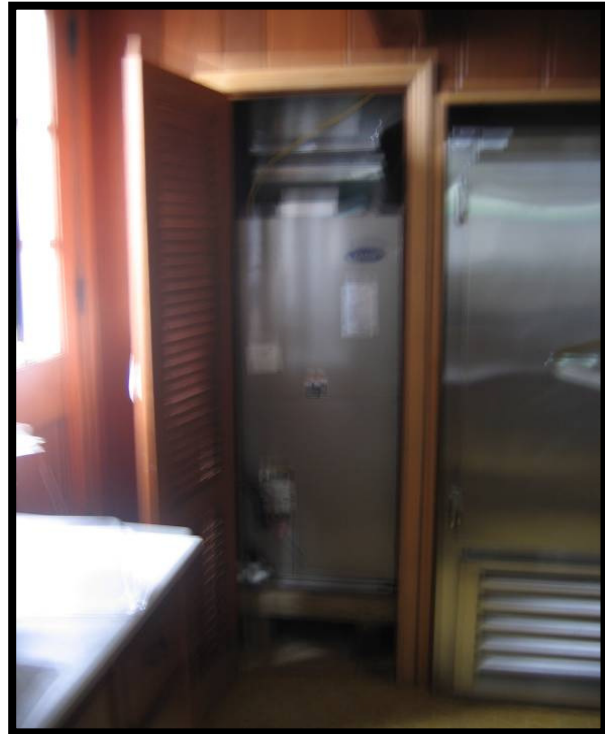
Photo No. 80

Depicts vertical HVAC unit providing air conditioning for Kitchen and Snack Bar area located on the north side of the main Club House.

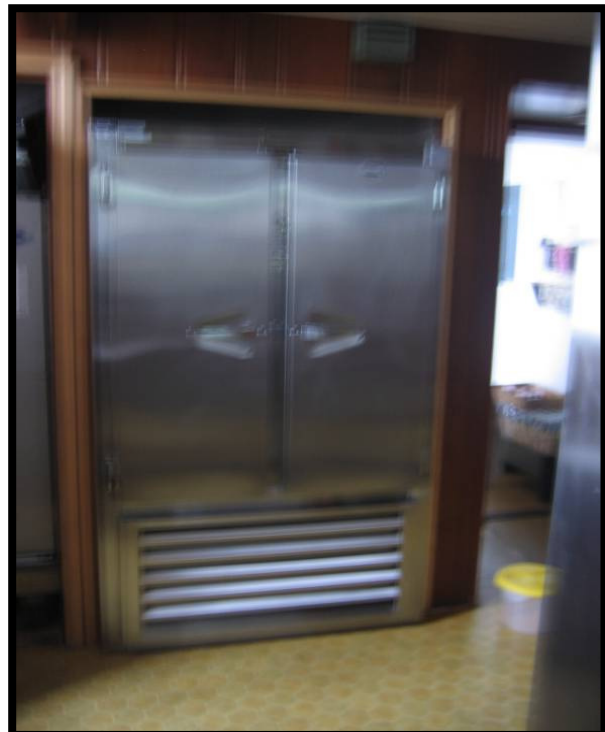
Photo No. 81

Depicts typical reach-in refrigerator/freezer commercial equipment in Snack Bar area.

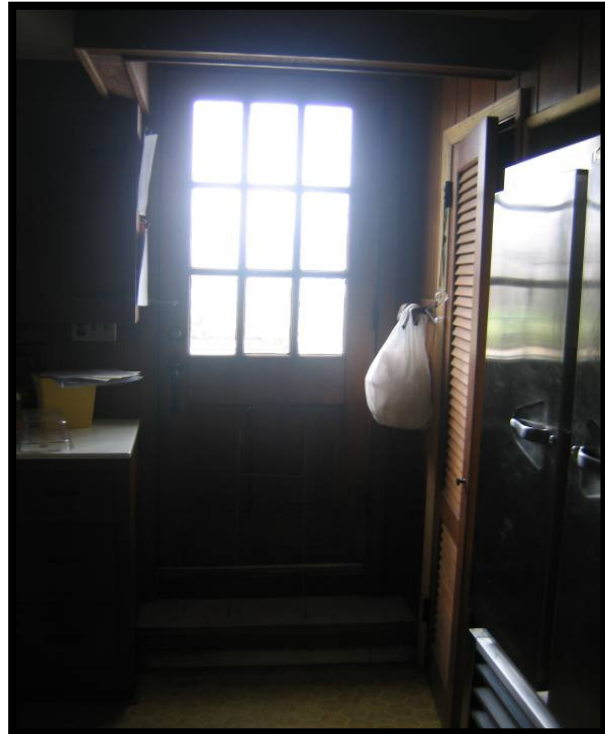
Photo No. 82

Depicts north Kitchen service entry and existing cabinetry. Note the door is elevated some two (2) steps above the main floor area in the Kitchen.
