LAN ASSOCIATES

**CONDITIONS ASSESSMENT
& RECOMMENDATIONS
FOR THE
HOMINY HILL CLUBHOUSE (BUILDING 1301)
HOMINY HILL GOLF COURSE
COLTS NECK, NJ**

LAN REFERENCE #2.2882.2
August 11, 2008

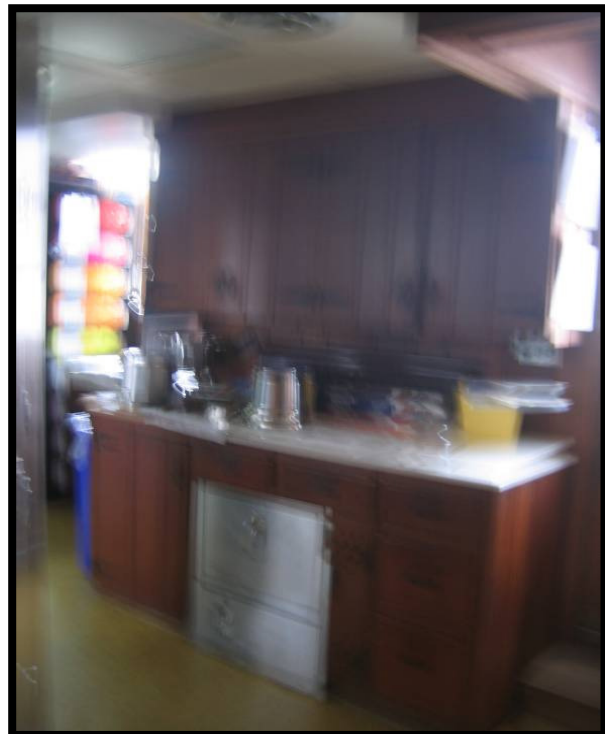
Photo No. 83

Depicts food prep counter and wood cabinetry with wall and base cabinetry, typical at north wall of Snack Bar.

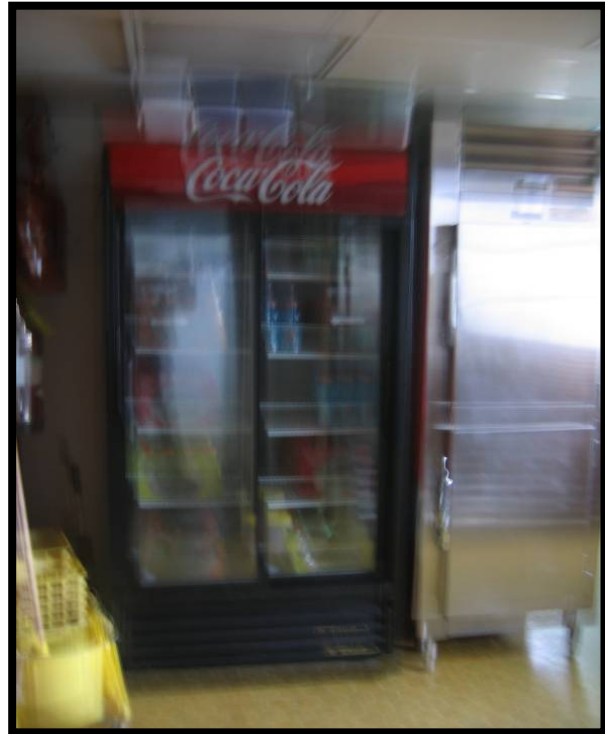
Photo No. 84

Depicts soft drink and commercial refrigerator/freezer at Snack Bar.

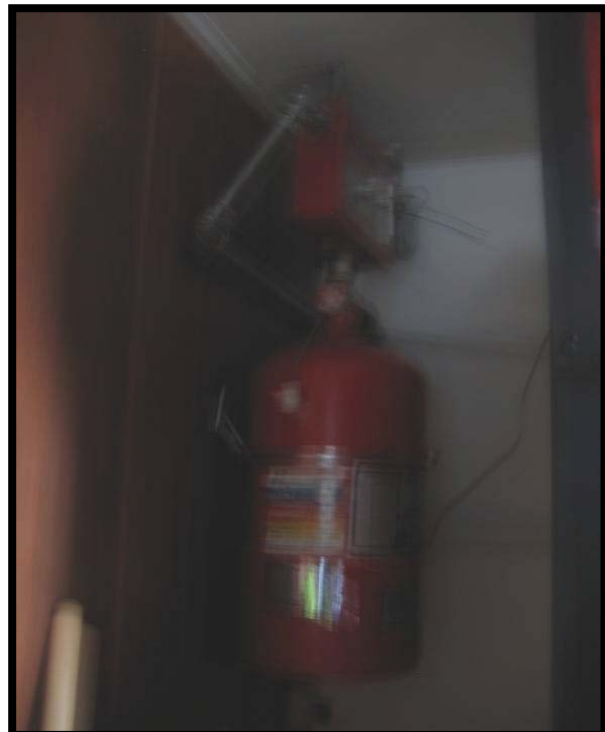
Photo No. 85

Depicts Ansul systems for Kitchen grill exhaust hood.

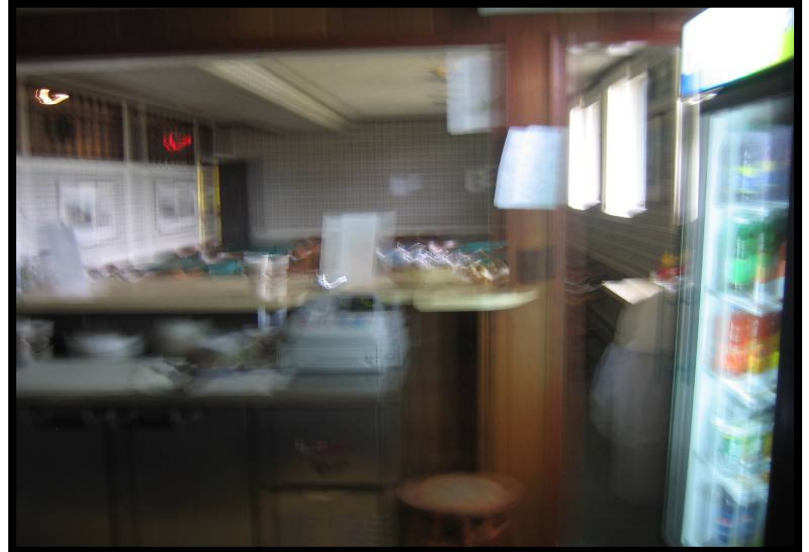
Photo No. 86

Depicts an overall view of the Snack Bar service counter as viewed from the Snack Bar looking west towards the Snack Bar lounge.

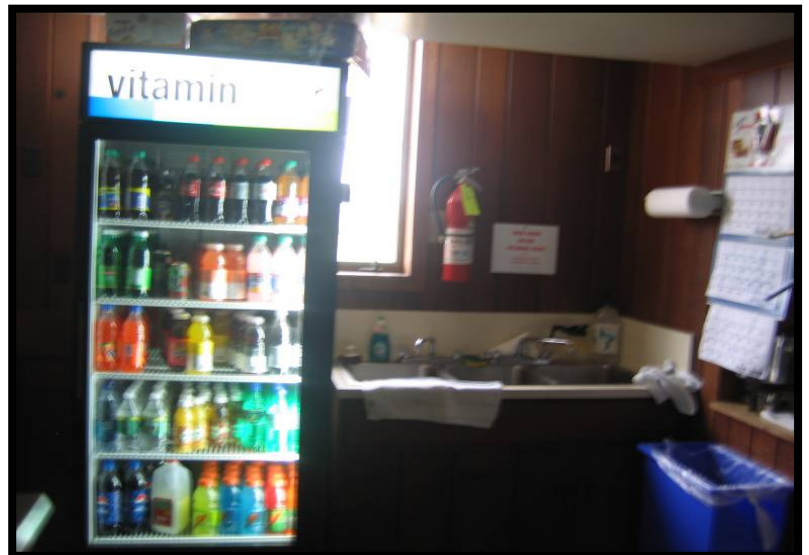
Photo No. 87

Depicts soft drink refrigerator and existing three (3) bay sink with fire extinguisher in Snack Bar area at north wall.

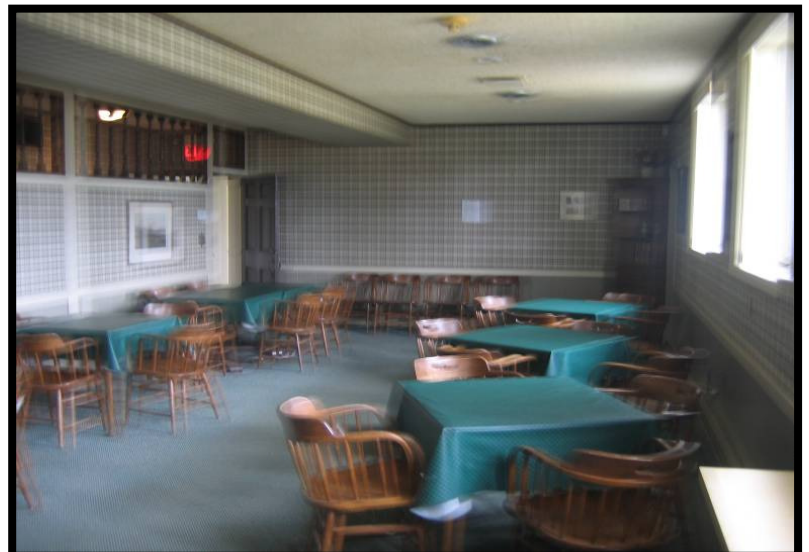
Photo No. 88

Depicts an overall view of the Snack Bar lounge including existing finishes.

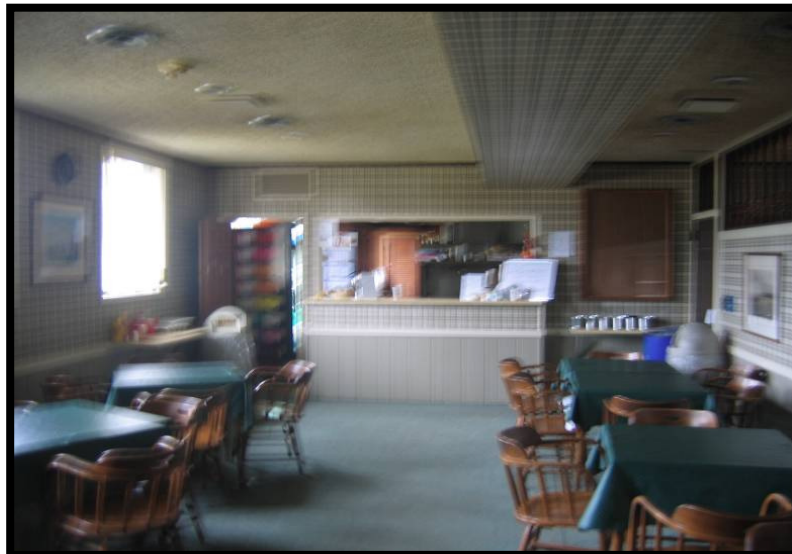
Photo No. 89

Depicts an overall view of the Snack Bar as viewed from the west end looking east towards the Snack Bar service counter.

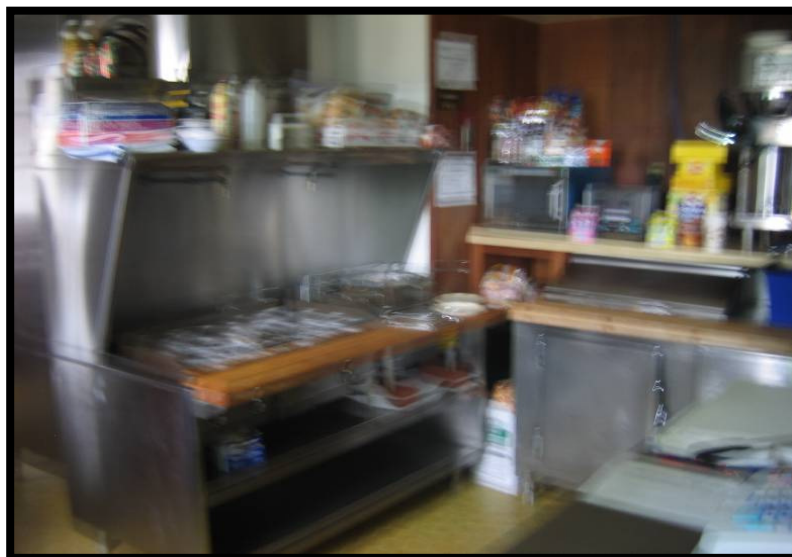
Photo No. 90

Depicts an overall view of the food prep area including griddle and overhead exhaust hood.

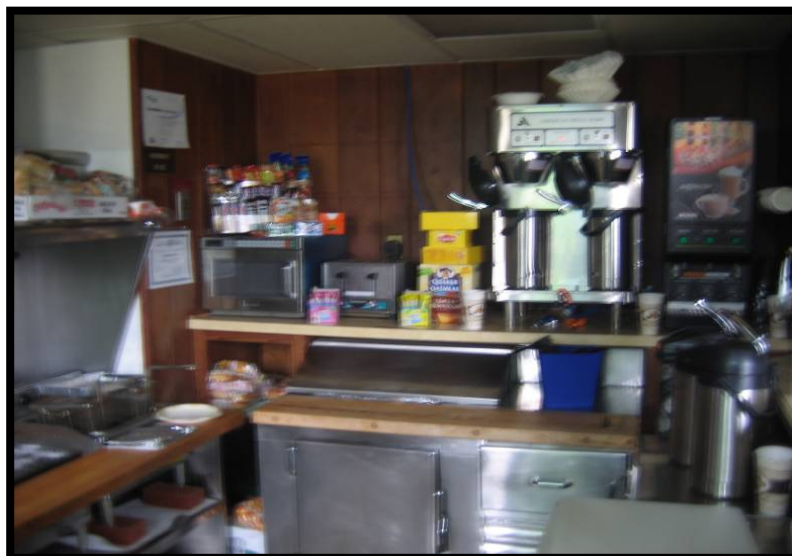
Photo No. 91

Depicts overall base refrigeration units with counter top and other kitchen appliances including toasters, coffee makers, mixers, etc.

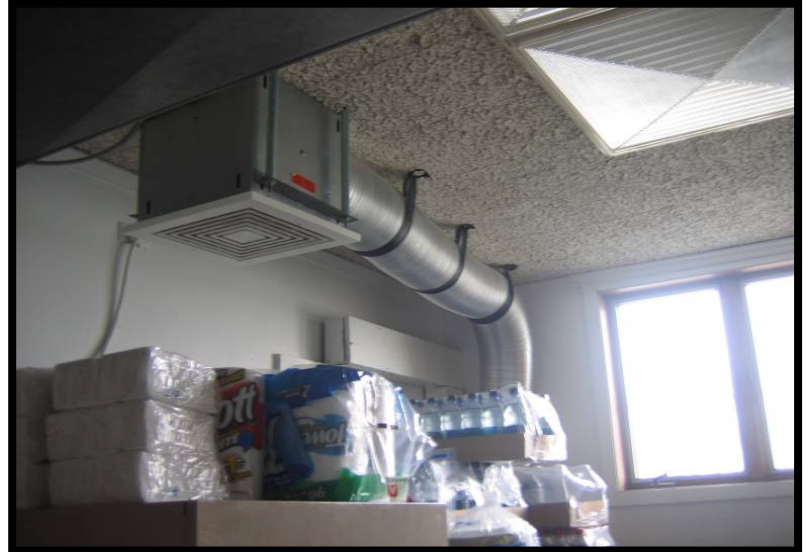
Photo No. 92

Depicts new exhaust fan installed on timer in rear Storage Room at Kitchen.

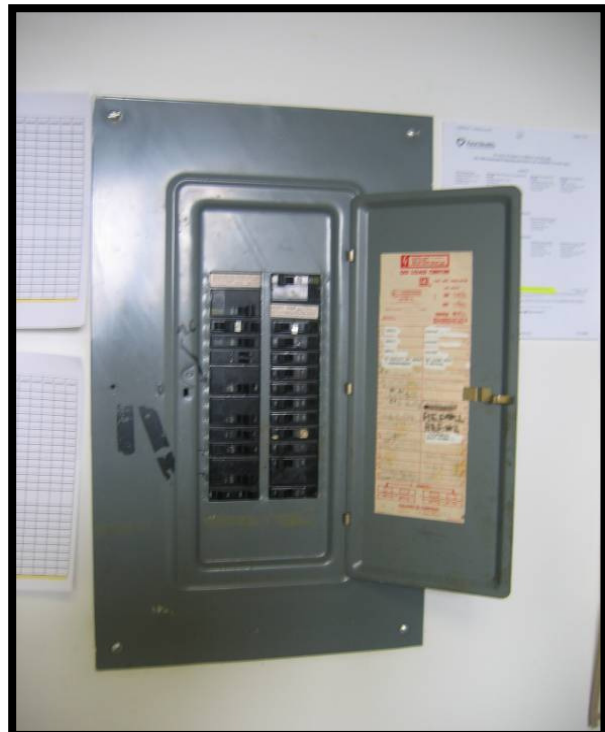
Photo No. 93

Depicts main electric service panel in Storage Room at rear of Snack Bar Kitchen.

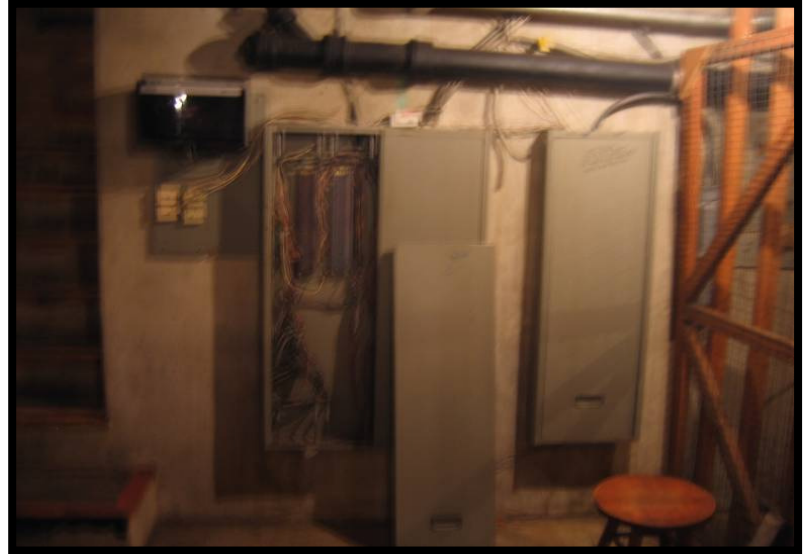
Photo No. 94

Depicts existing patch panels and AT&T phone equipment mounted at the west wall of the Basement.

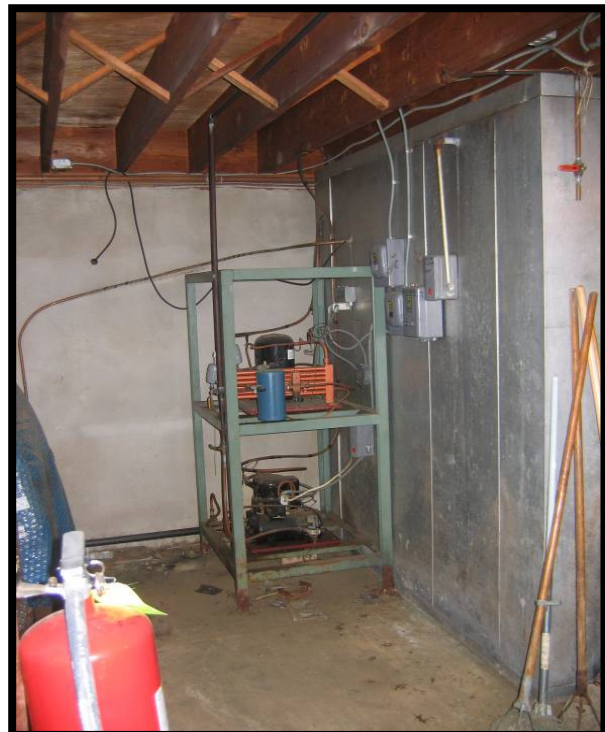
Photo No. 95

Depicts condensers for abandoned walk-in freezer at southwest corner of Basement.

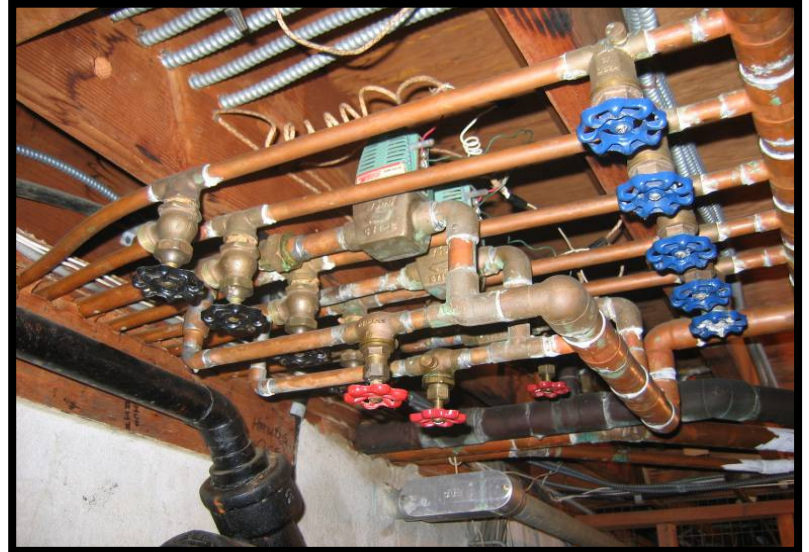
Photo No. 96

Depicts zone valve controls for radiant floor slab heating systems for Men's and Women's Locker Rooms. These zone valves are located above the telephone patch equipment on the west wall of the Basement.

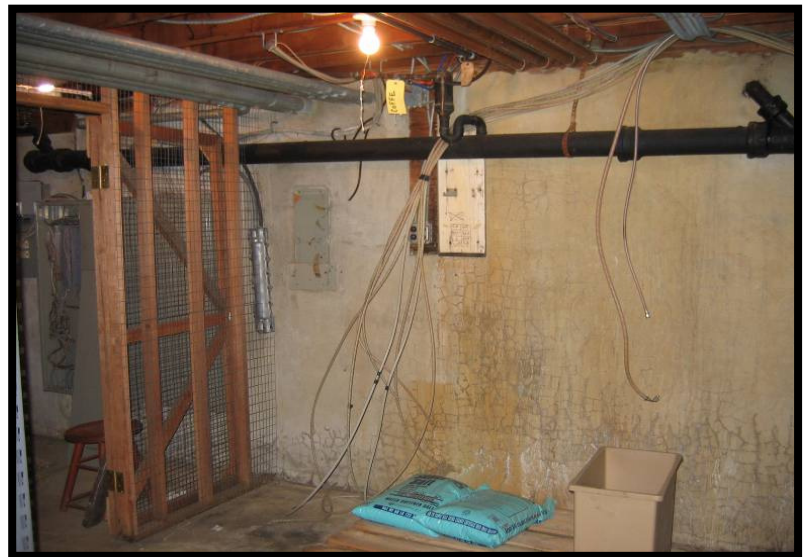
Photo No. 97

Depicts old soda distribution piping abandoned on the west side of the Basement. The photograph also depicts the main case iron sanitary pipe on the west wall.

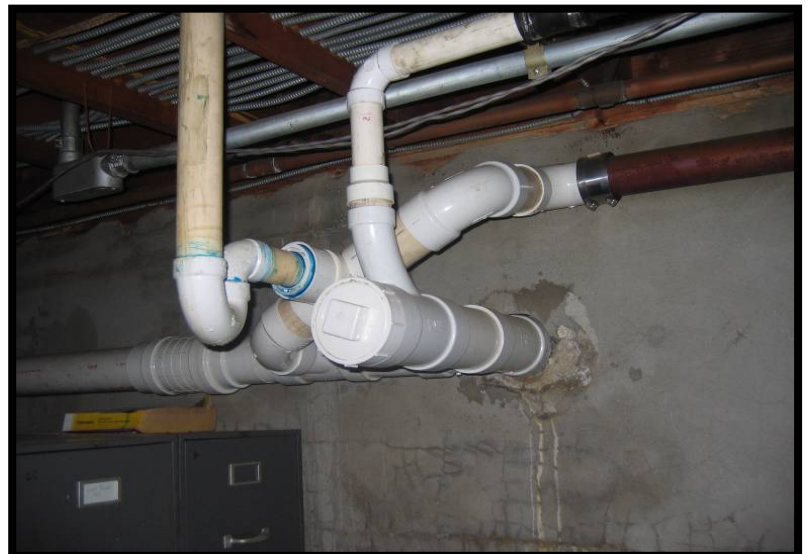
Photo No. 98

Depicts new PVC piping and main PVC sanitary outlet located on the north wall of the Basement.

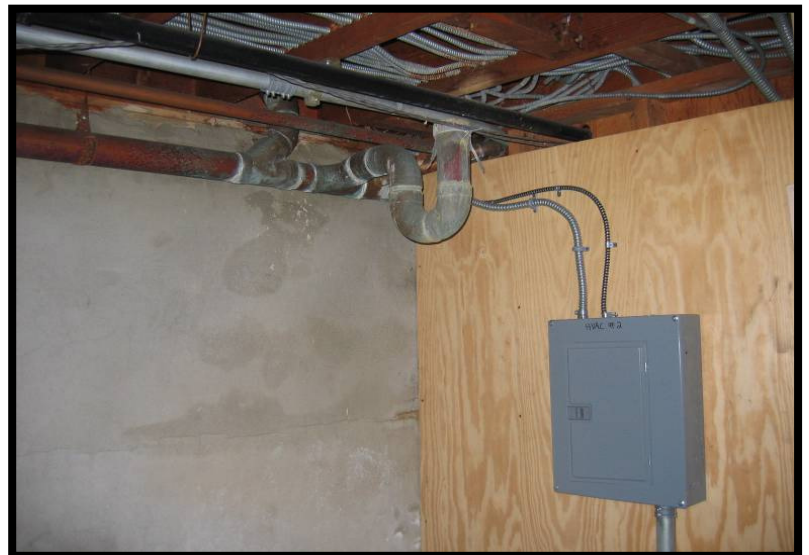
Photo No. 100

Depicts uncapped U trap and electric panel. U trap should be capped and sealed.

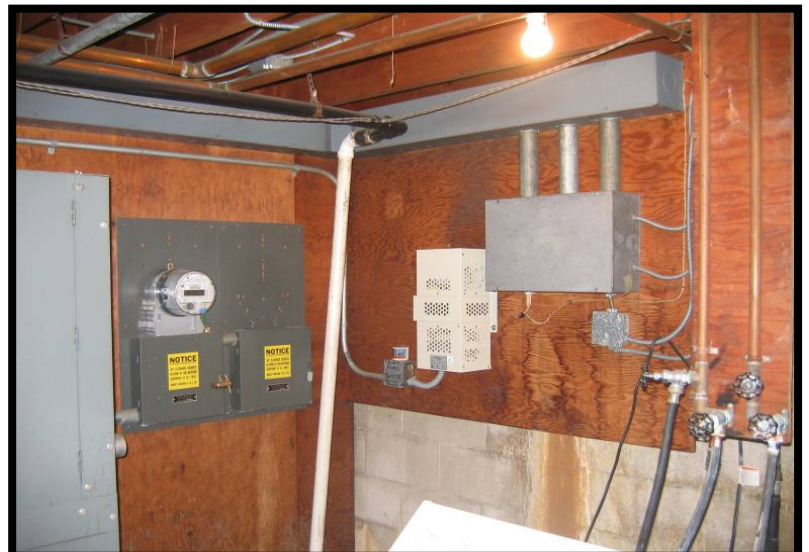
Photo No. 101

Depicts main electric service meter and step down transformers for perimeter irrigation systems for the main Club House. This equipment is located at the northeast corner of the Basement. One (1) of two (2) sump pumps is also located at this corner of the building.

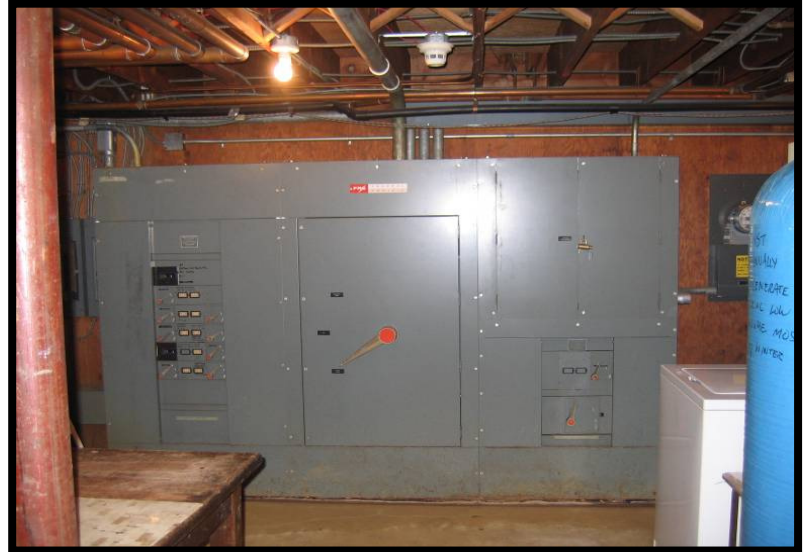
Photo No. 102

Depicts the Federal Pacific main distribution panel located on the north wall in the Basement.

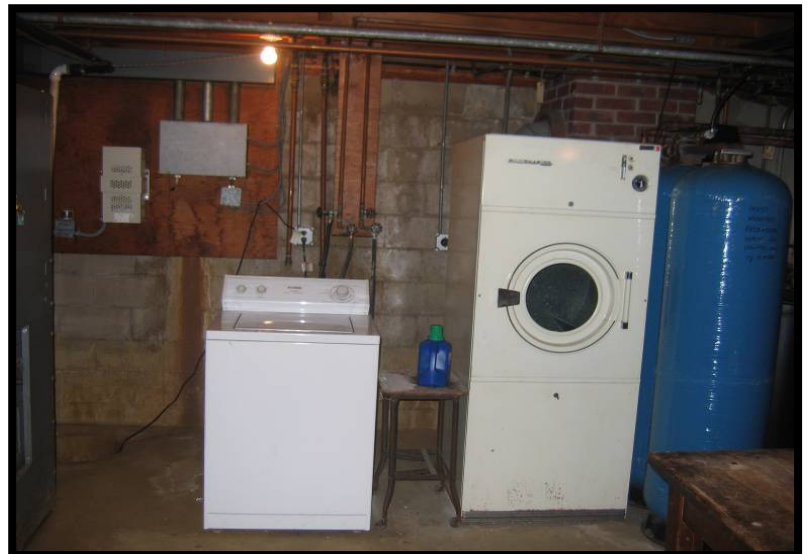
Photo No. 103

Depicts residential style washer and electric dryer located along the east wall of the Basement.

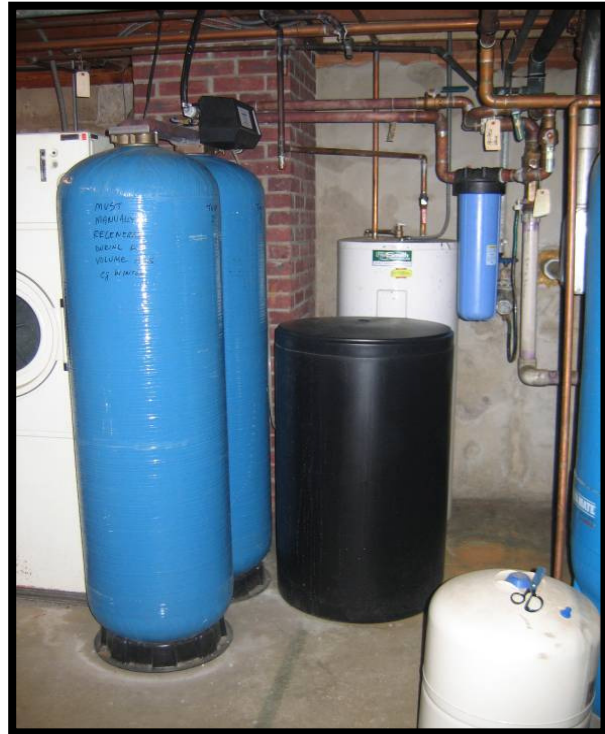
Photo No. 104

Depicts new water softening equipment installed at the east wall of the Basement.

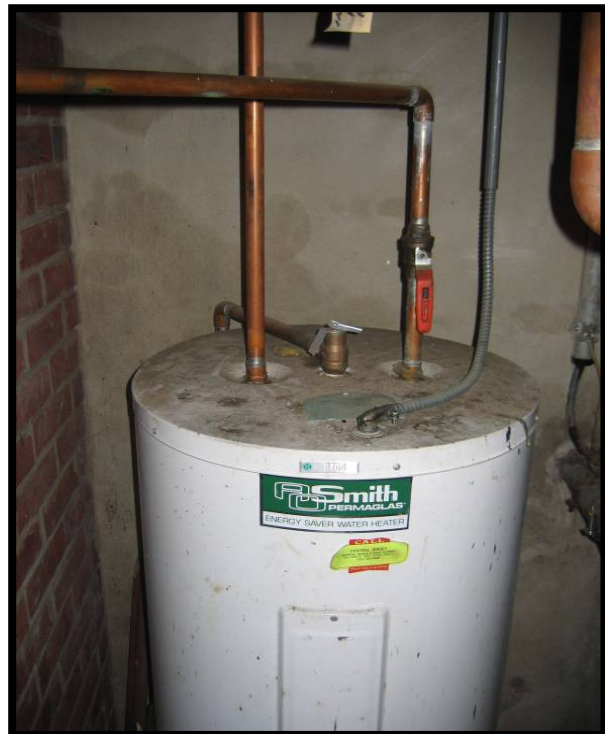
Photo No. 105

Depicts 50 gallon electric hot water heater used exclusively for the washing machine located in the Basement.

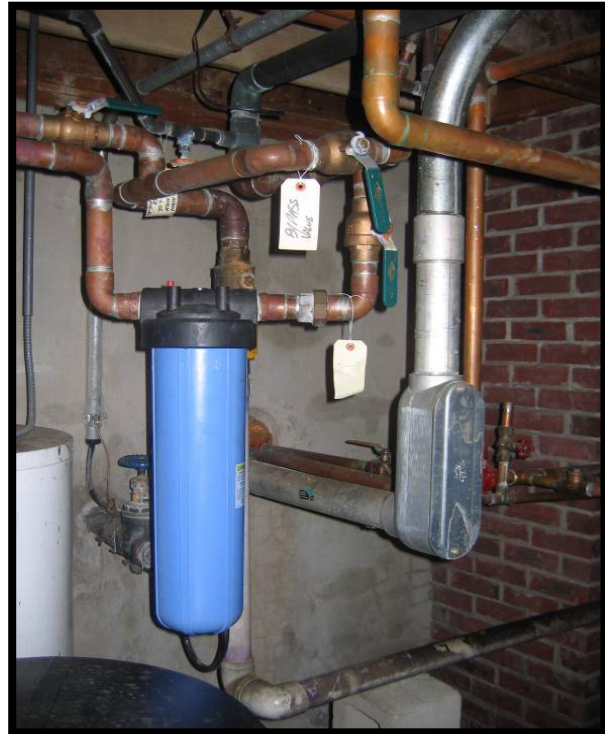
Photo No. 106

A more close-up view of the back feed electric service to the Pro Shop and the domestic water filtering cartridge.

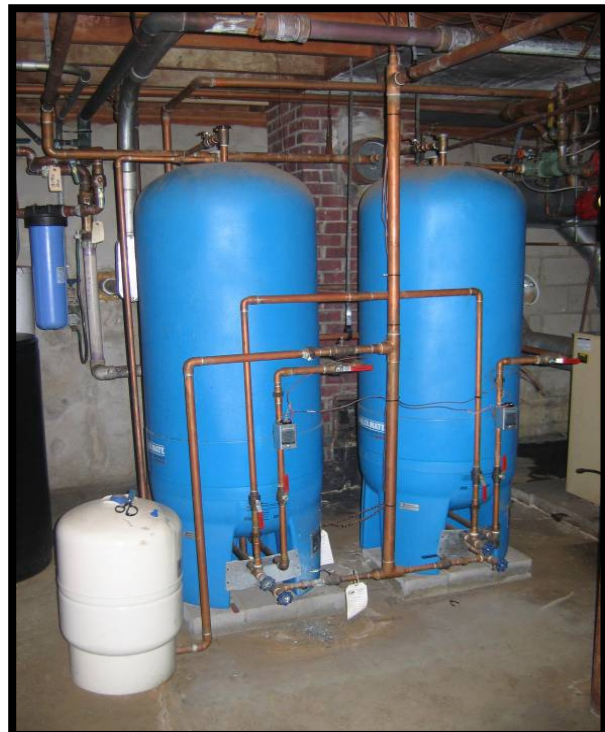
Photo No. 107

Depicts domestic hot water storage tanks piped to a transfer loop through fuel oil fired boilers.

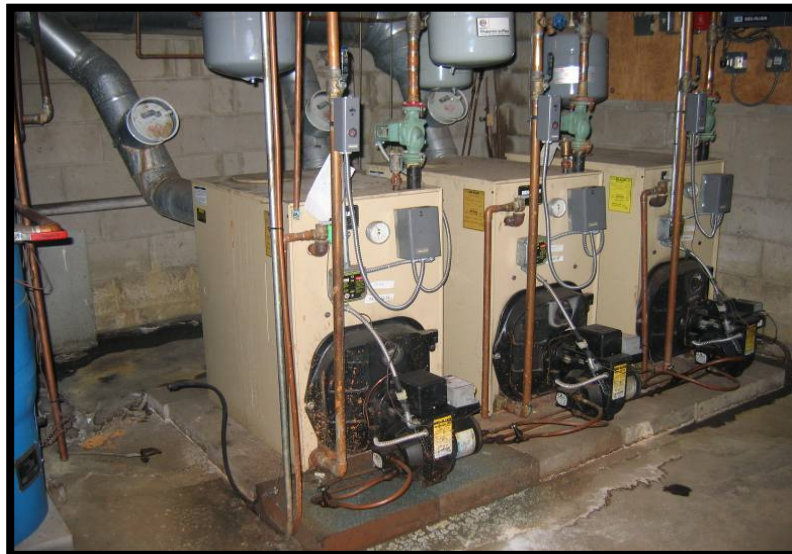
Photo No. 108

Depicts three (3) fuel oil fired boilers located at the southeast corner of the Basement. Note concrete floor adjacent to exterior wall is damp and area is subject to water infiltration.

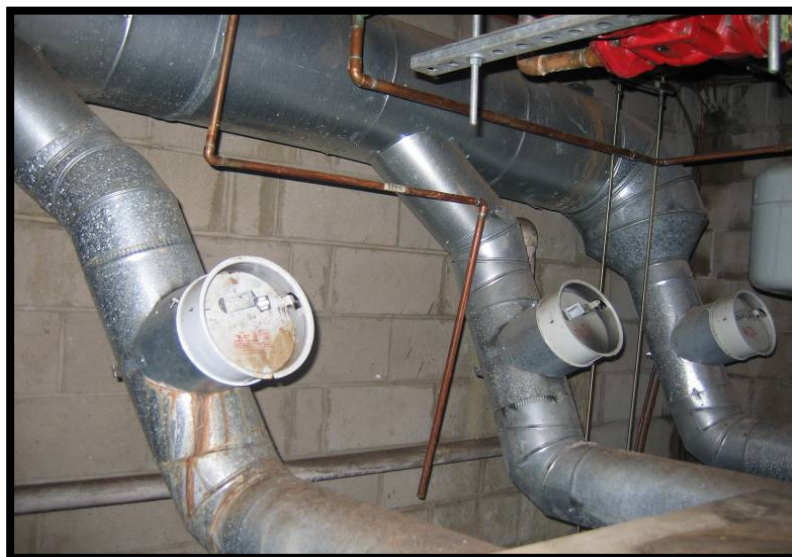
Photo No. 109

Depicts three (3) boiler flues and main breaching connected to existing chimney at east wall of the Basement.

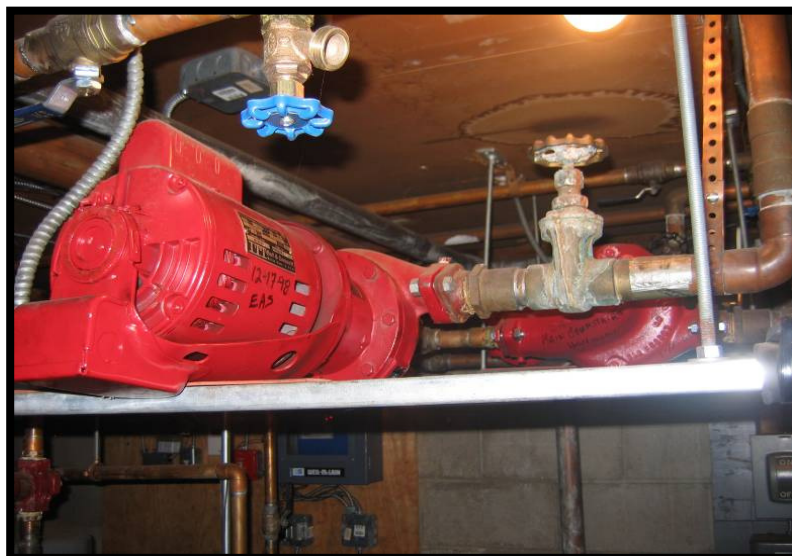
Photo No. 110

Depicts one (1) of five (5) new circulating pumps for heating system. Typical.

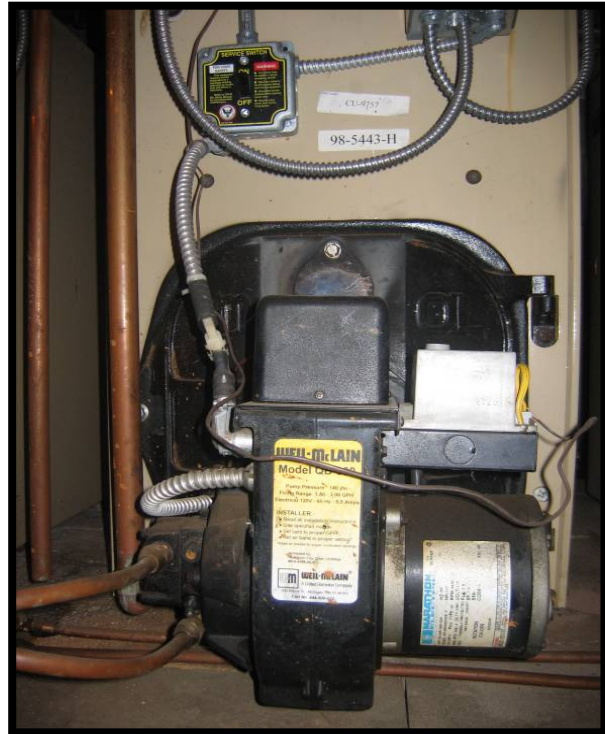
Photo No. 111

A close-up view of typical burner and controls for Weil McLain modular boilers.

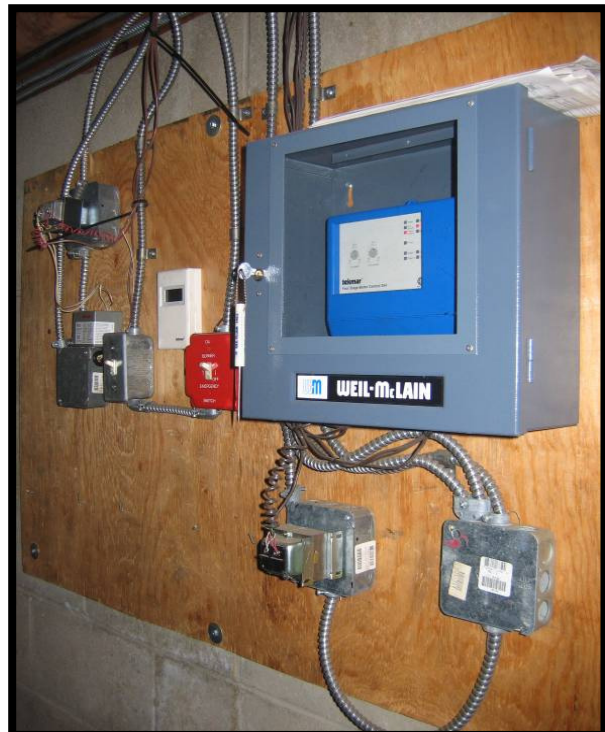
Photo No. 112

Depicts Weil McLain controls for boilers. These controls are mounted at the southeast corner of the Basement.

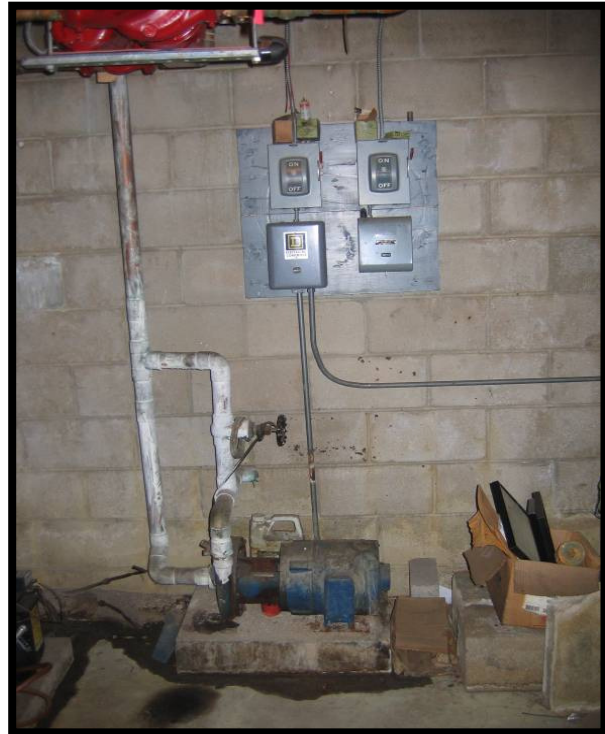
Photo No. 113

Depicts abandoned pump and controls mounted on the south wall of the Basement for old domestic water systems which have been disconnected.

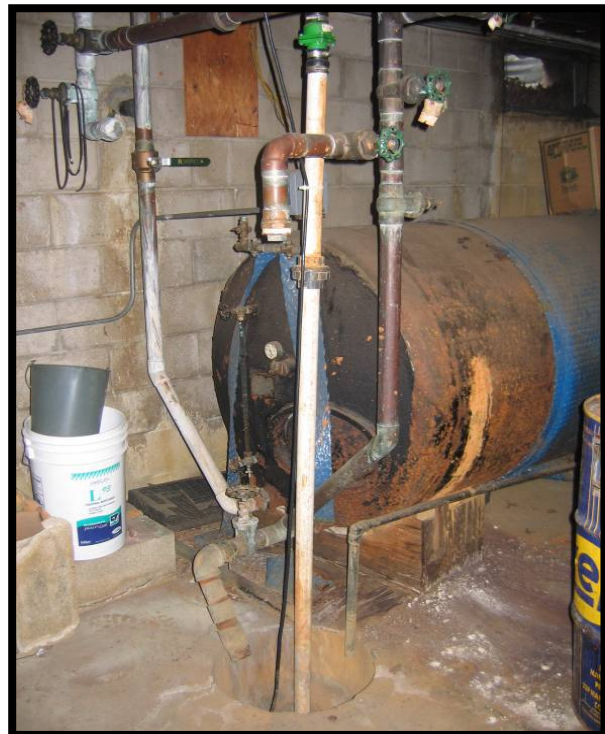
Photo No. 114

Depicts old water storage tank and piping which has been disconnected. The photograph also depicts the sump pump, ejector piping, and pit located at the south wall of the Basement.

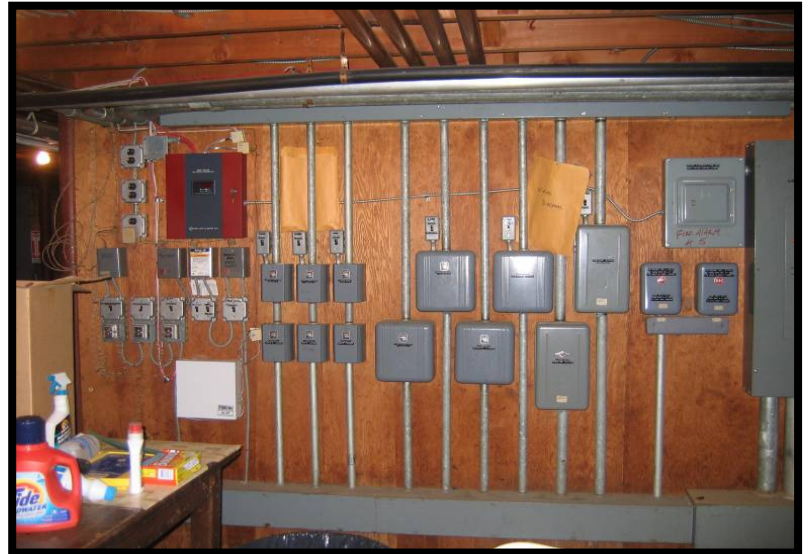
Photo No. 115

Depicts abandoned controls for old HVAC systems. The photo also depicts new electric panels and fire alarm control panel.

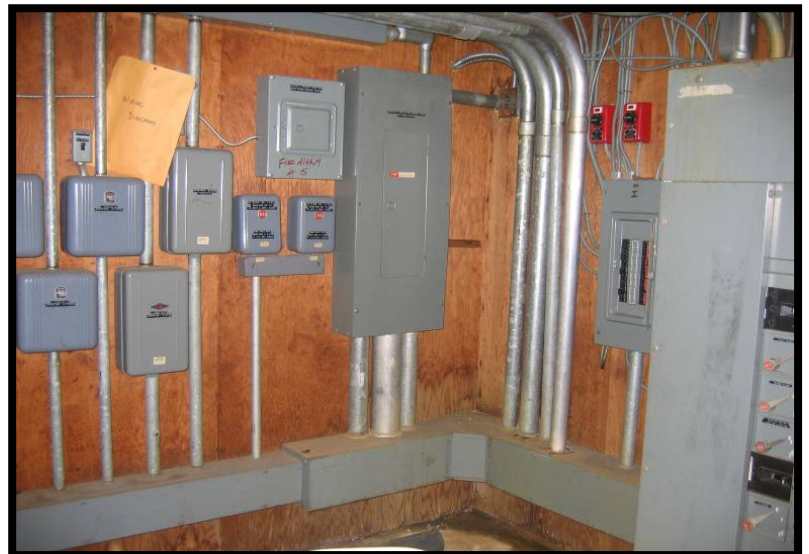
Photo No. 116

Ditto Photo No. 115.

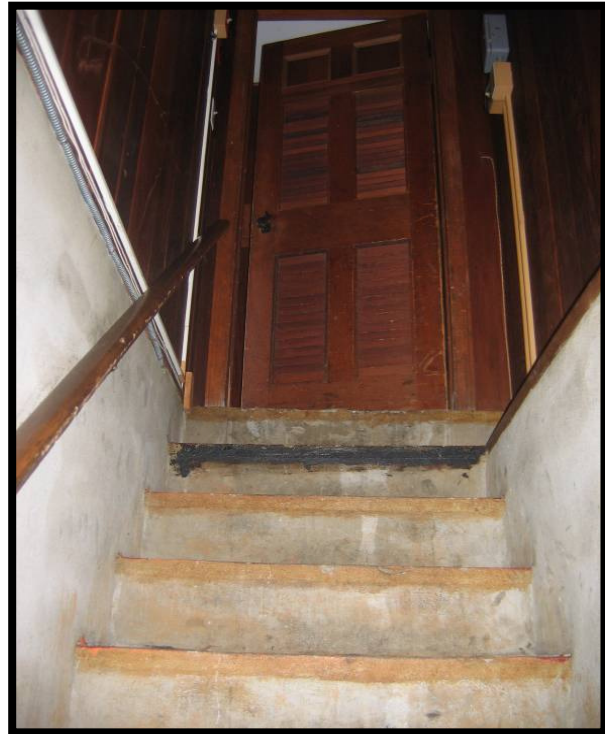
Photo No. 117

Depicts an overall view of the Basement entry stair which should be rated. Egress signage and emergency lighting should be provided.

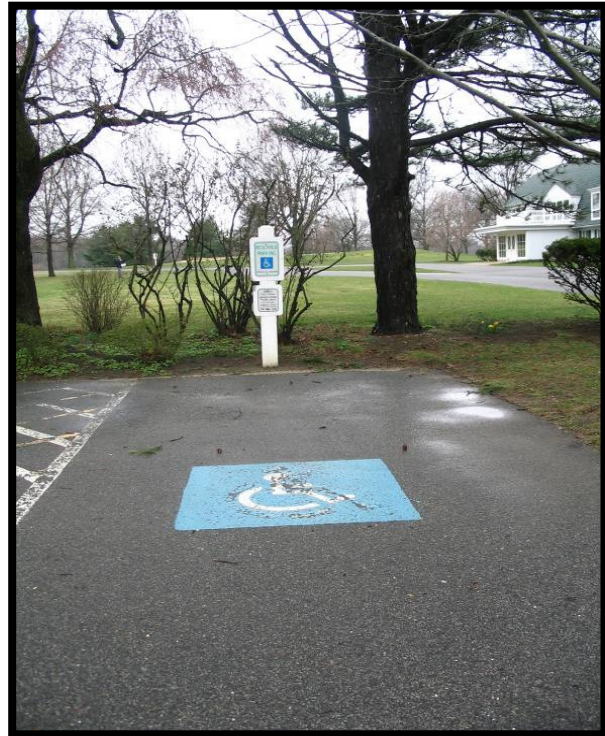
Photo No. 1

Depicts a view of a handicap reserved parking space located to the southeast of the Clubhouse at the northern part of the parking lot. This is the closest parking space to the Clubhouse.

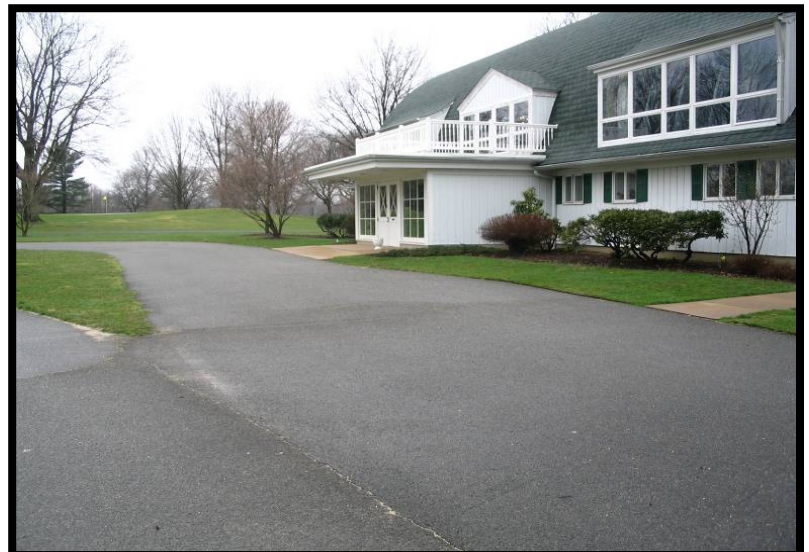
Photo No. 2

Depicts a view of the macadam driveways leading to the main entrance of the Clubhouse on the south side. This would be considered the ADA accessible route of travel.

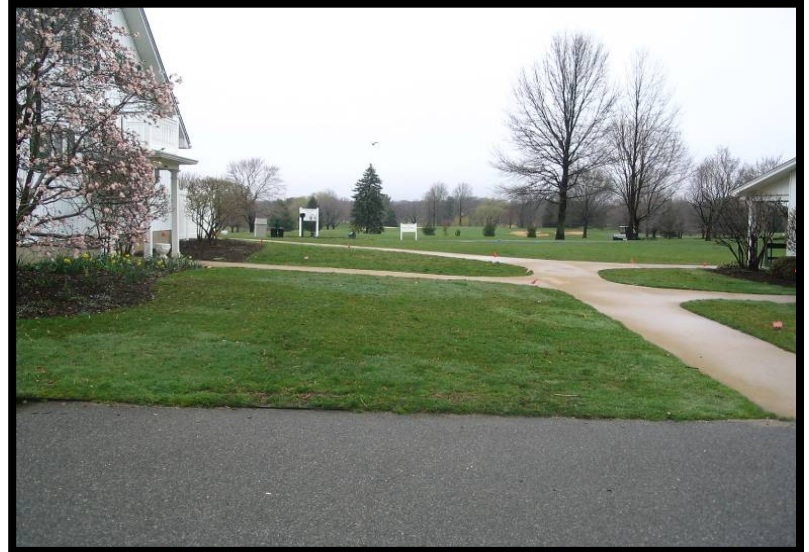
Photo No. 3

Depicts a view of concrete sidewalks leading into the east end of the Clubhouse at the Men's Locker Room.

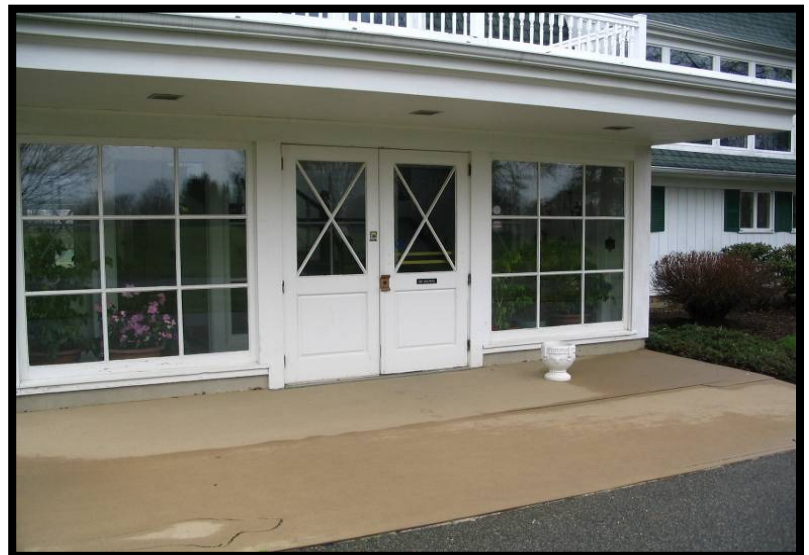
Photo No. 4

Depicts a view of the main doors into the Foyer at the center of the south elevation. This concrete pad is flat and then has a slight slope down to the macadam surface.

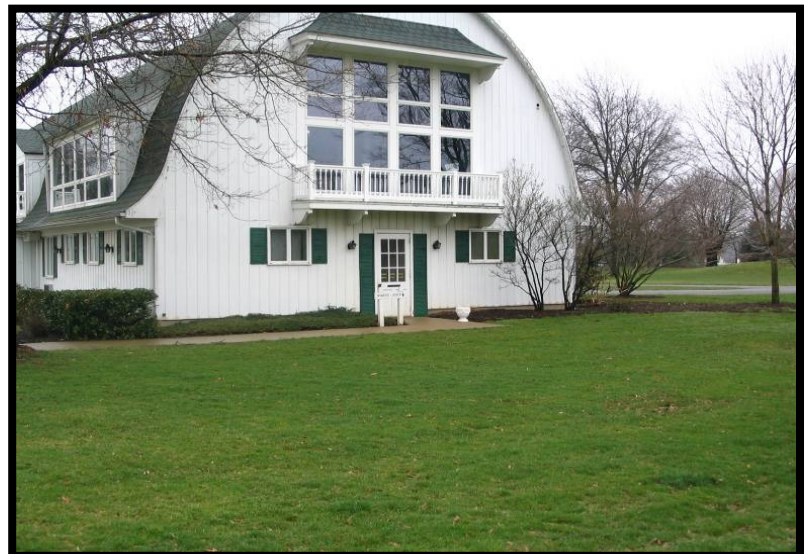
Photo No. 5

Depicts a view of the exterior of the western elevation. The door on this elevation leads into the Women's Locker Room.

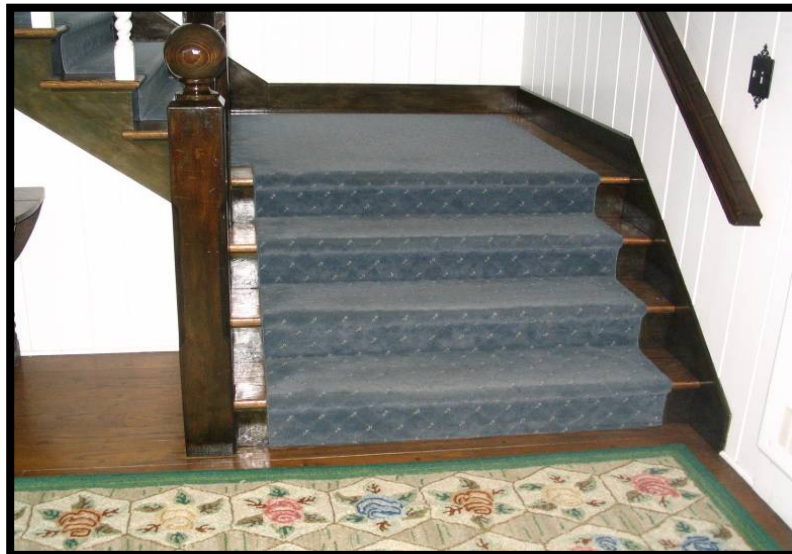
Photo No. 6

Depicts a view of the stairs off of the main Foyer leading to the second story.

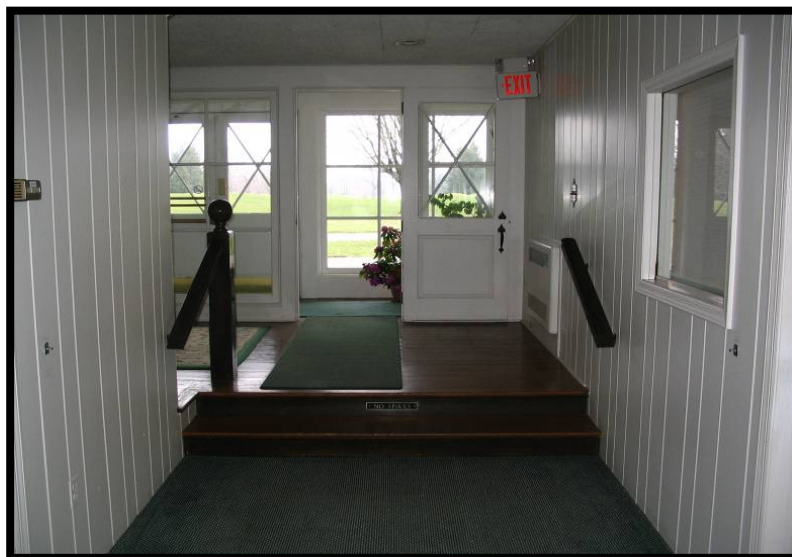
Photo No. 7

Depicts a view looking south towards the main Foyer and Vestibule. There is a set of two (2) steps between the main level of the Clubhouse and the Foyer.

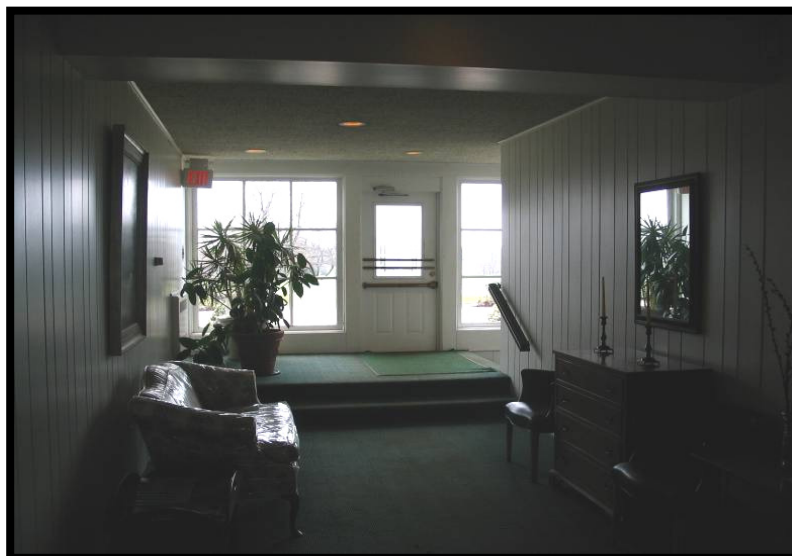
Photo No. 8

Depicts a view looking to the north at the northern Vestibule leading onto the patio outside the Snack Bar. There are also two (2) steps between this entry point and the main level of the Clubhouse.

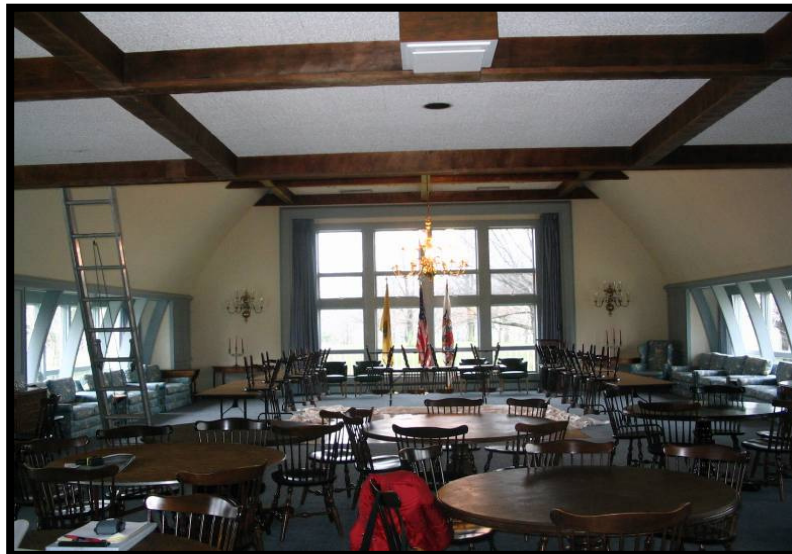
Photo No. 9

Depicts a view looking to the west of the second floor Banquet Room.

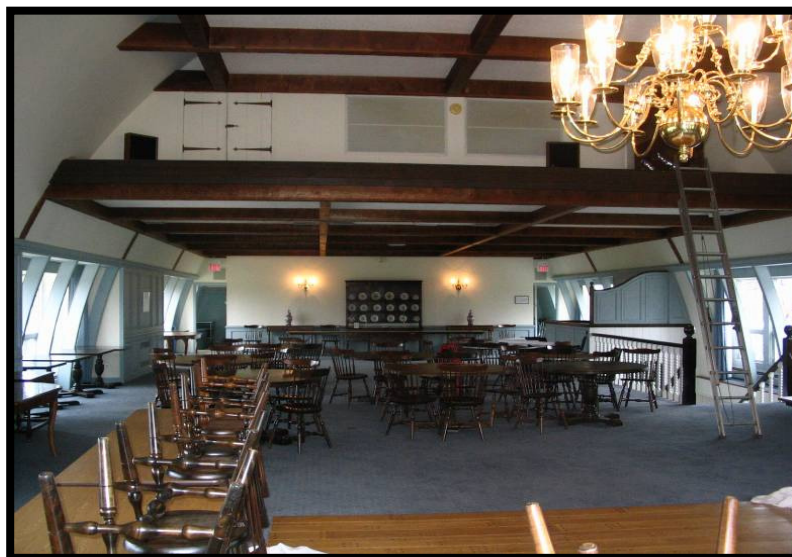
Photo No. 10

Depicts a view looking to the east in the second floor Banquet Room. Depicted in this photo is the difference in ceiling elevations and the access to the attic above.

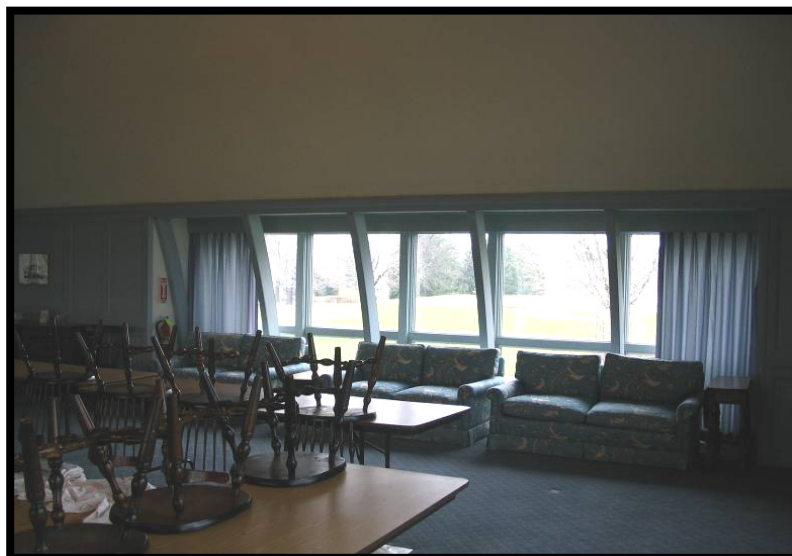
Photo No. 11

Depicts a view of a typical dormer window bay at the second floor level.

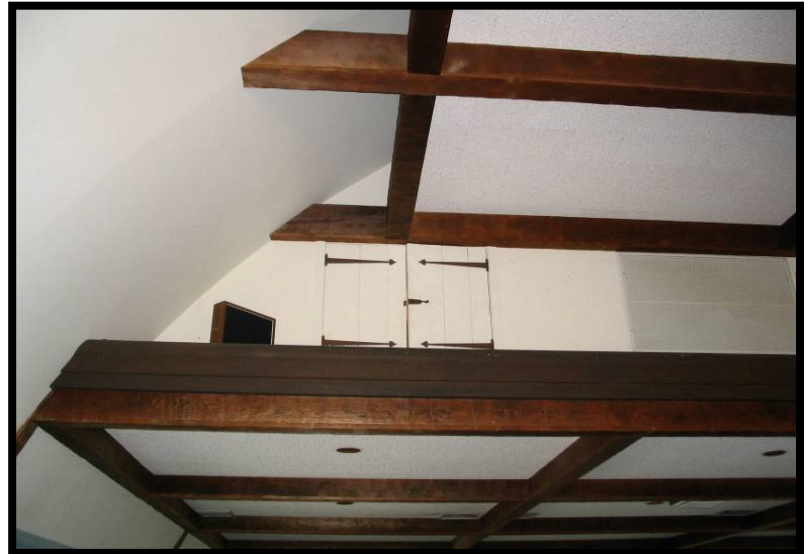
Photo No. 12

Depicts a view of one (1) of the two (2) access doors to the attic located to the east of the cathedral ceiling in the Banquet Room.

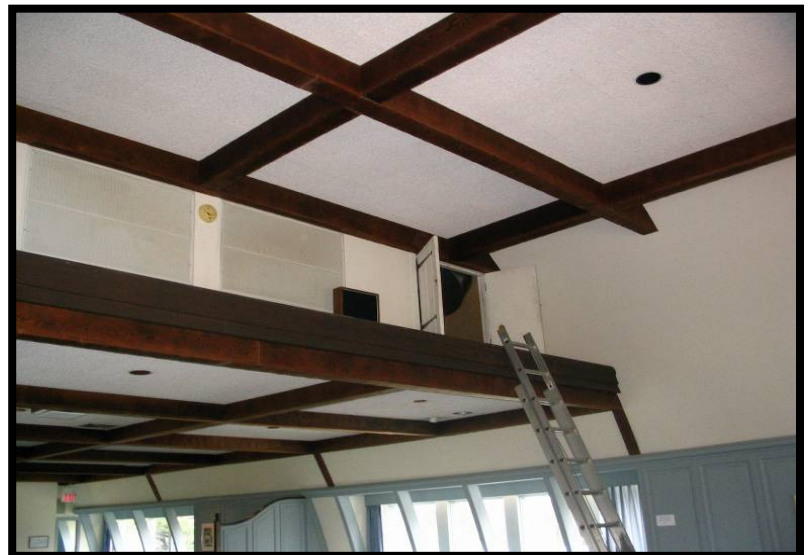
Photo No. 13

Depicts a view of the second access into the attic.

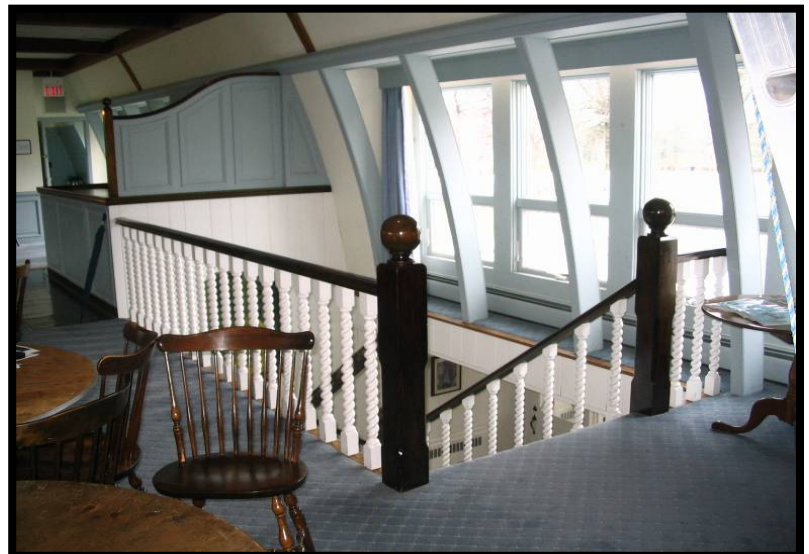
Photo No. 14

Depicts a view of the open staircase leading down to the first floor level located on the south side of the second floor Banquet Room.
