LAN ASSOCIATES

**CONDITIONS ASSESSMENT
& RECOMMENDATIONS
FOR THE
HOMINY HILL CLUBHOUSE (BUILDING 1301)
HOMINY HILL GOLF COURSE
COLTS NECK, NJ**

LAN REFERENCE #2.2882.2
August 11, 2008

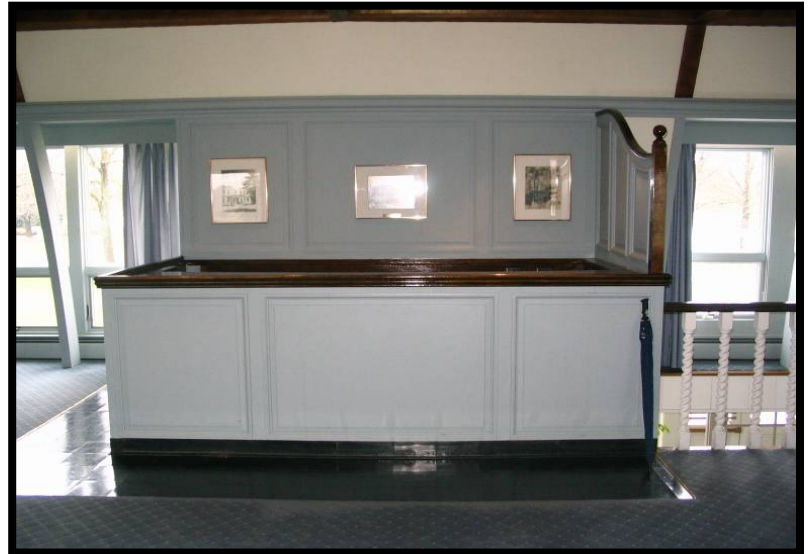
Photo No. 15

Depicts a view of the built-in bar located on the south side of the Banquet Room.

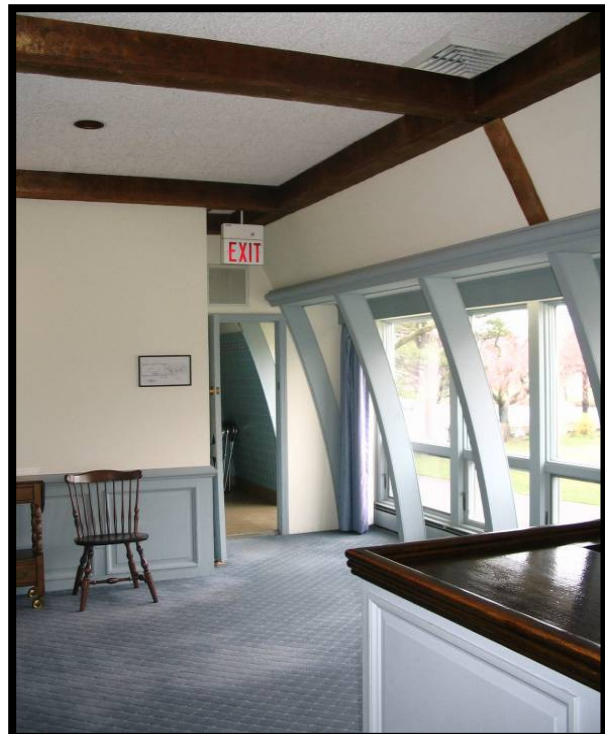
Photo No. 16

Depicts a view of the door from the Banquet Room into the Kitchen on the south side. Notice that there is exit signage at this location leading to the secondary egress stair located to the east of the Kitchen.

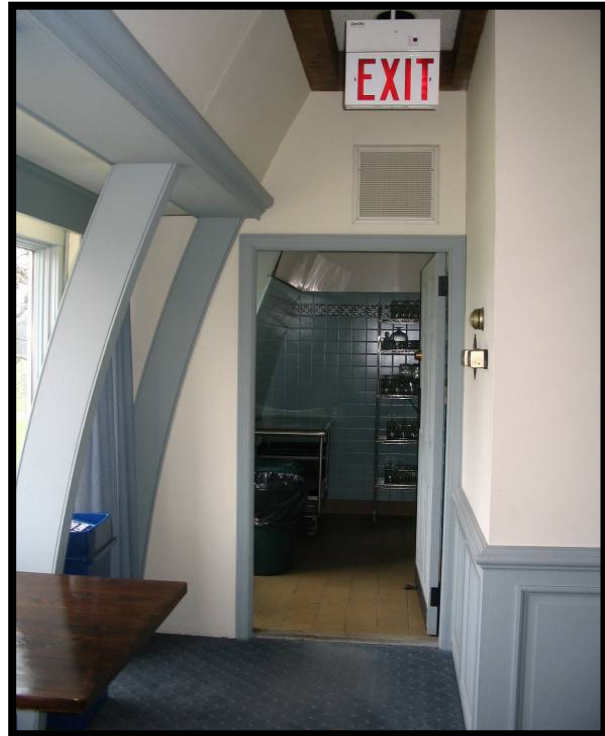
Photo No. 17

Depicts a view of the door to the Kitchen on the north side of the Banquet Room.

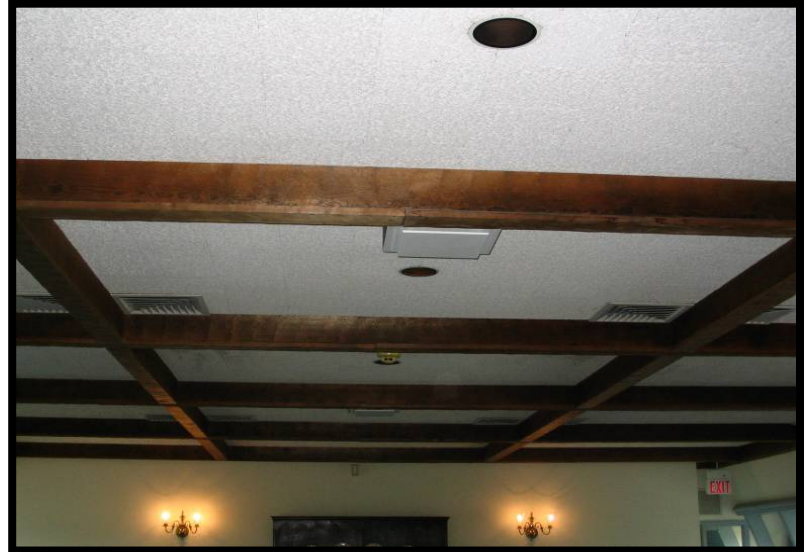
Photo No. 19

Depicts a view of the underside of the lower ceiling at the eastern end of the Banquet Room. There are large timber grids with 12" x 12" adhered Z spline ceiling tiles in between.

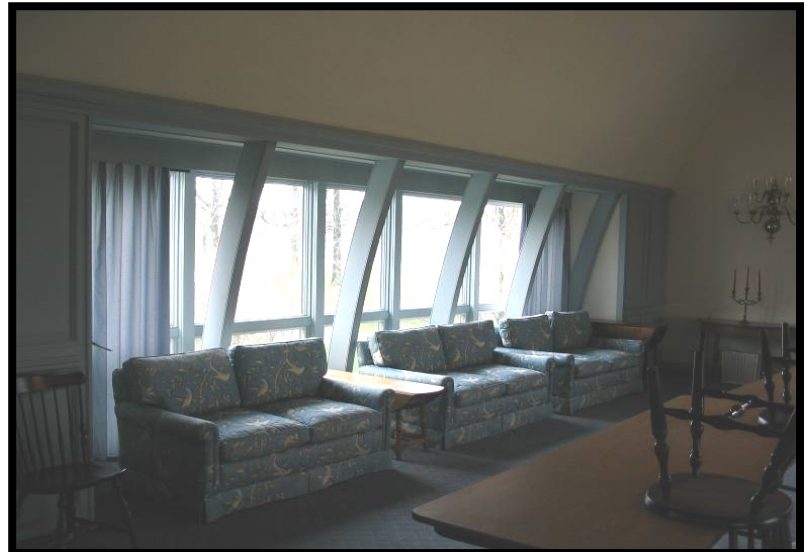
Photo No. 20

Depicts a view of a typical window bay located on the south side of the Banquet Room.

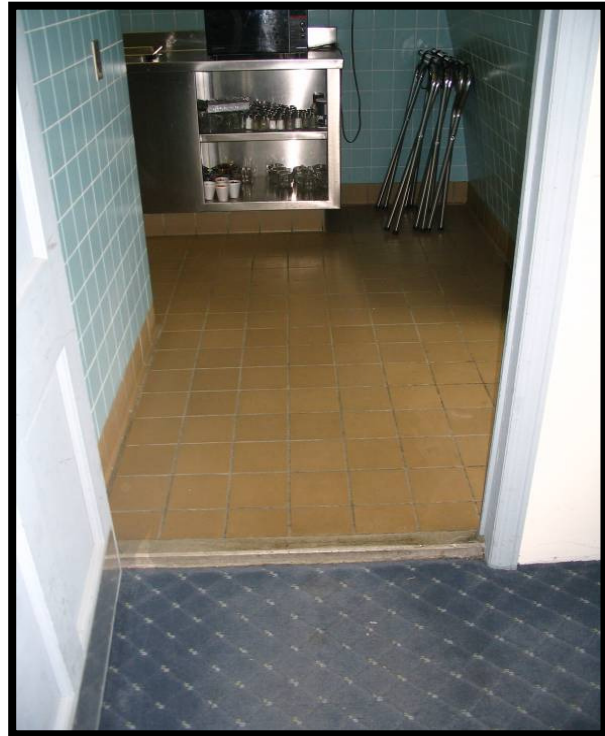
Photo No. 21

Depicts a view of the transition between the carpet in the Banquet Room and the 6" x 6" quarry tile in the Kitchen.

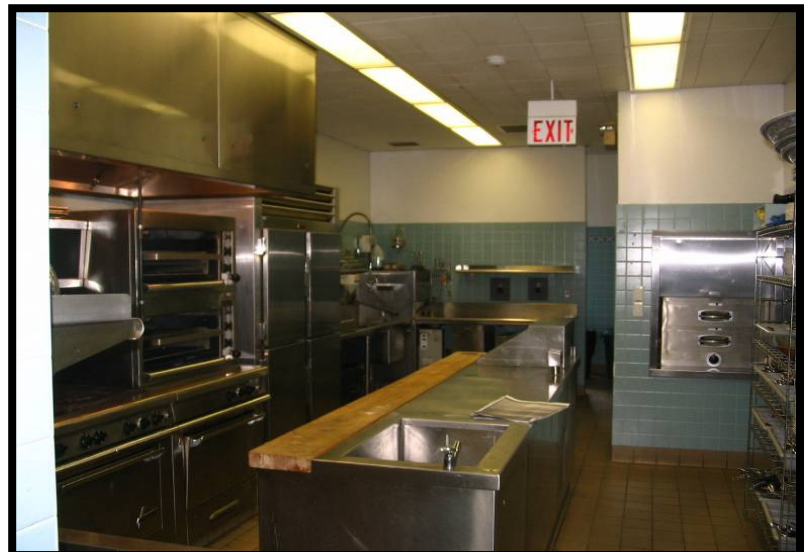
Photo No. 22

Depicts a view looking to the north in the Kitchen. Note the exit signage directing to the secondary egress corridor beyond the Kitchen.

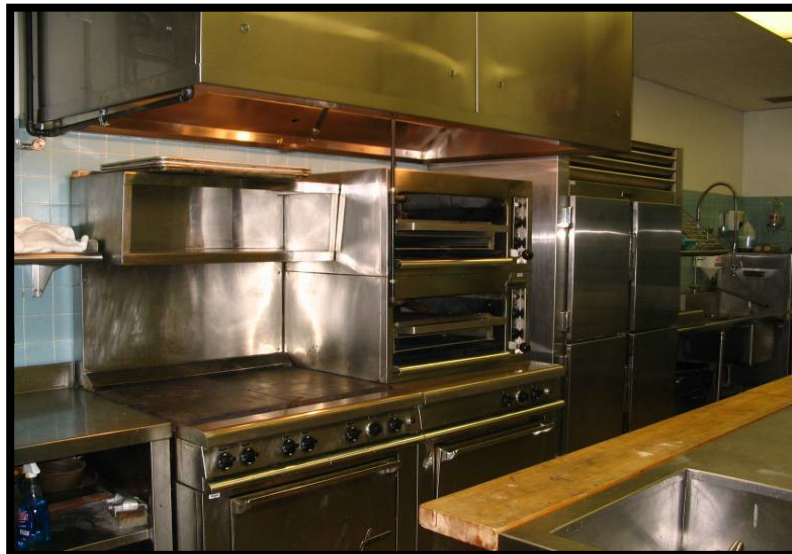
Photo No. 23

Depicts a view of the built-in range with an adjacent refrigerator and hood above.

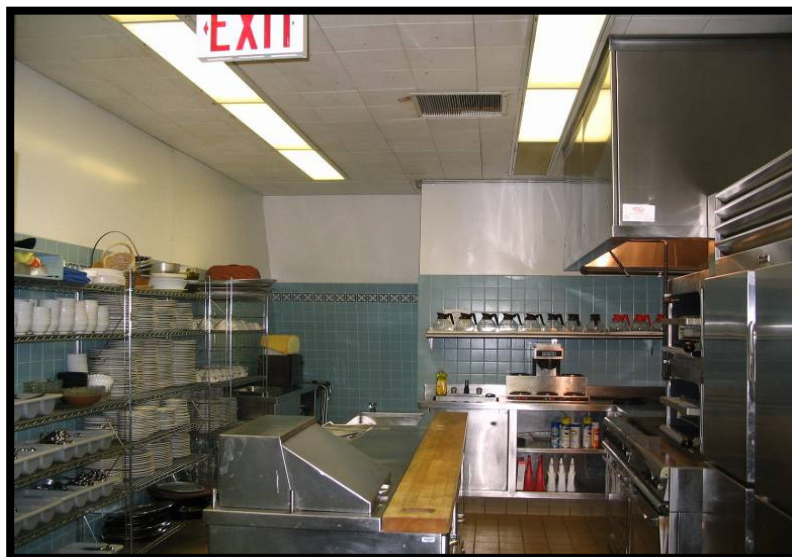
Photo No. 24

Depicts a view looking to the south in the Kitchen.

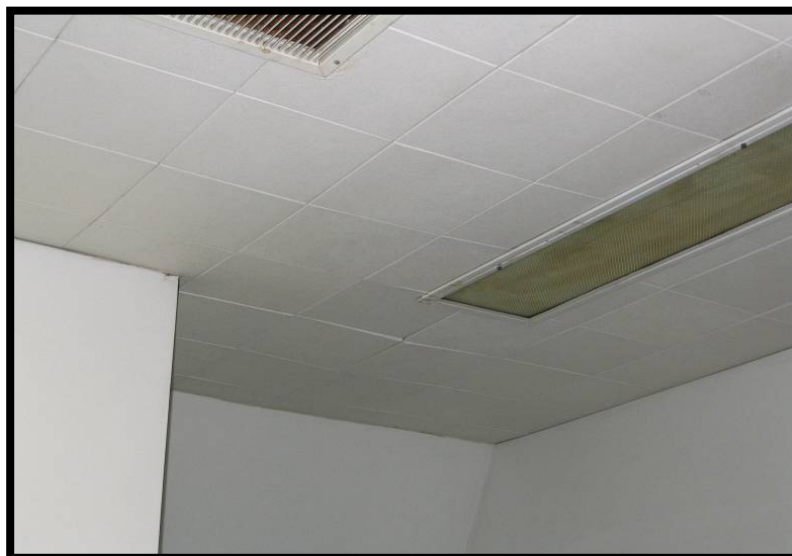
Photo No. 25

Depicts a view of the ceiling tiles and a recessed 1' x 4' fluorescent lighting fixture in the Kitchen. Depicted in this photo is warping of the ceiling tiles.

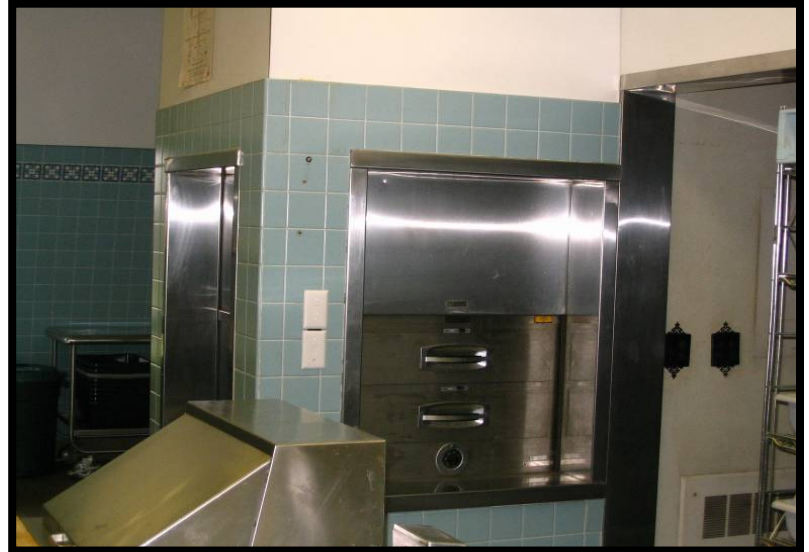
Photo No. 26

Depicts a view of an abandoned dumb waiter from the Snack Bar below to the Kitchen. This dumb waiter has been abandoned and a bread warmer has been installed on the southern face of the shaft.

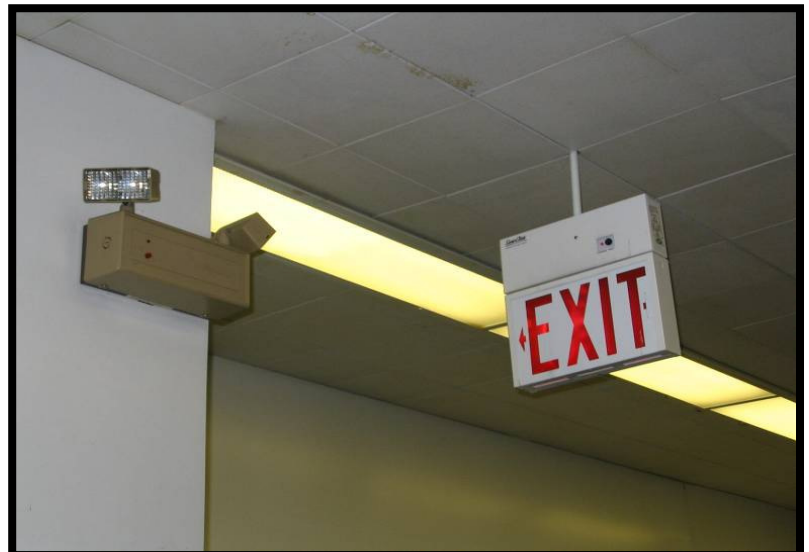
Photo No. 27

Depicts a view of exit signage and emergency lighting located in the Kitchen.

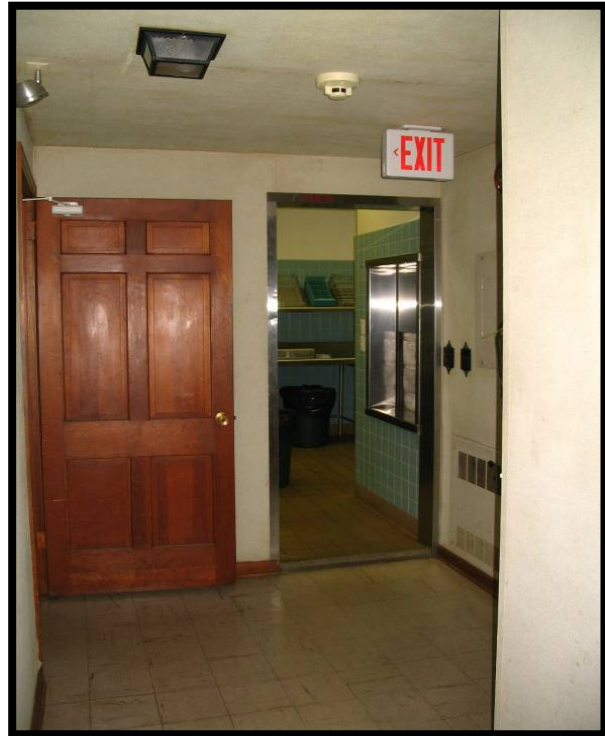
Photo No. 28

Depicts a view from the service corridor looking towards the entrance into the Kitchen. The photo is taken towards the west.

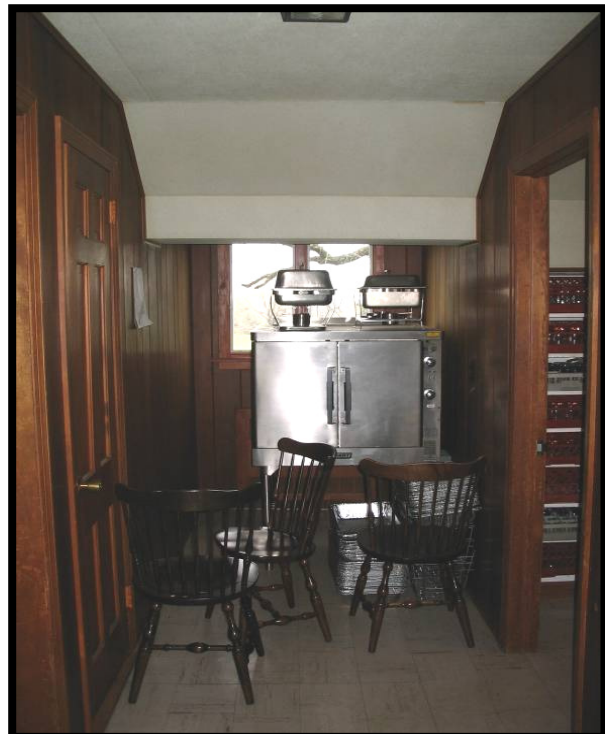
Photo No. 29

Depicts a view looking to the north of a dormer off of this service corridor. Most of this area is used for storage.

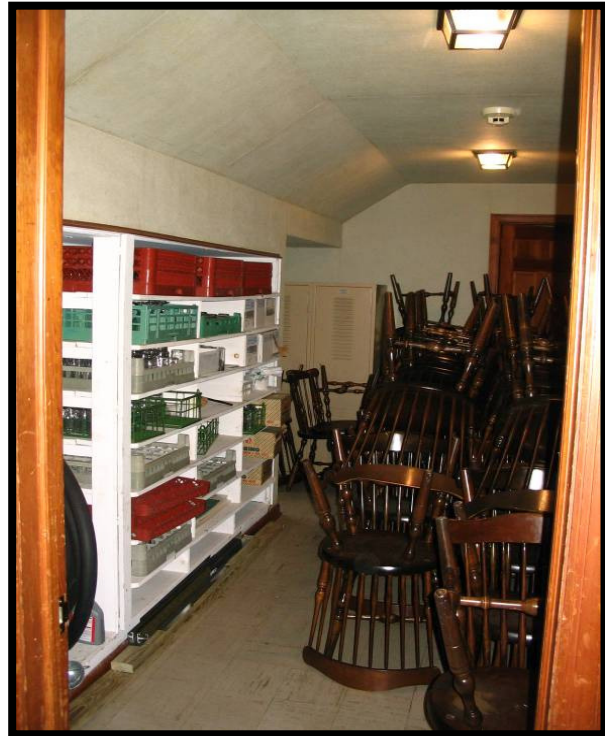
Photo No. 30

Depicts a view of a storage room used for chair storage on the north side of the service corridor. The door depicted in this photo is to a toilet room that was not accessible at the time of the observation.

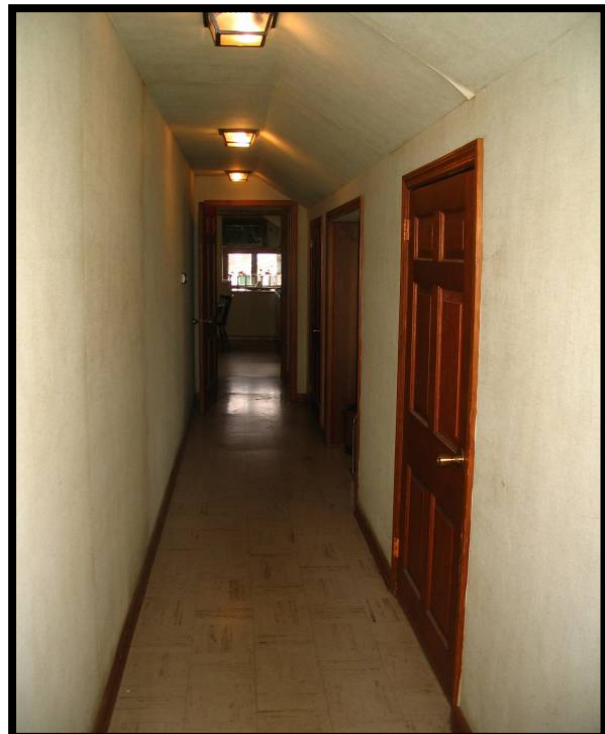
Photo No. 31

Depicts a view looking to the east of the service corridor on the second floor. Depicted in the photo is peeling of the vinyl wall/ceiling cover.

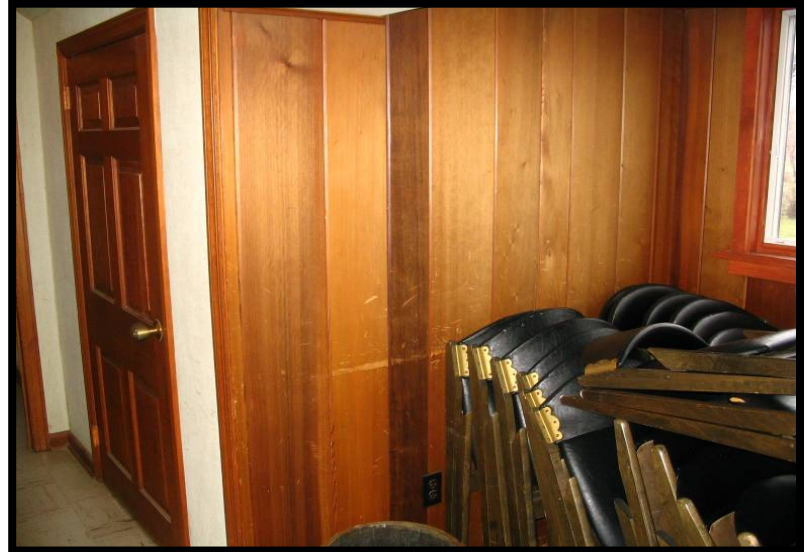
Photo No. 32

Depicts a view of typical wood paneling in the dormers at the second floor level off of the service corridor.

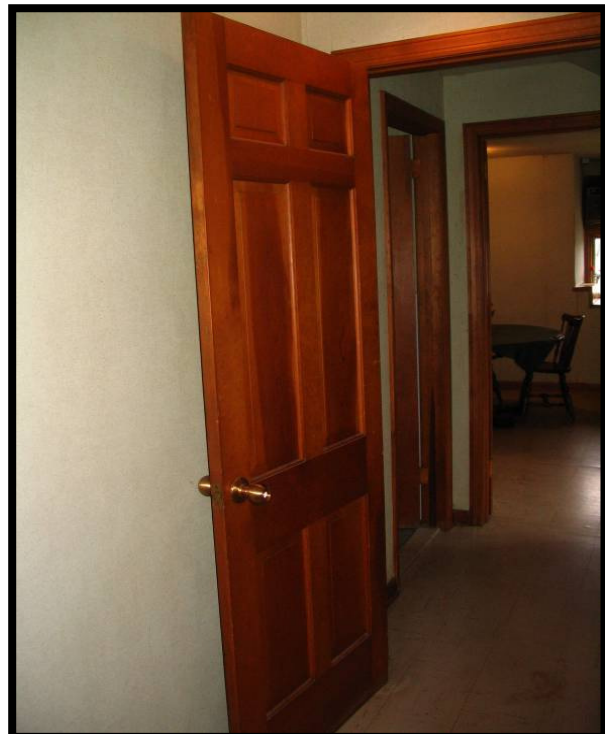
Photo No. 33

Depicts a view of a typical six (6) panel raised panel door with knob type hardware in the service corridor in the second floor.

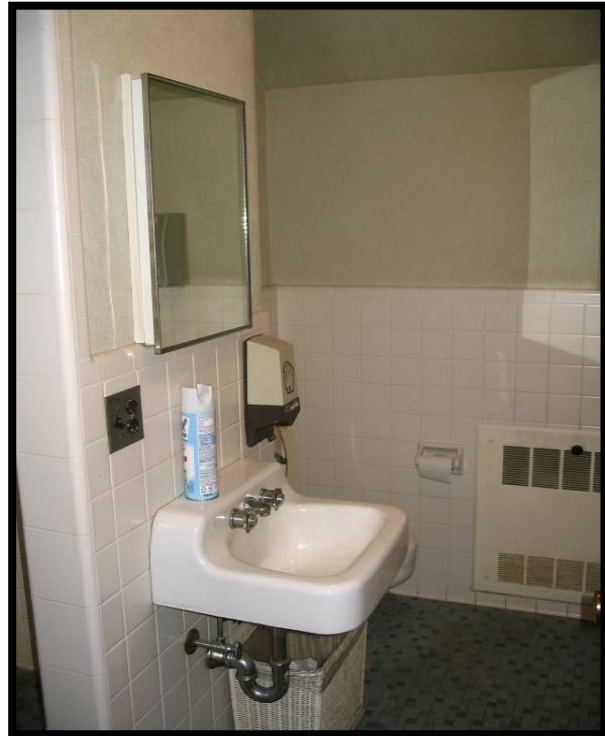
Photo No. 34

Depicts a view of the wall hung lavatory located in the Staff Toilet Room off of the service corridor on the second floor.

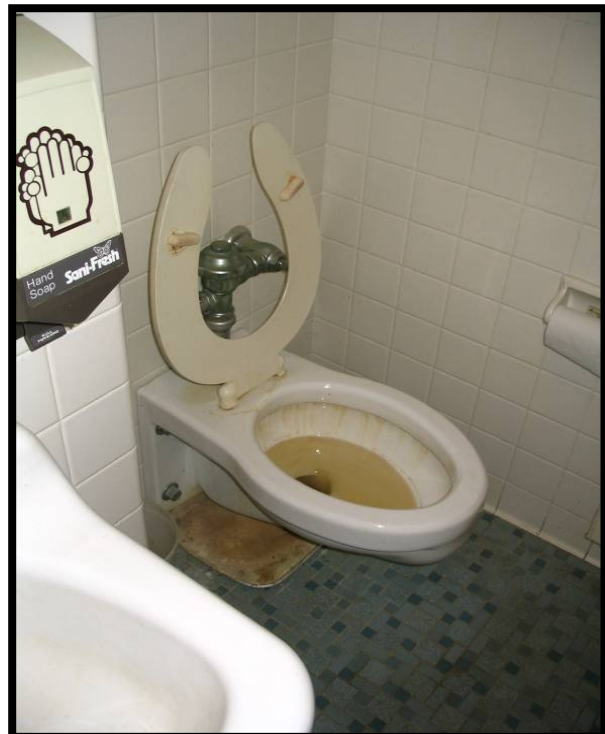
Photo No. 35

Depicts a view of the wall hung water closet in the Staff Toilet Room.

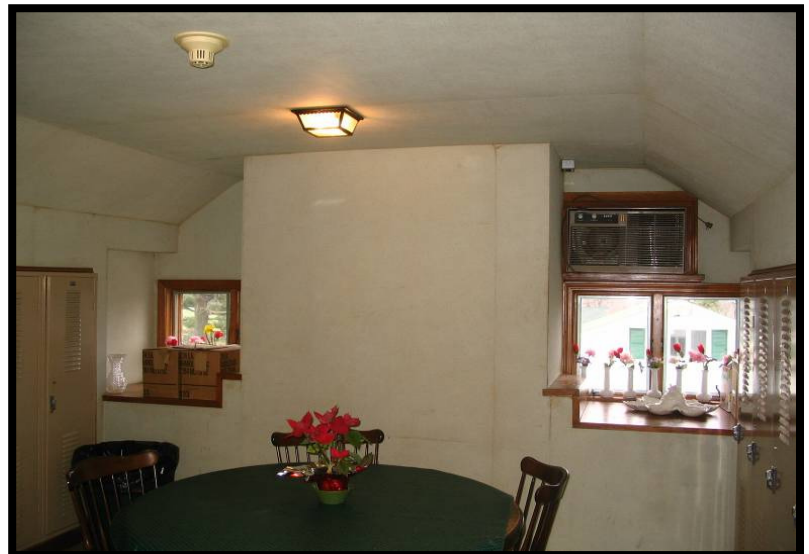
Photo No. 37

Depicts a view looking to the east in the Staff Break Room. Depicted in this photo is a through-wall air conditioning unit for this space.

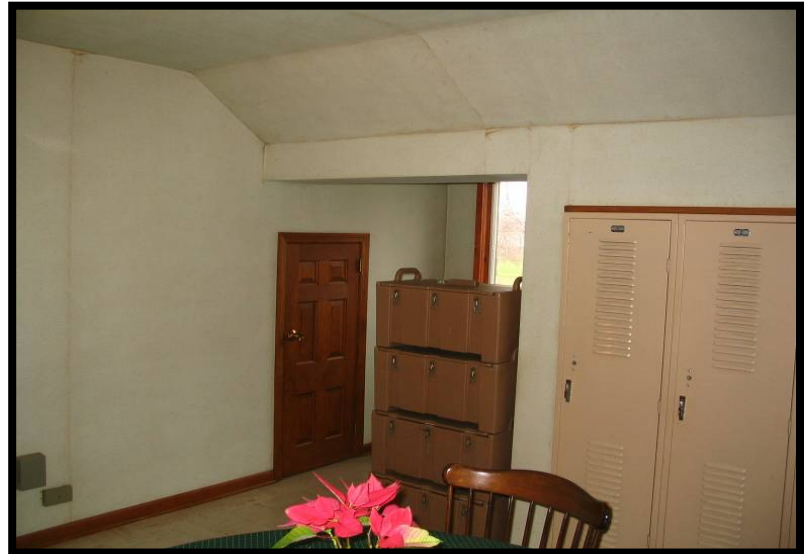
Photo No. 38

Depicts a view of a 4'-9" high raised panel door leading into a storage space located off of the Staff Locker Room.

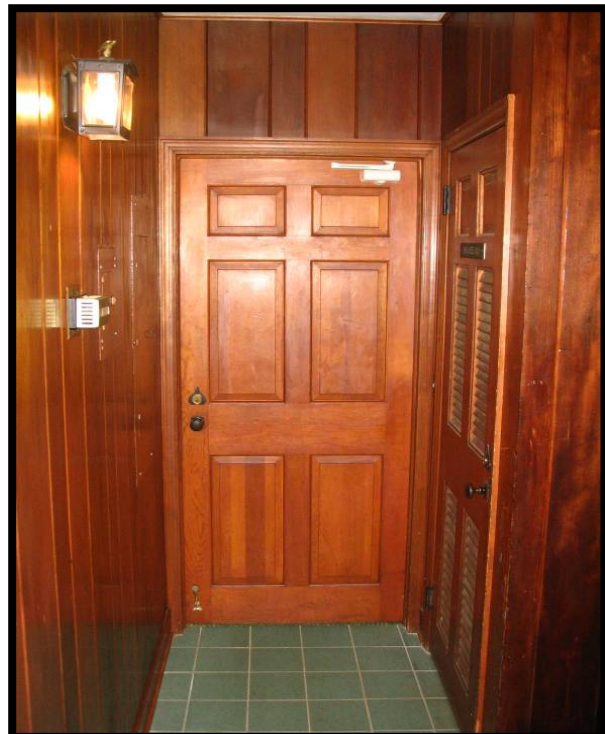
Photo No. 41

Depicts a view of a six (6) panel raised door leading into the Men's Lounge area from the secondary egress stair. Also depicted in this photo is the door to the stair down to the Basement.

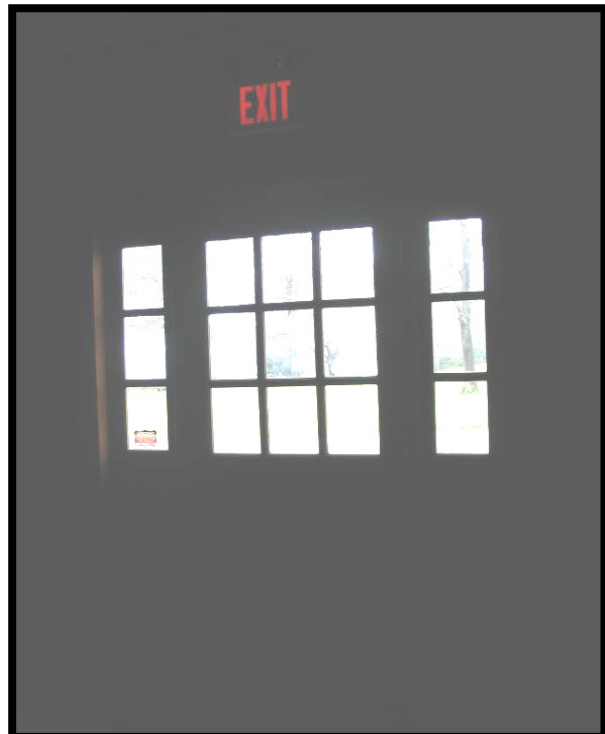
Photo No. 43

Depicts a view of the egress door from the egress stairwell on the south side of the building.

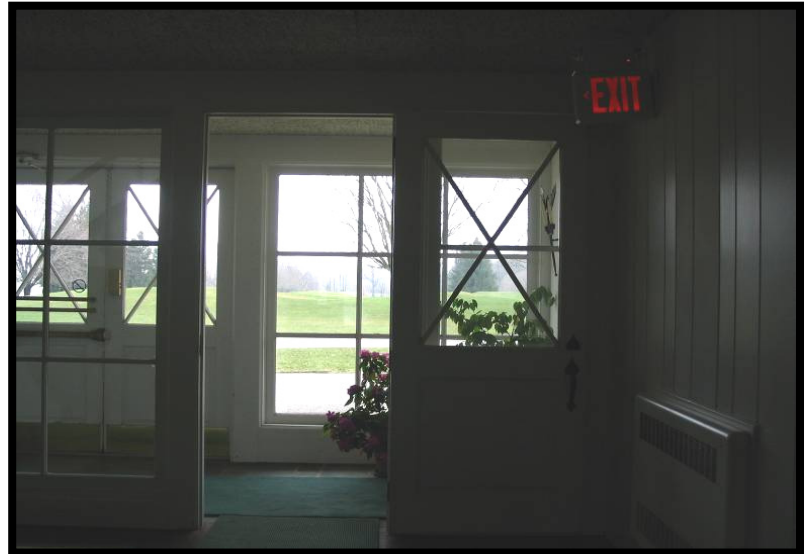
Photo No. 47

Depicts a view of one (1) of the two (2) wooden doors in the main Vestibule. Also depicted in this photo is egress signage.

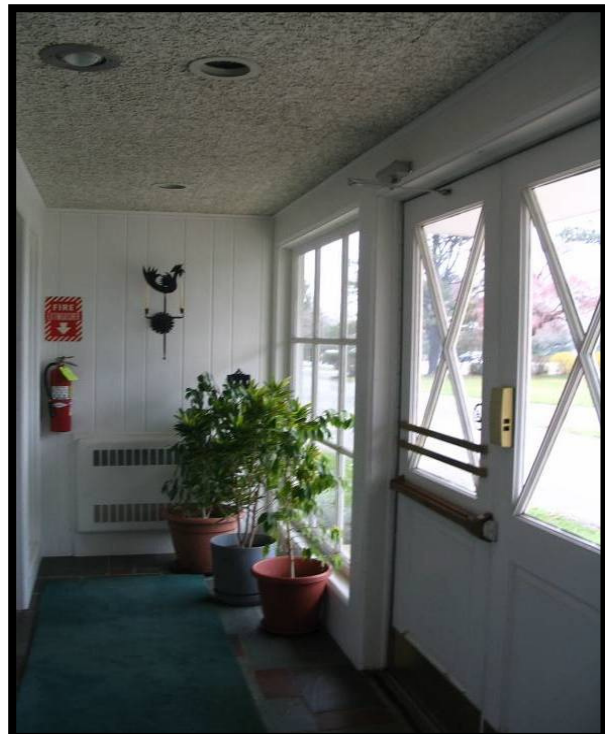
Photo No. 48

Depicts a view of the exterior double doors in the main Vestibule on the south side of the building.

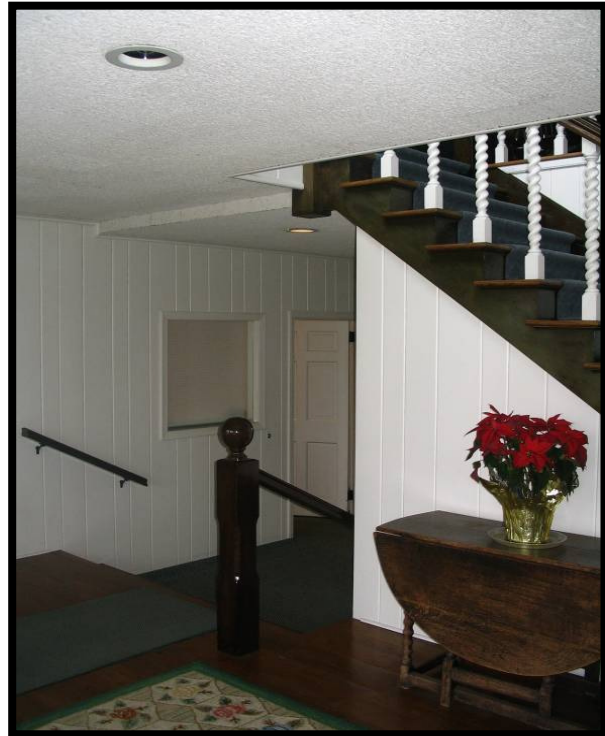
Photo No. 51

Depicts a view of the two (2) steps between the level of the Foyer and the level of the remainder of the main floor of the building.

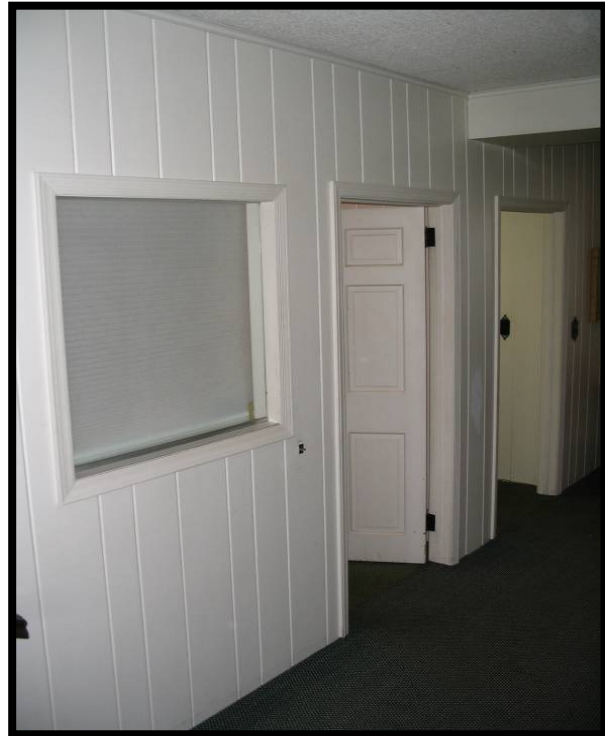
Photo No. 53

Depicts a view of the door and vision window from the center hallway into the Manager's Office.

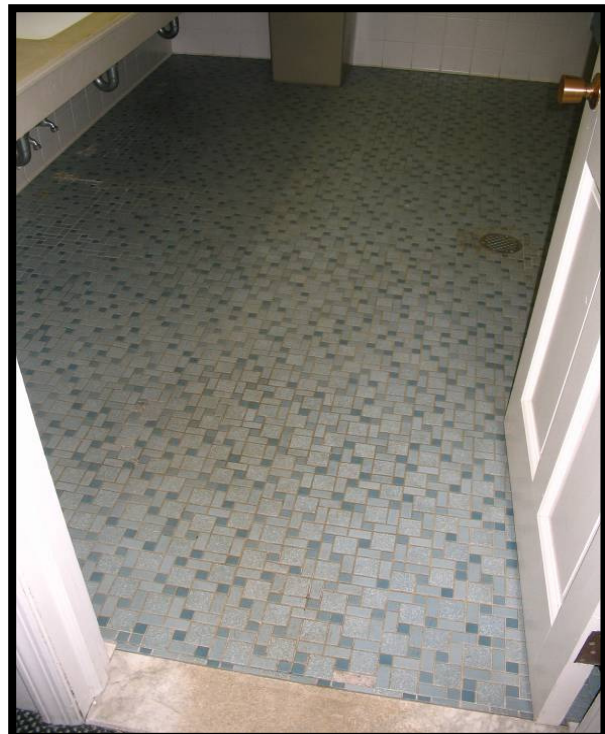
Photo No. 66

Depicts a view of the ceramic mosaic tile floor in the Women's Toilet Room.

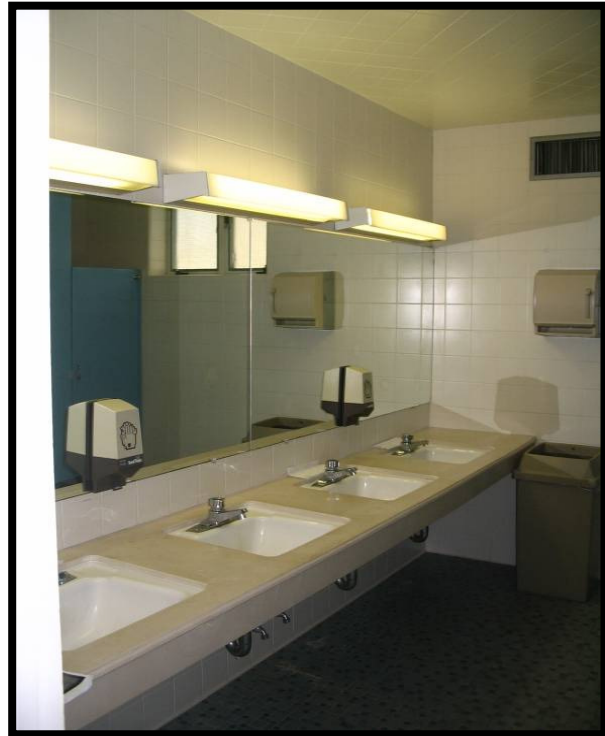
Photo No. 67

Depicts a view of the vanity with four (4) lavatories on the east wall of the Women's Toilet Room.

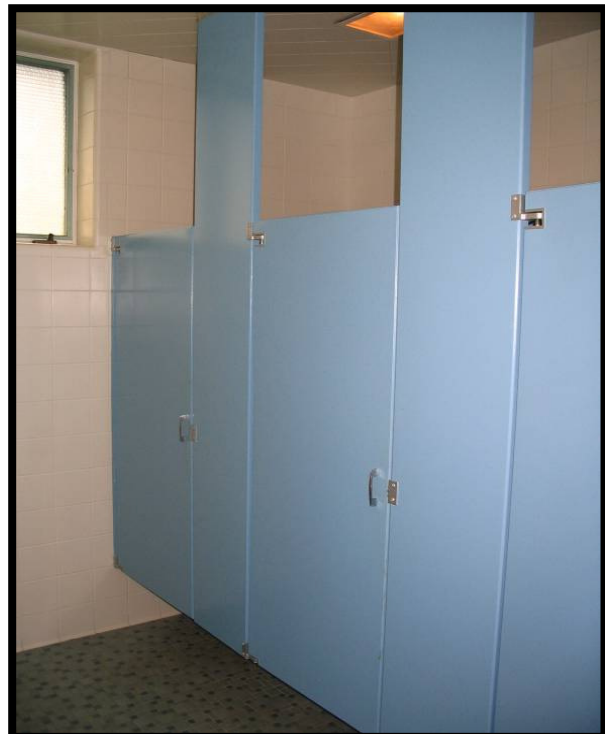
Photo No. 68

Depicts a view of the ceiling hung metal toilet partitions at the west wall of the Women's Toilet Room.

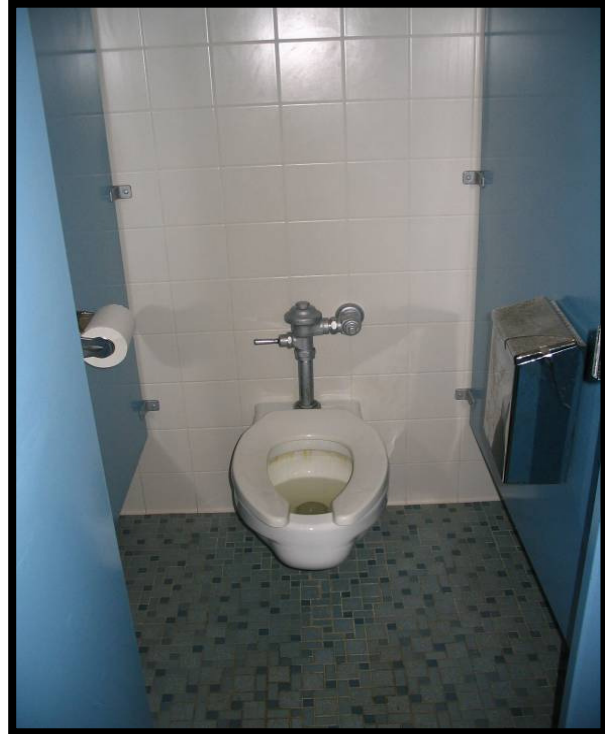
Photo No. 69

Depicts a view of a typical wall hung water closet in the Women's Toilet Room.

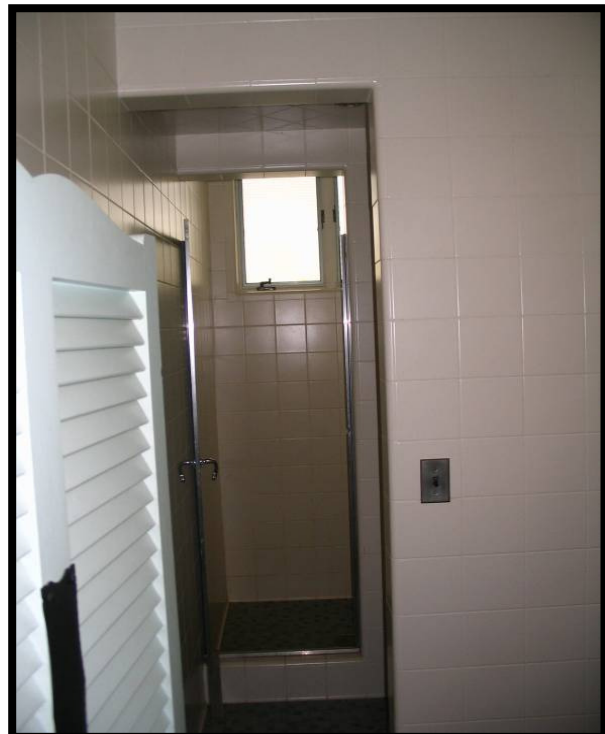
Photo No. 70

Depicts a view looking into one (1) of the two (2) typical shower stalls in the Women's Shower Room.

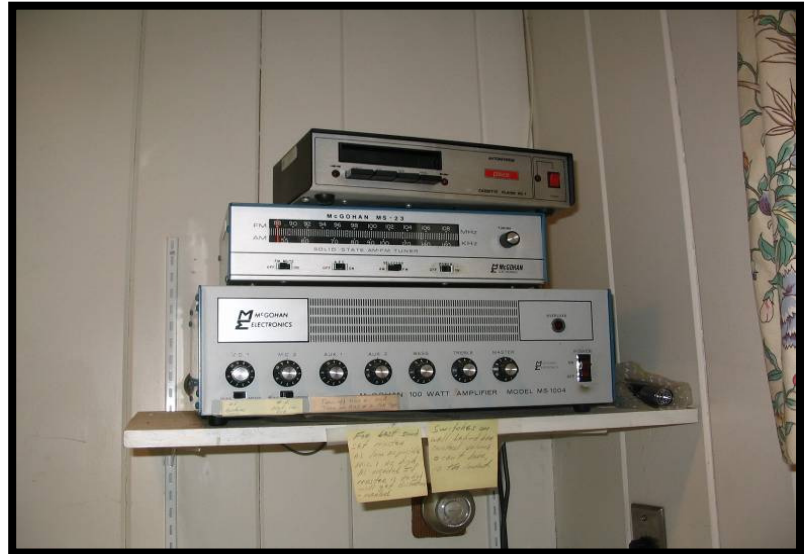
Photo No. 75

Depicts a view of the controls for the public address system located in the Manager's Office. The speakers for this system are located at the second floor level in the Banquet Room.

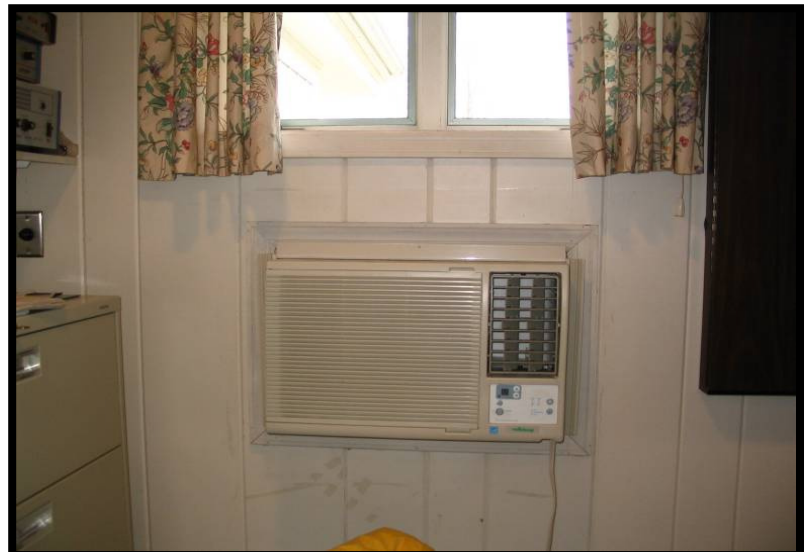
Photo No. 76

Depicts a view of a through-wall air conditioning unit in the Manager's Office.

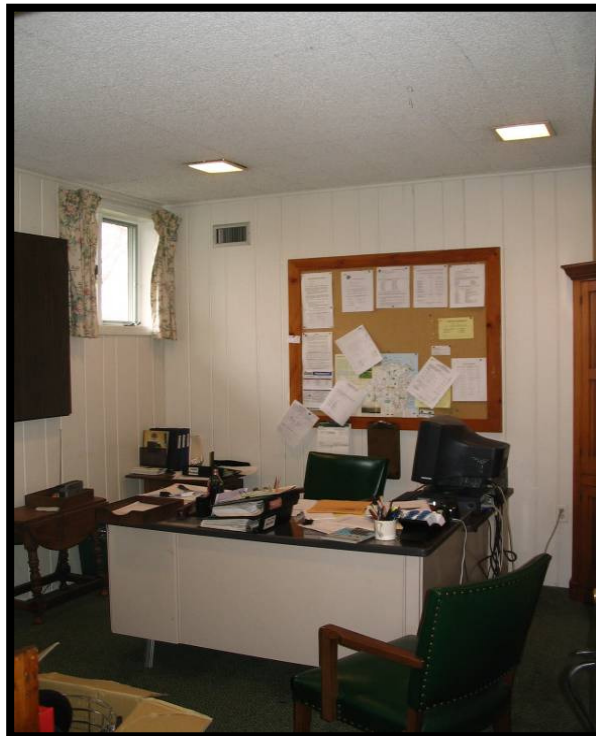
Photo No. 77

Depicts a view looking to the west in the Manager's Office.

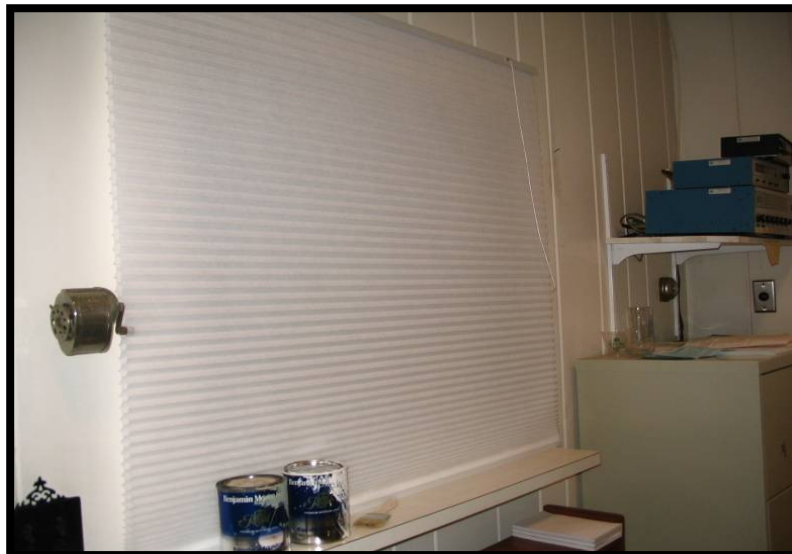
Photo No. 78

Depicts a view of the vision window located in the Manager's Office.

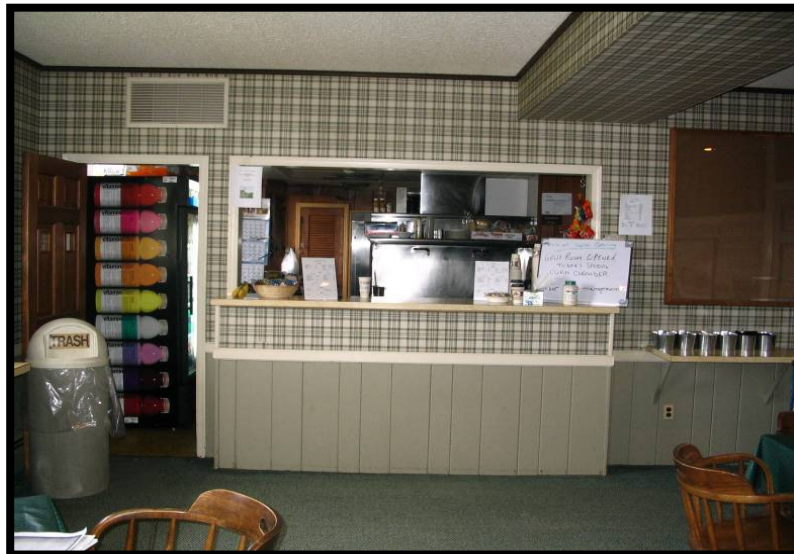
Photo No. 79

Depicts a view looking to the east at the pass-through in the Snack Bar.

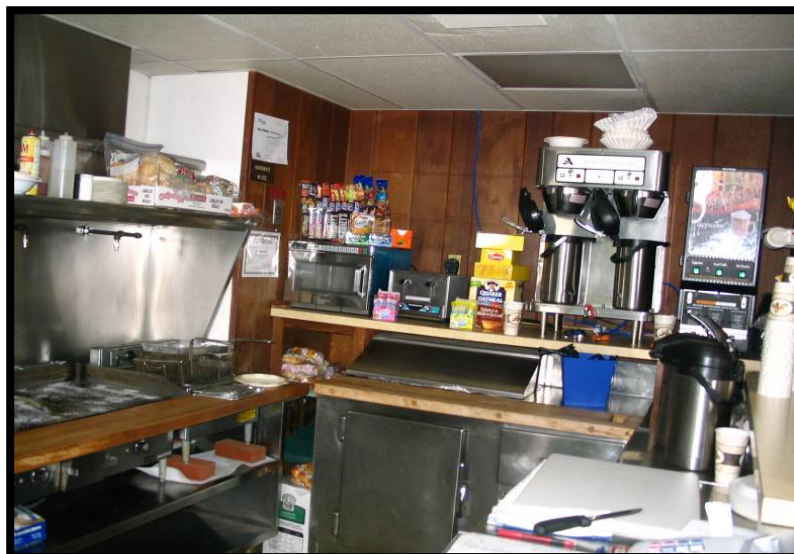
Photo No. 80

Depicts a view of the southern wall in the Snack Bar.

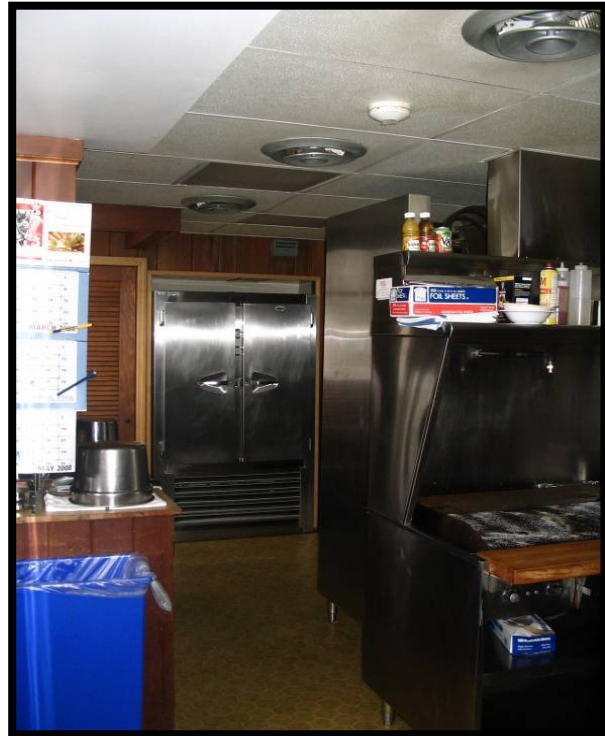
Photo No. 81

Depicts a view looking to the east into the Snack Bar kitchen.

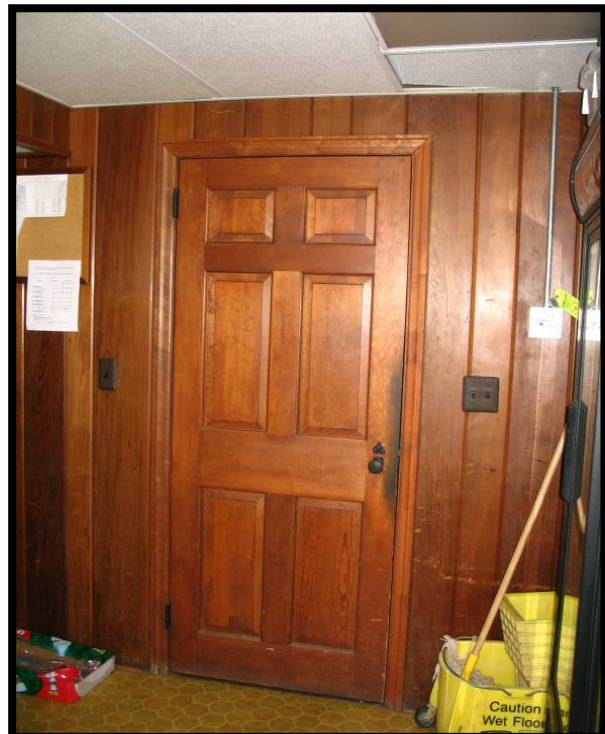
Photo No. 82

Depicts a view of the door leading from the Snack Bar kitchen out to the Men's Lounge hallway.

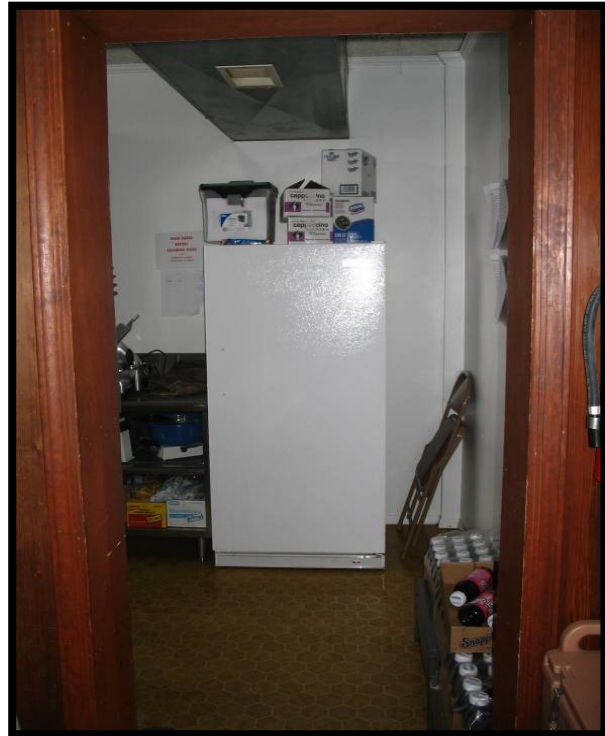
Photo No. 83

Depicts a view looking to the east into the storage room adjacent to the Snack Bar.

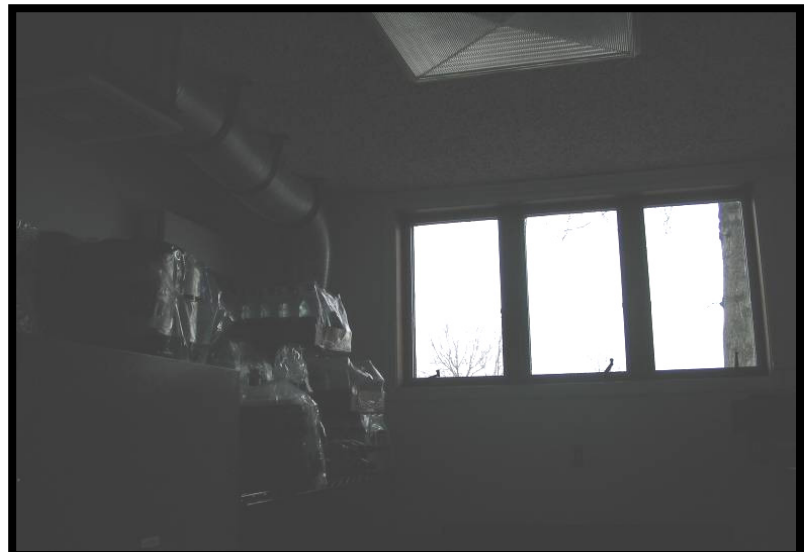
Photo No. 84

Depicts a view of the northern wall of the Snack Bar storage room.

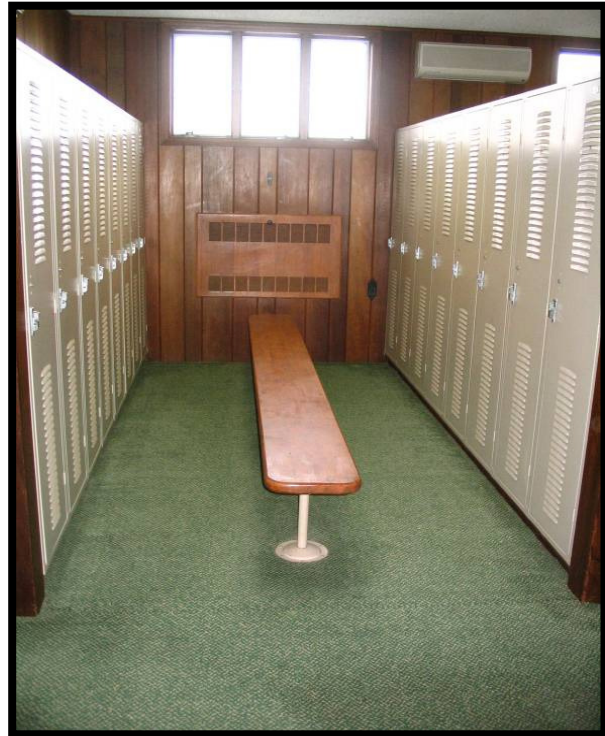
Photo No. 85

Depicts a view of a typical bay of lockers and bench in the Men's Locker Room.

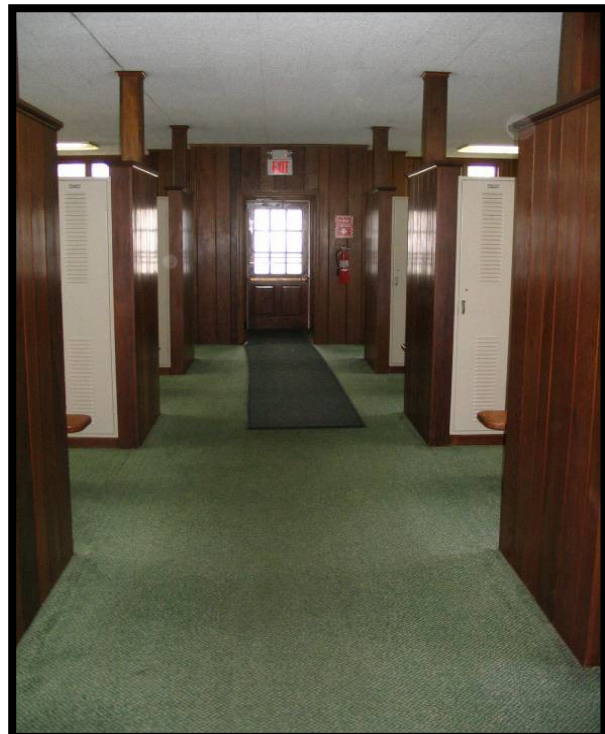
Photo No. 86

Depicts a view looking to the east in the Men's Locker Room.

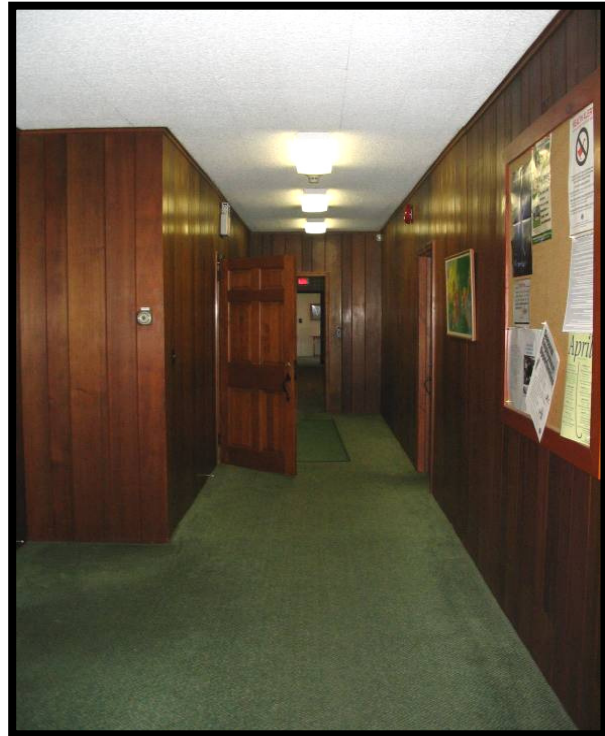
Photo No. 87

Depicts a view looking to the west from the Men's Locker Room.

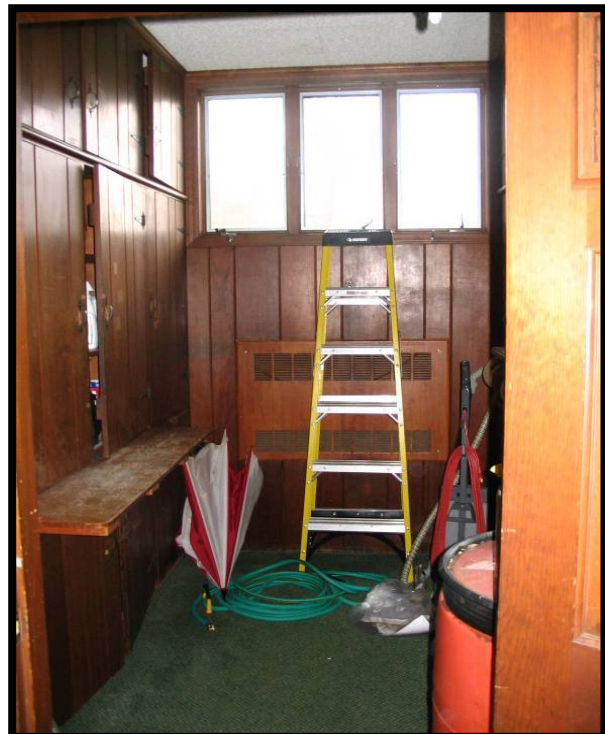
Photo No. 88

Depicts a view looking to the south into the Maintenance Shop.

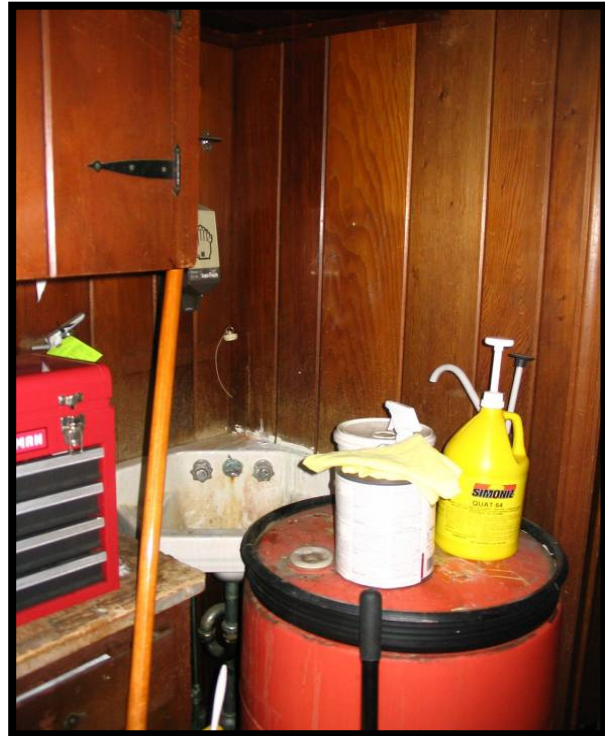
Photo No. 89

Depicts a view of a corner wall hung lavatory located in the Maintenance Shop.
