LAN ASSOCIATES

**CONDITIONS ASSESSMENT
& RECOMMENDATIONS
FOR THE
HOMINY HILL CLUBHOUSE (BUILDING 1301)
HOMINY HILL GOLF COURSE
COLTS NECK, NJ**

LAN REFERENCE #2.2882.2
August 11, 2008

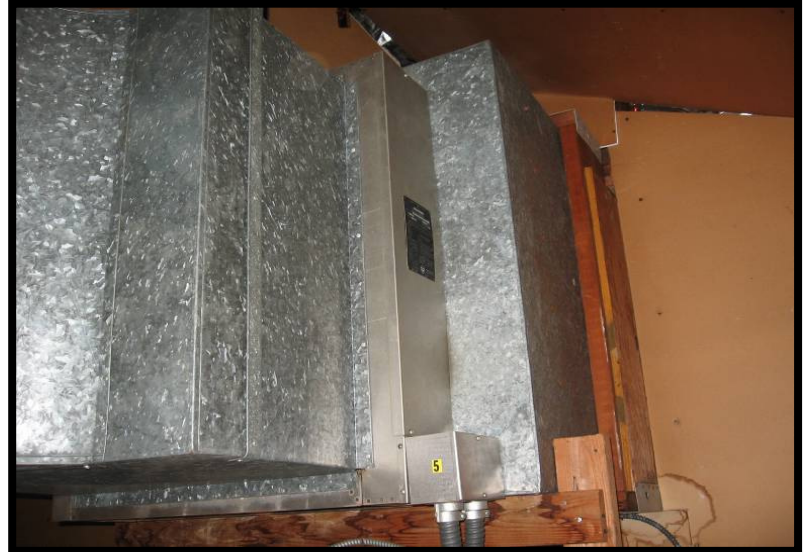
Photo No. 1

Overall view of the electric duct heater abandoned in place in the make-up air duct leading to the four (4) air handlers in the attic above the Banquet Hall. The electric heater is abandoned and should be removed and ductwork modified.

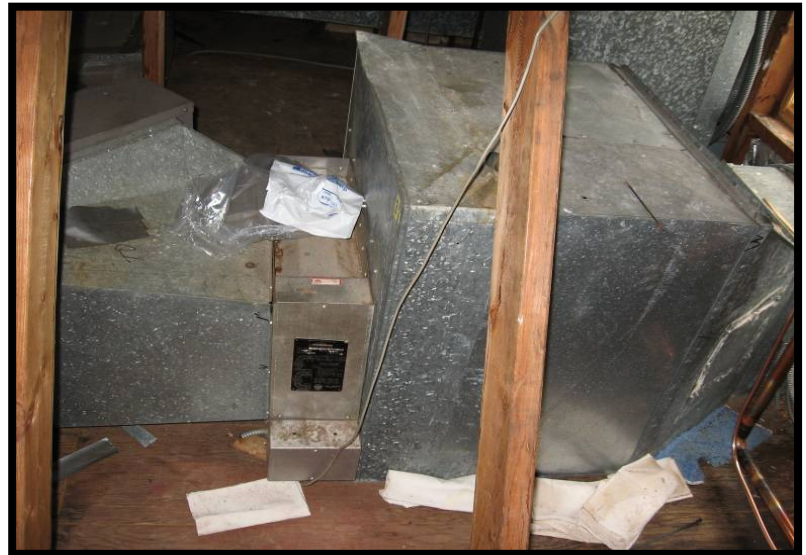
Photo No. 2

Make-up air duct leading to the kitchen. This is one the southeast end of the attic. Electric duct heater can be seen in the center of the photo. This is abandoned in place.

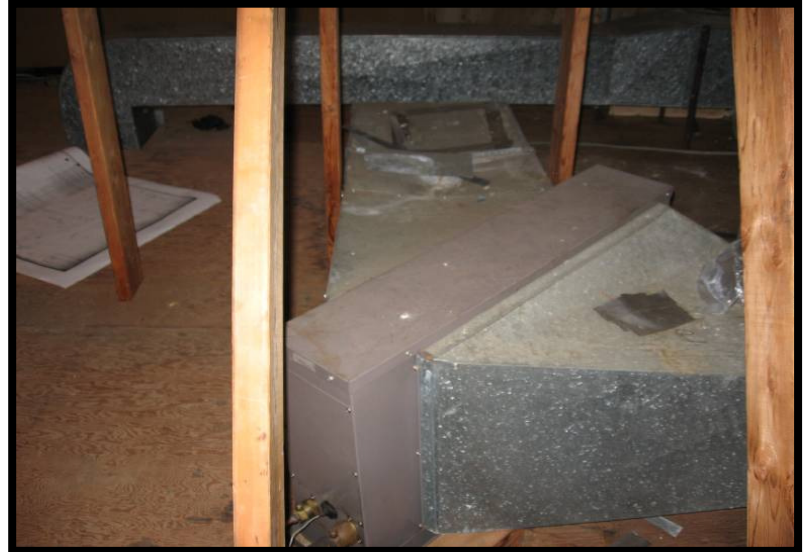
Photo No. 4

View of make-up air to kitchen area. Cooling coil can be seen in photo.

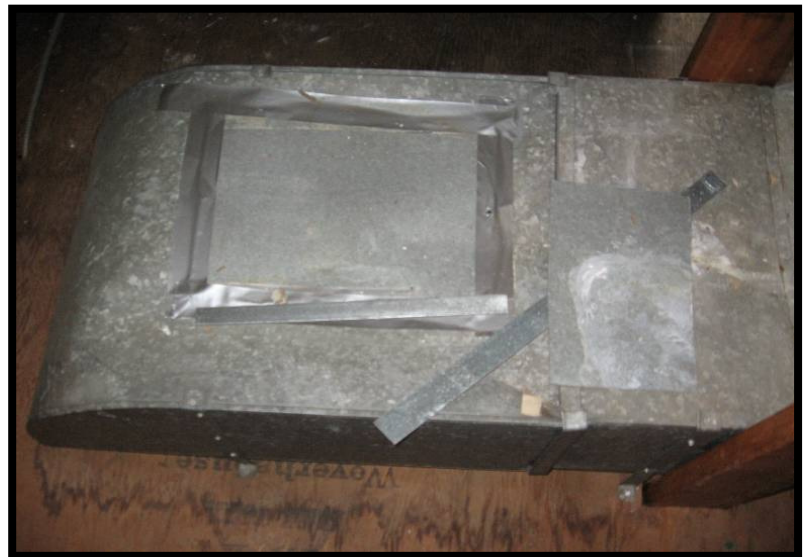
Photo No. 5

View of patches made to ductwork leading down to kitchen area to supply air to the kitchen.

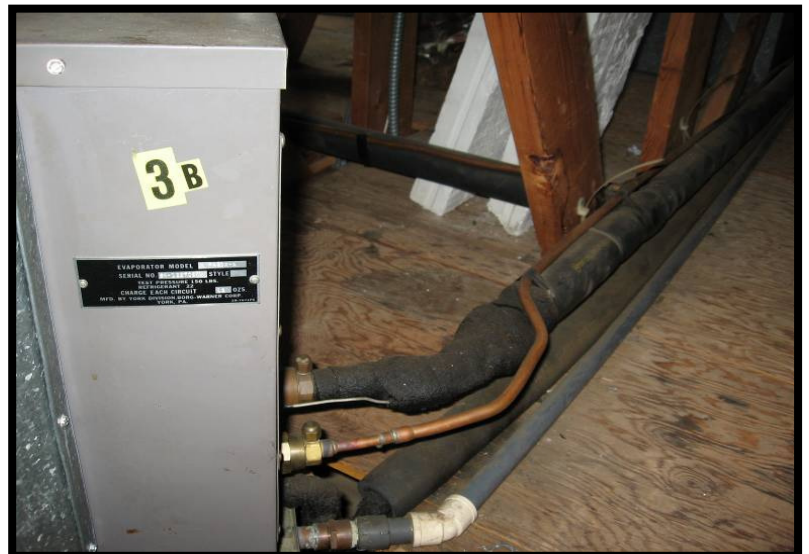
Photo No. 6

View of side of evaporator coil for make-up air to kitchen at northeast corner. Also shown in photo is the condensate line from drip pan, condensate line from the coil and liquid and suction lines which run in a southerly direction.

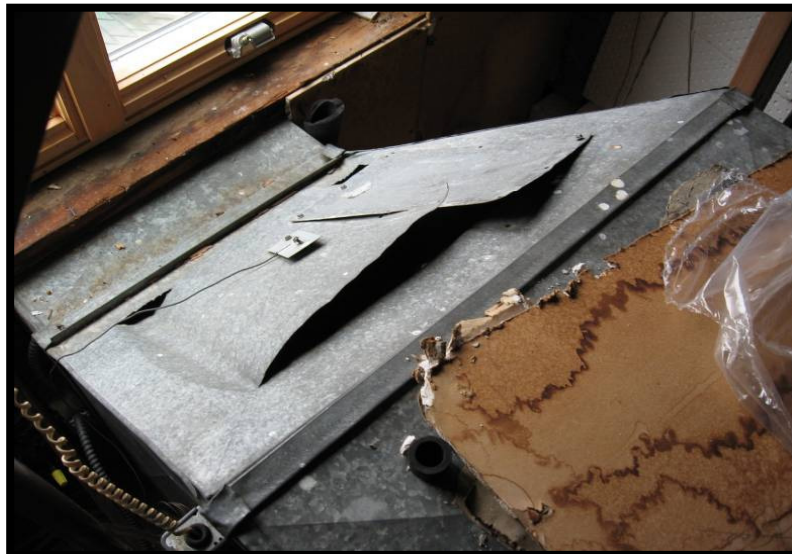
Photo No. 7

View of fresh air duct leading to the southeast end of the kitchen. Photo shows the condition of the ductwork which has been cut open and not properly sealed.

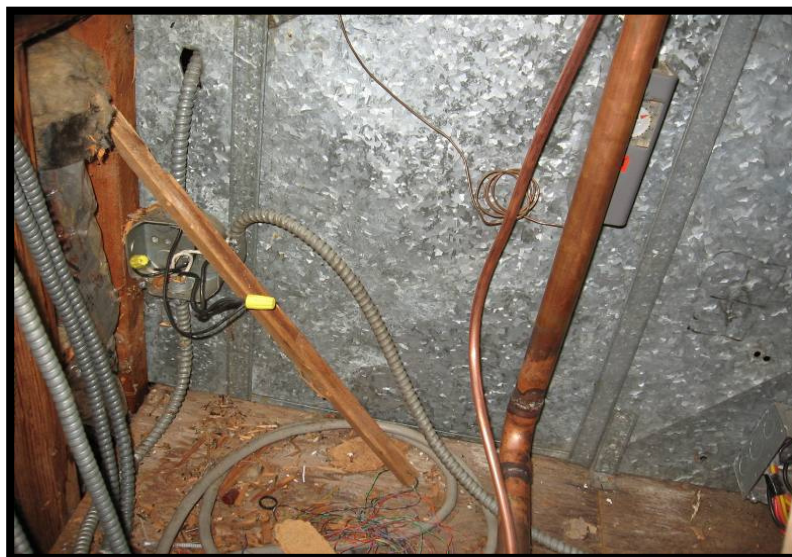
Photo No. 8

View of fresh air inlet at northeast end of kitchen showing open electrical junction box on side.

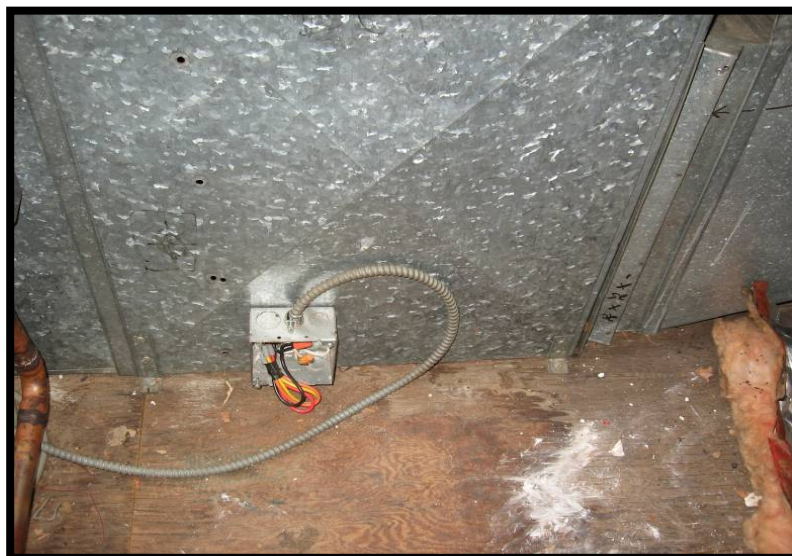
Photo No. 9

Ditto previous photo further to the west showing another open junction box.

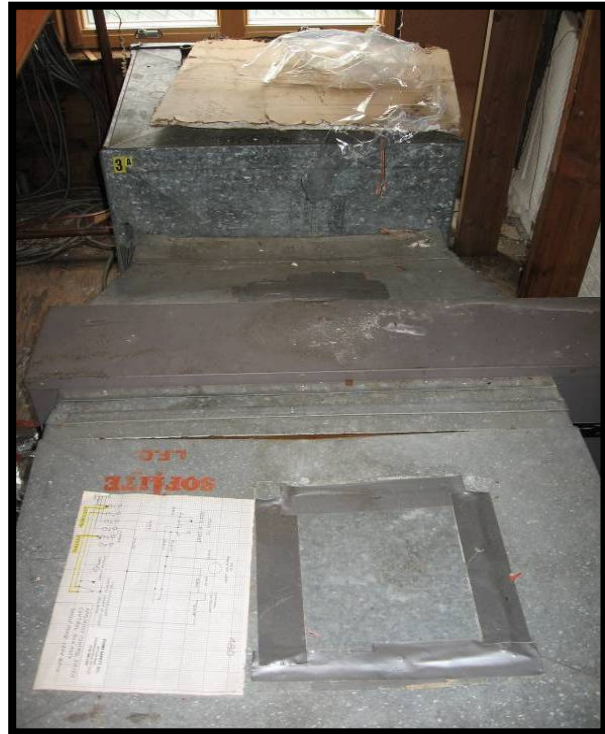
Photo No. 10

Overall view of make-up air unit on northeast side of kitchen. Cooling coil is in middle of photo.

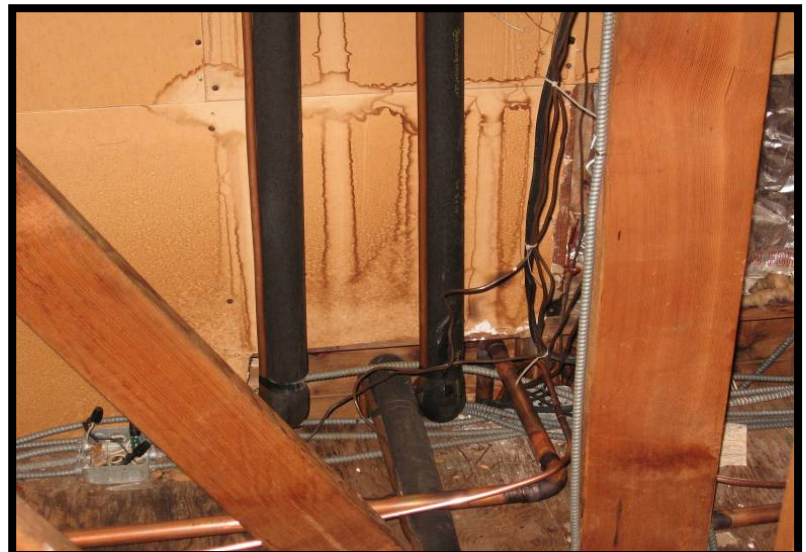
Photo No. 11

Far east wall of attic over kitchen area showing the liquid and suction lines for the various pieces of equipment. The two (2) vertical lines service the old air handlers for the lower ceiling area of the Banquet Hall. The horizontal insulated line services the two (2) evaporator coils for the kitchen. The uninsulated lines running from left side of photo to right are the refrigerant lines servicing the new Carrier unit for the open ceiling area of the Banquet Hall.

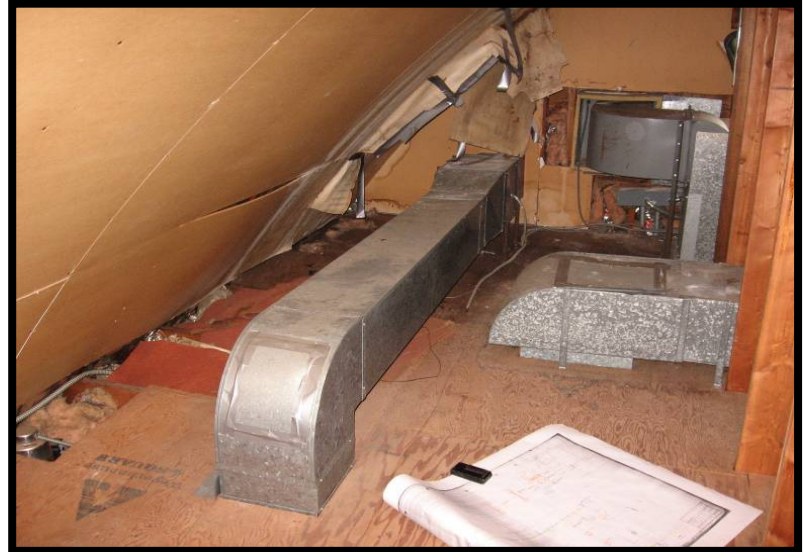
Photo No. 12

Overall view of general exhaust for kitchen. Exhaust fan is located within the ductwork. This fan was operational and was operated by a manual on/off switch.

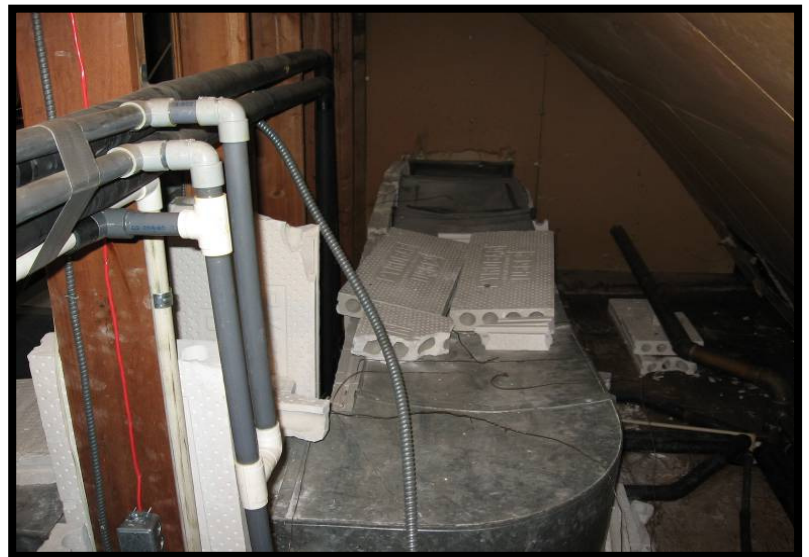
Photo No. 13

Overall view of kitchen hood ductwork showing gypsum block compromised on the majority of the upper part of the ductwork.

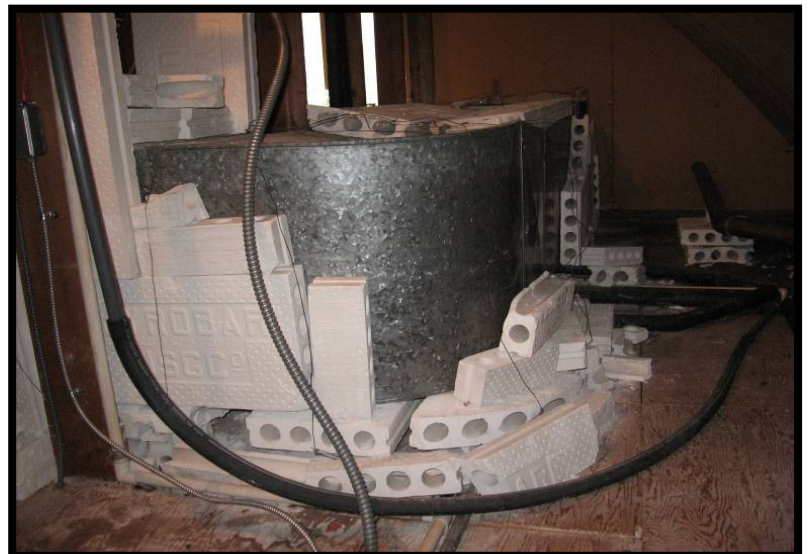
Photo No. 14

View of side of kitchen duct showing compromises to the gypsum block.

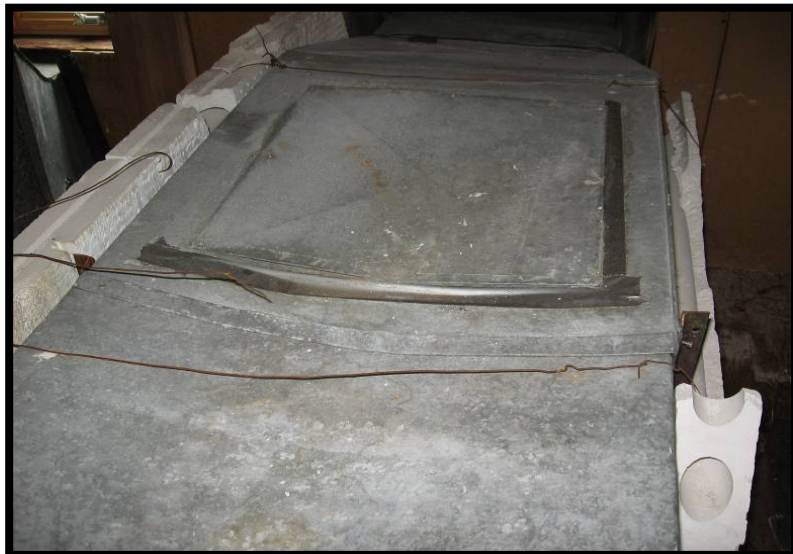
Photo No. 15

View of cut out patch made to the kitchen exhaust duct towards the outside of the building.

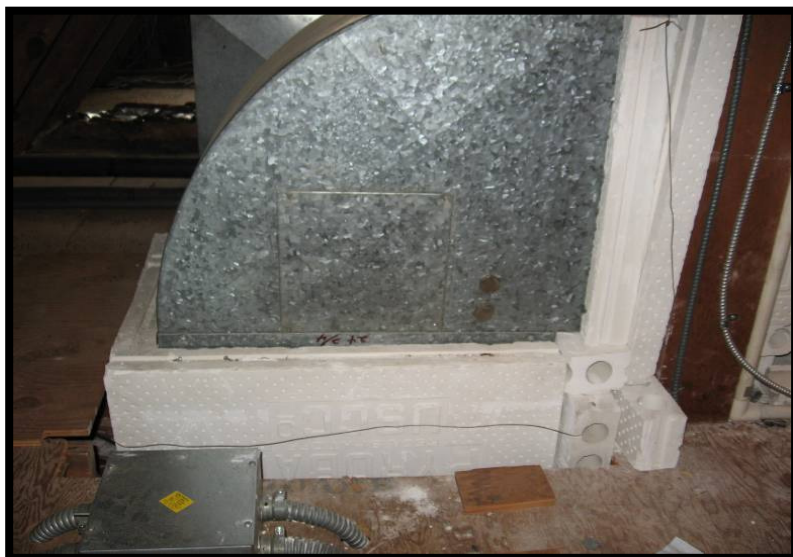
Photo No. 16

View of cut in ductwork servicing the kitchen hood exhaust fan which was patched. This is not proper.

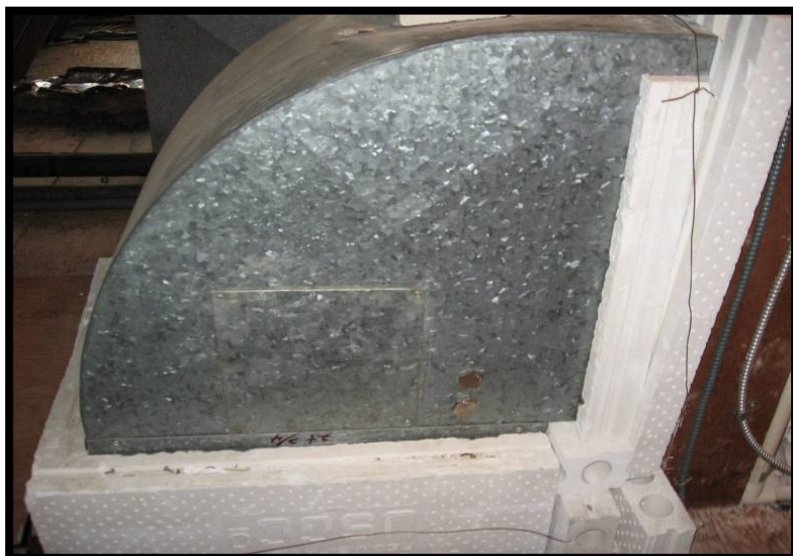
Photo No. 17

Ditto previous photo from a different angle.

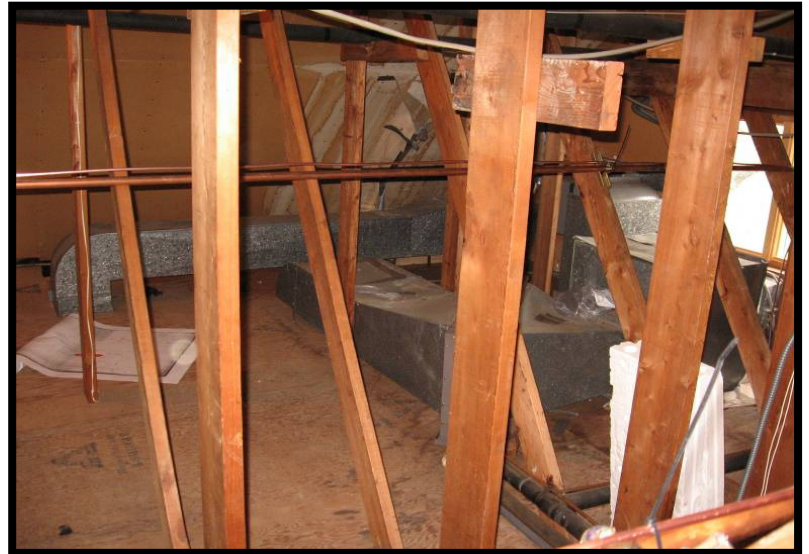
Photo No. 18

Overall view of the attic area at the southeast corner showing the make-up air ductwork to the kitchen and in the far background the general exhaust to the kitchen.

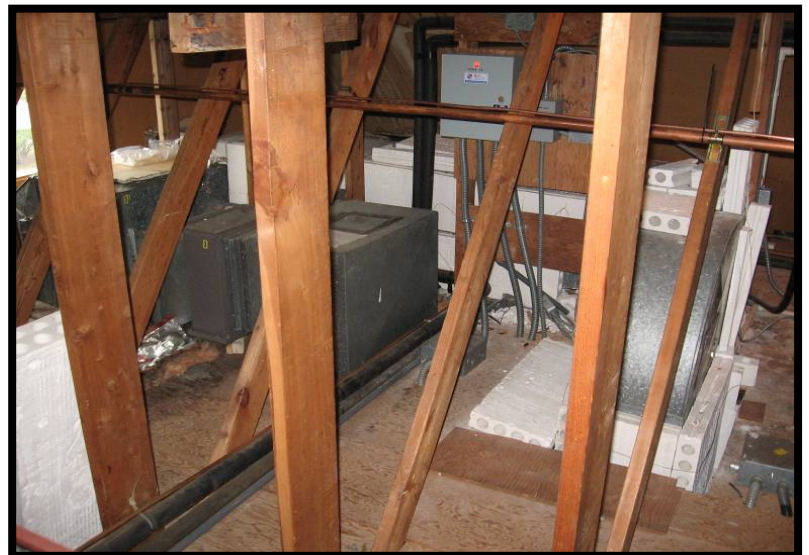
Photo No. 19

Overall view of attic conditions at the northeast corner of the attic. Make-up air unit to kitchen is in foreground. Kitchen hood exhaust duct is in the background.

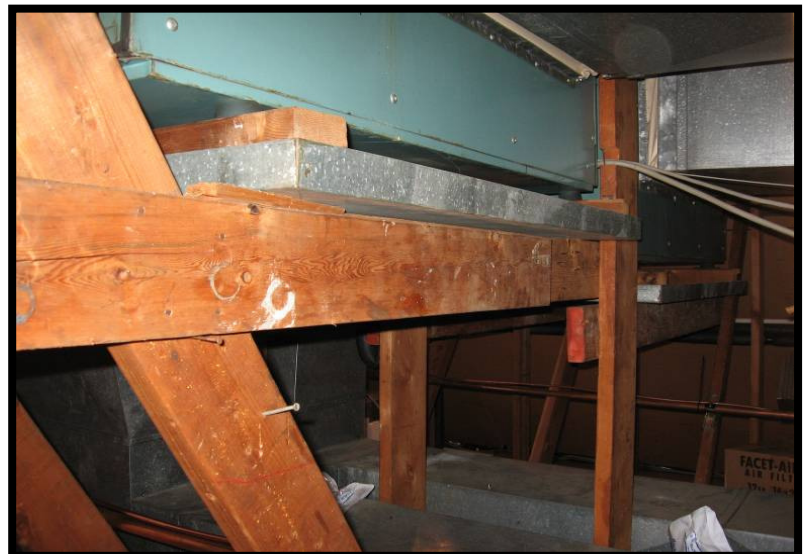
Photo No. 20

Side of AHU-2 showing the splice support member attached to the roof truss system. This should be a solid member and lag bolted into the support members.

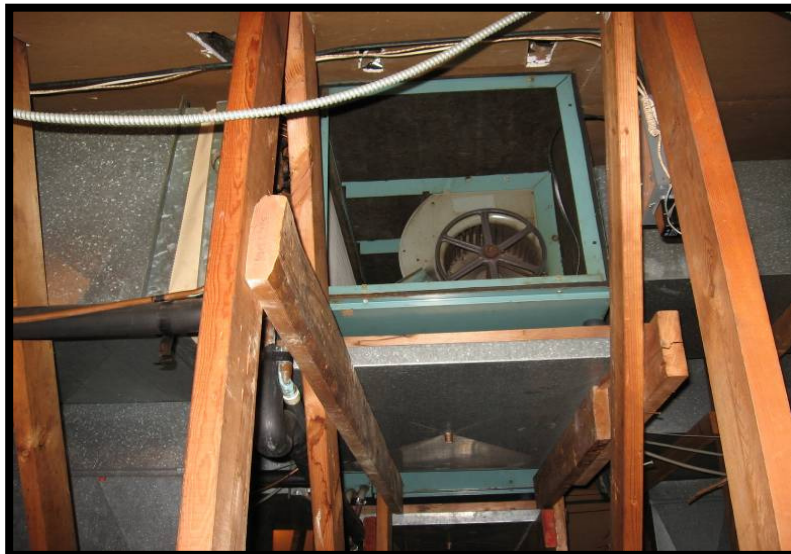
Photo No. 21

Overall view of air handler unit 2. The cover on the unit is off. This is a York unit, size unknown.

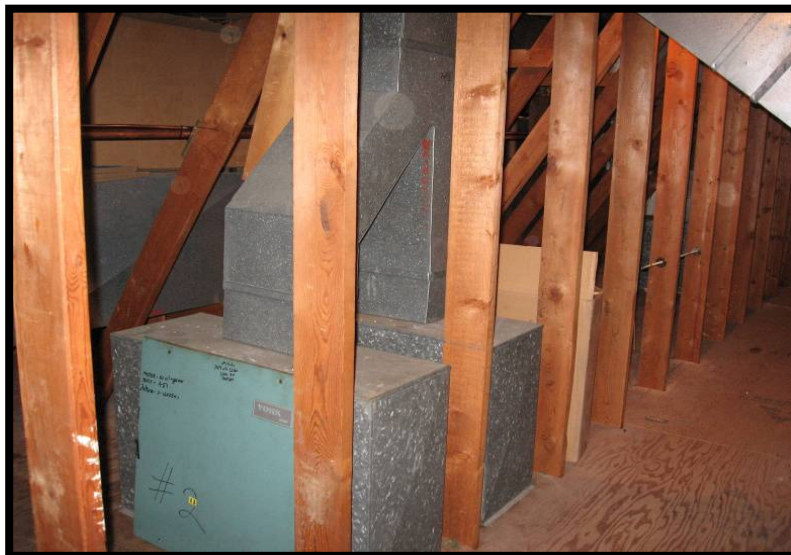
Photo No. 22

View of supply duct tap offs to air diffusers below from AHU-2.

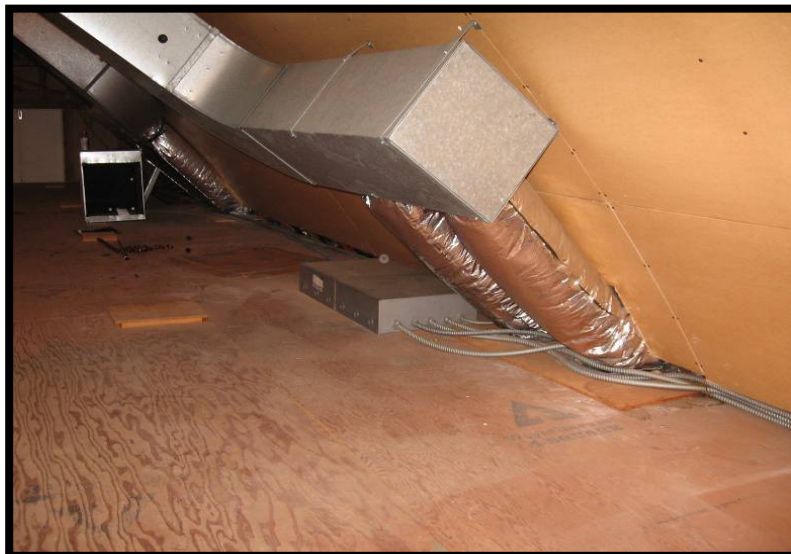
Photo No. 23

View of connection to flex duct to additional supply air diffusers off of AHU-2.

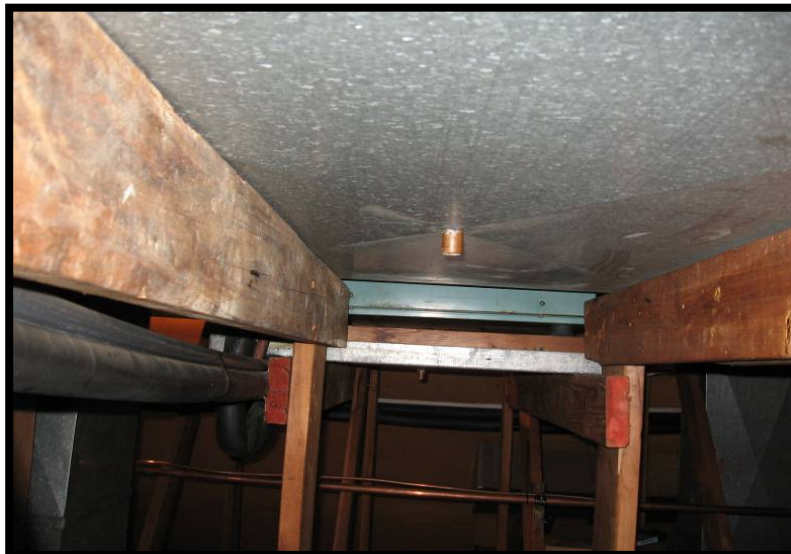
Photo No. 24

View of missing condensate drain pan connection.
Any drips into the drain pan would leak right on to the
plywood of the attic.

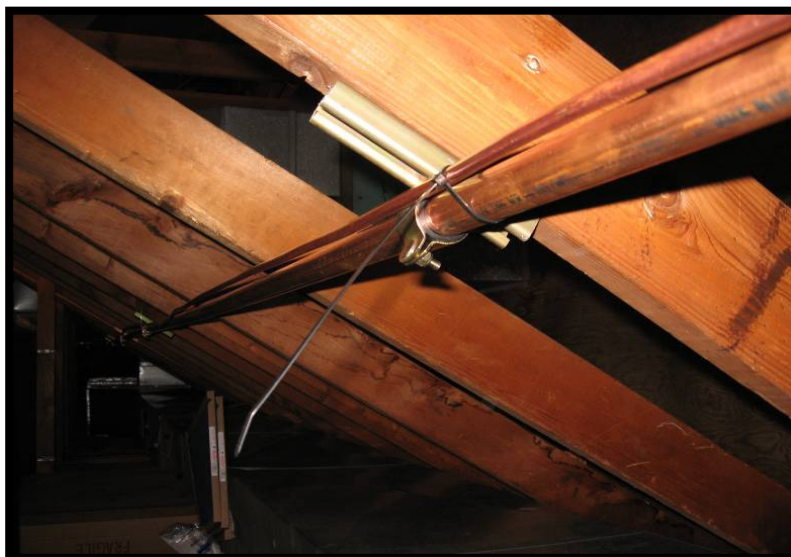
Photo No. 25

View of uninsulated refrigerant line going to the new
Carrier unit servicing the open banquet area.

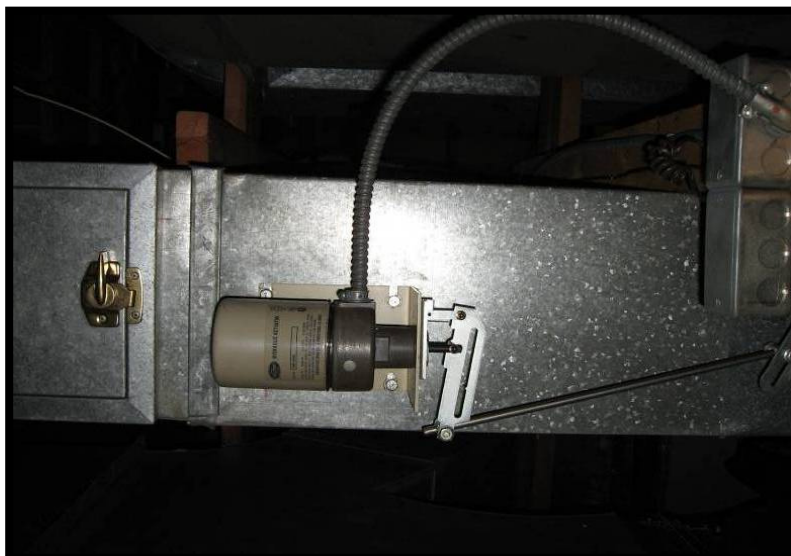
Photo No. 26

Overall view of the damper actuator in the supply
ductwork leading to the banquet area.

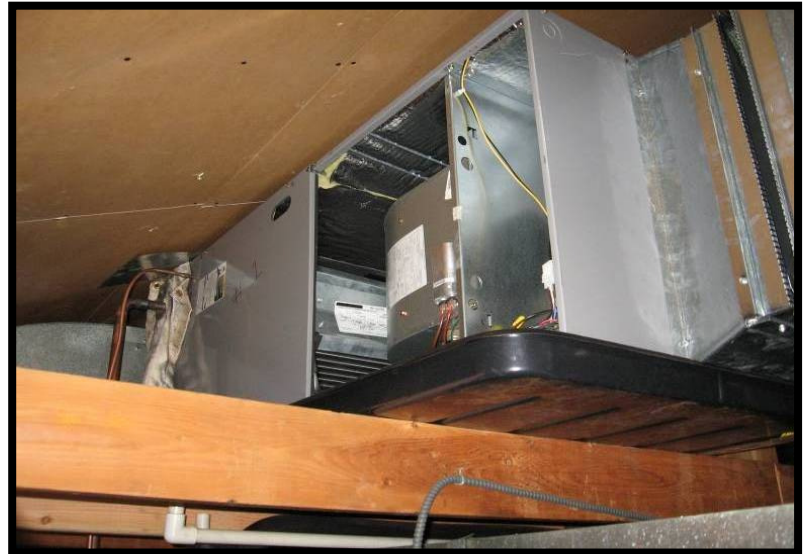
Photo No. 27

Overall view of newly installed Carrier unit identified as unit #1. For purposes of this report the unit will be identified as unit #4. This unit services the south side of the upper ceiling banquet area. Installation is incomplete. The disconnect switch for the unit is hanging.

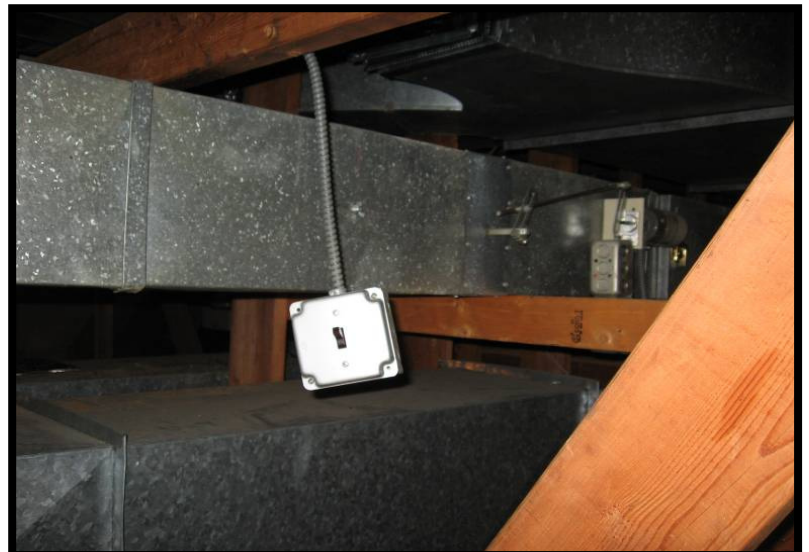
Photo No. 28

View of hanging disconnect switch for air handler unit #4.

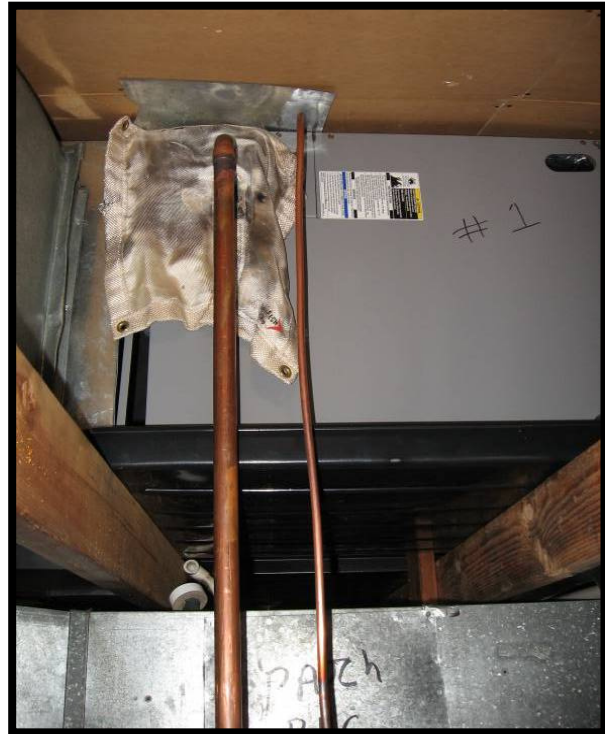
Photo No. 29

View of uncompleted piping work to AHU-4.

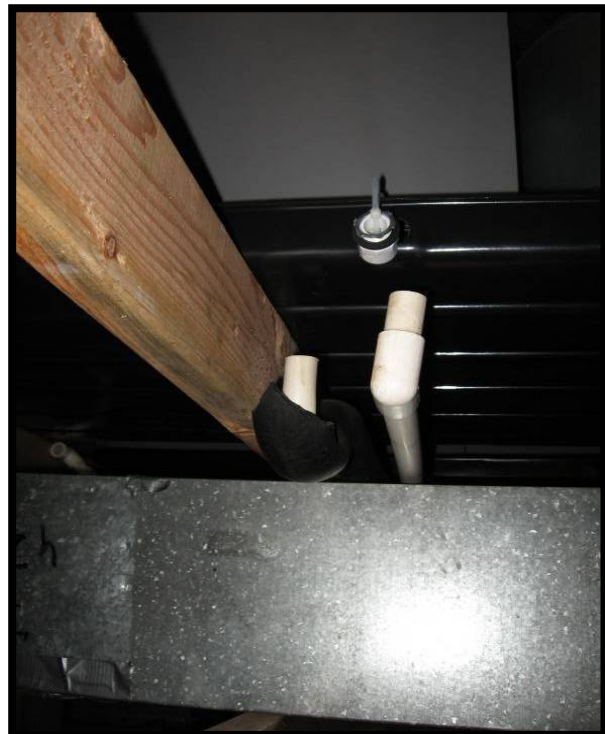
Photo No. 30

View of uncompleted condensate line to AHU-4.

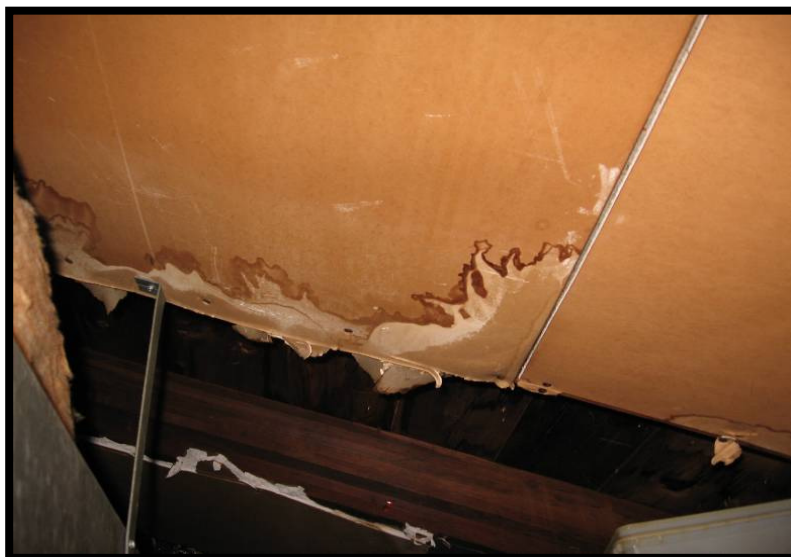
Photo No. 32

View of missing sheetrock on ceiling of attic at the far northwest corner. Insulation has also been removed above the sheetrock.

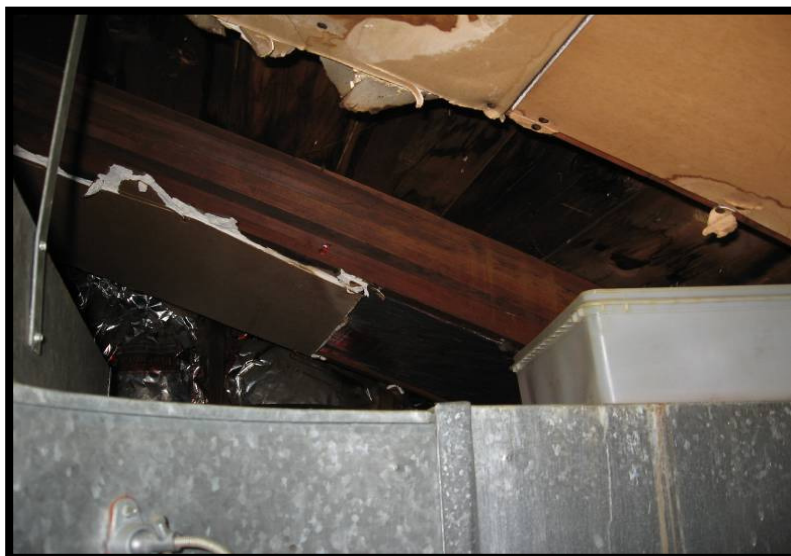
Photo No. 33

Ditto previous photo.

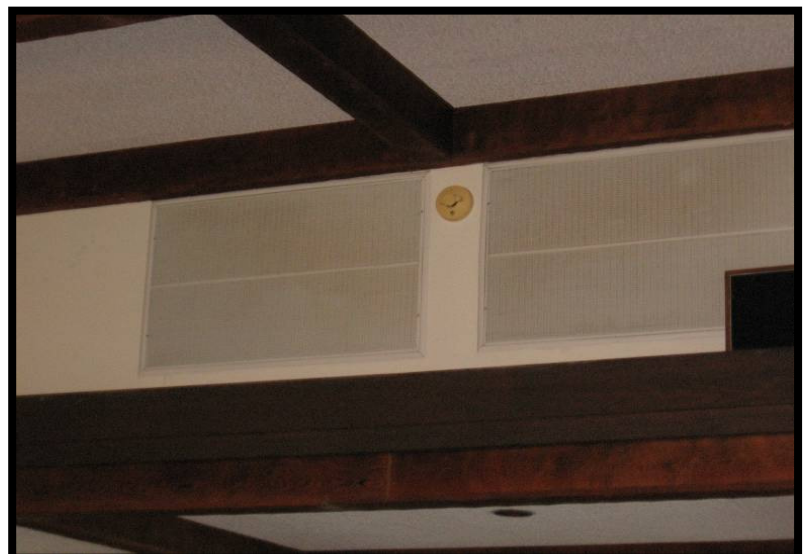
Photo No. 39

View showing the return air grilles for AHU's 1 through 4. Smoke detector can be seen between the grilles. This is the only smoke detector in the Banquet Hall high ceiling area.

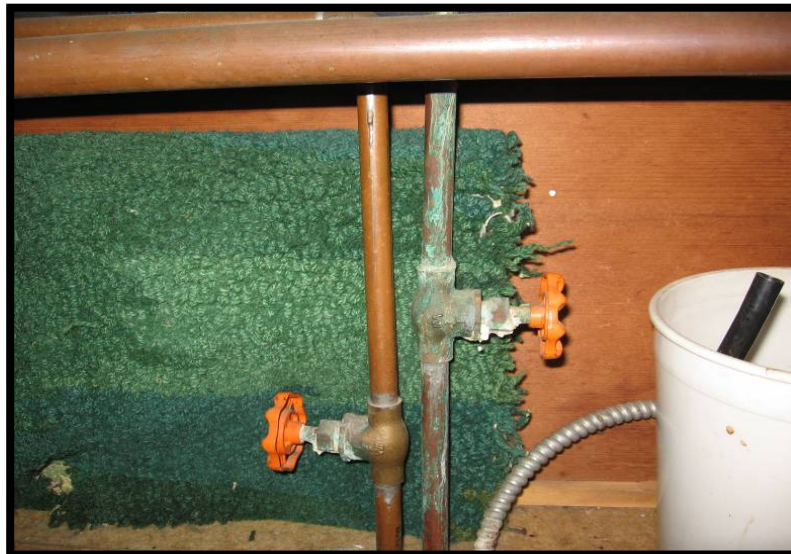
Photo No. 45

View of hot and cold water isolation valves to faucet at double basin sink in bar area of Banquet Hall. Isolation valves were not operational and it was recommended that they be replaced.

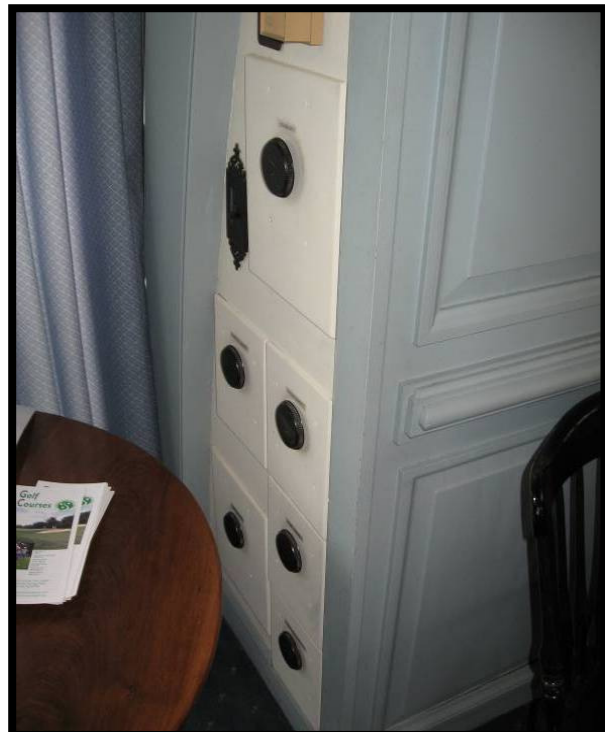
Photo No. 50

View of old Rheostat type dimmer switches operating the light fixtures on the Banquet Hall level.

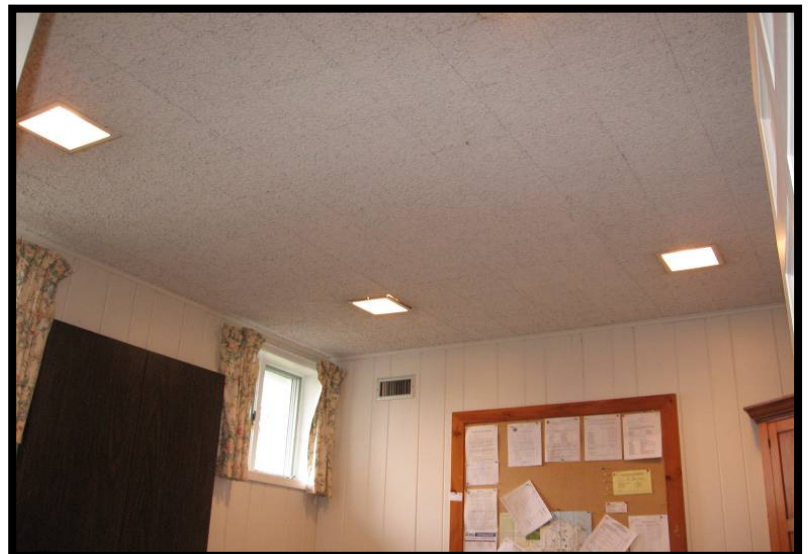
Photo No. 53

Overall view of the ceiling in the manager's office showing lighting which could be improved with fluorescent lighting for better lighting levels and energy conservation.

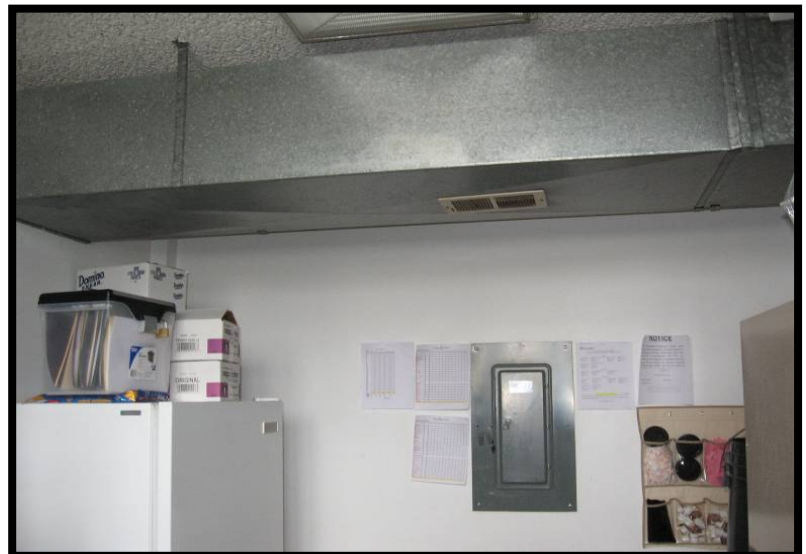
Photo No. 62

Ditto previous photo from a different angle showing ductwork at the ceiling which may be abandoned.

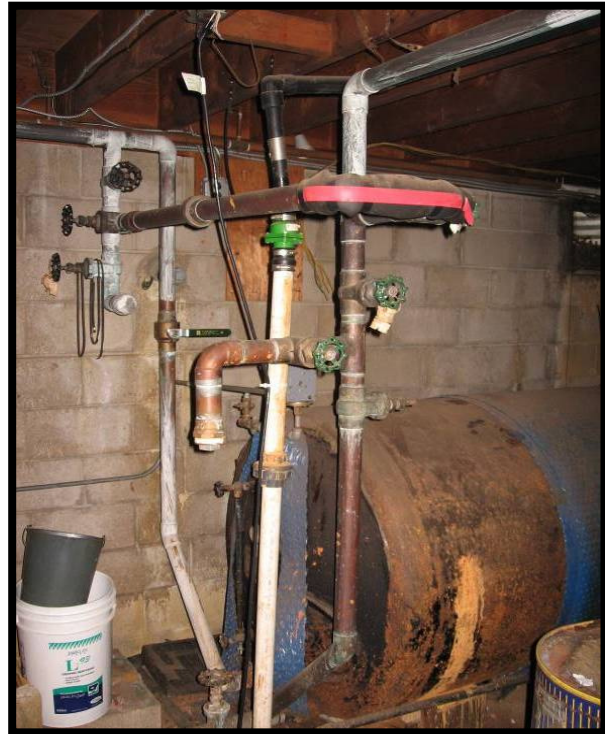
Photo No. 63

View of incoming water line piping. Vertical line at the lower half of the photo connects to the abandoned water storage tank. This should all be cut out and removed.

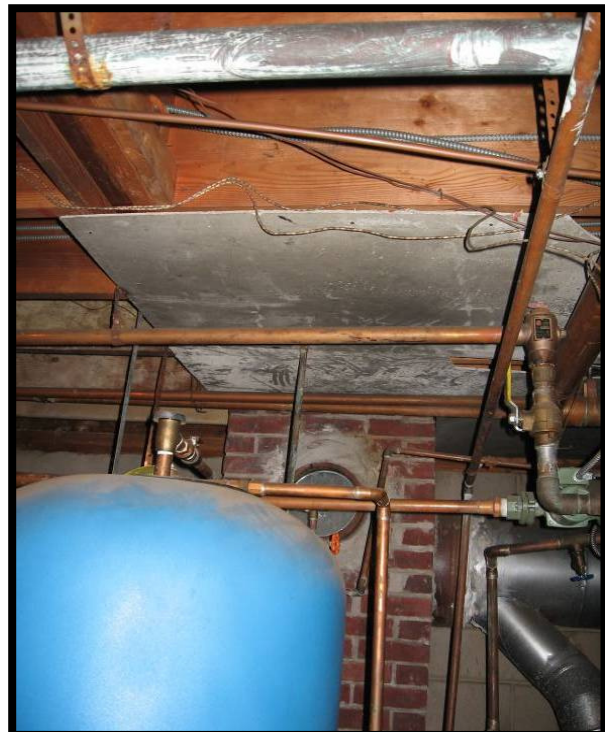
Photo No. 64

View of existing transite panel above domestic water storage tank. This could possibly contain asbestos.
